HOOSIC RIVER BASIN
NORTH ADAMS, MASSACHUSETTS

ECLIPSE DAM
MA 00279

PHASE I INSPECTION REPORT
NATIONAL DAM INSPECTION PROGRAM

MARCH 1980

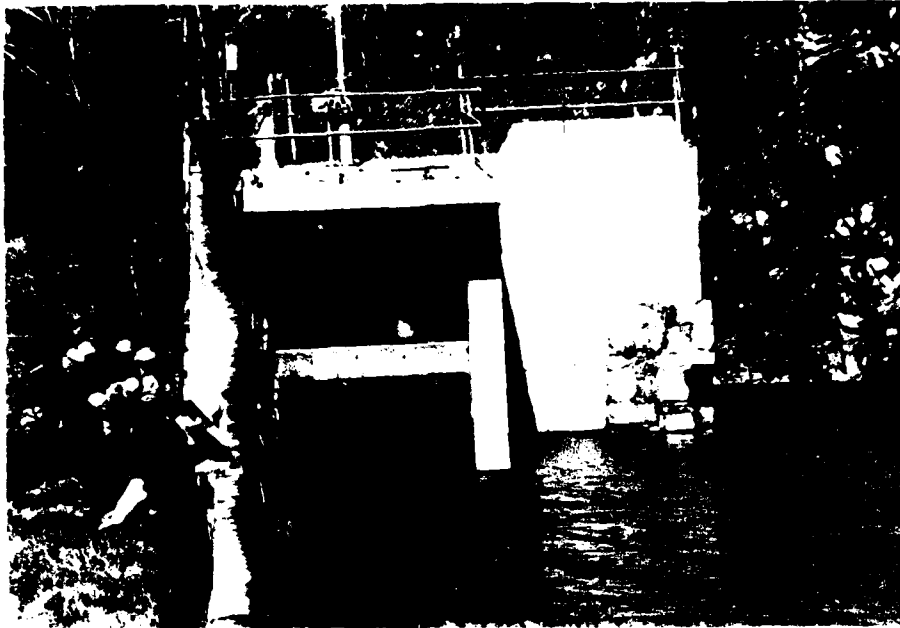
- (3) Several very small trees are growing in the masonry open joints of the spillway sidewalls as indicated in Photo 3.
- c. Appurtenant Structures - The outlet works shown in Photo 7 was found to be in good condition except that the 48-inch sluice gate was not operable due to an electrical problem. The power utility repair crew was called during the inspection and were at work on the problem at the time of departure of the inspection team. One panel of grating has been replaced with steel plate at the operating platform as shown in Photo 8.

The upstream channel left wall was found to be in very good condition but the top of the wall has a very poor alignment as shown in Photo 7. The poor alignment may be due to poor construction or due to differential deflection of the wall. No cracking or distress was observed that would indicate the problem is one of deflection.

7. TELEPHOTO VIEW OF OUTLET WORKS. NOTE ALIGNMENT OF LEFT UPSTREAM CHANNEL WALL.

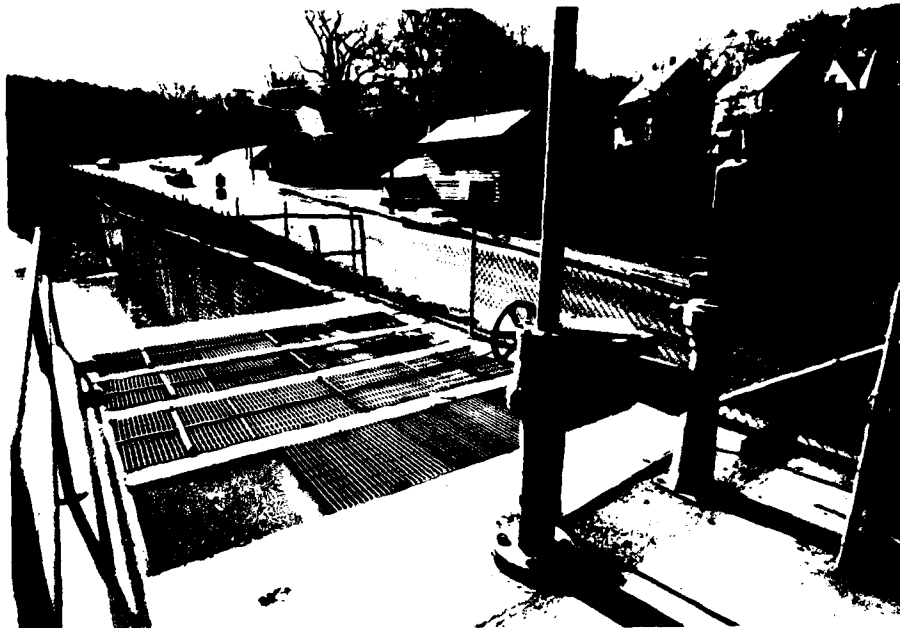
8. VALVE OPERATORS ON OUTLET WORKS PLATFORM.

- (5) Replace the steel plate on the operating platform with a grating panel.
- (6) Repair any eroded areas of ledge adjacent to the foundation of the downstream walls with concrete.

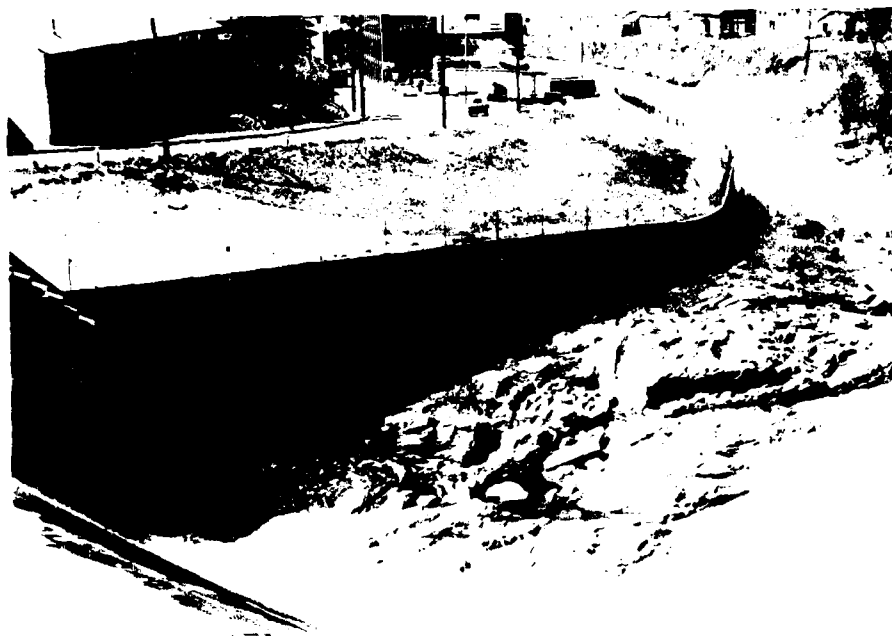
10. DOWNSTREAM CHANNEL. DISCHARGE PIPE FROM OUTLET WORKS AT END OF CONCRETE WALL LEFT SIDE OF PHOTO.

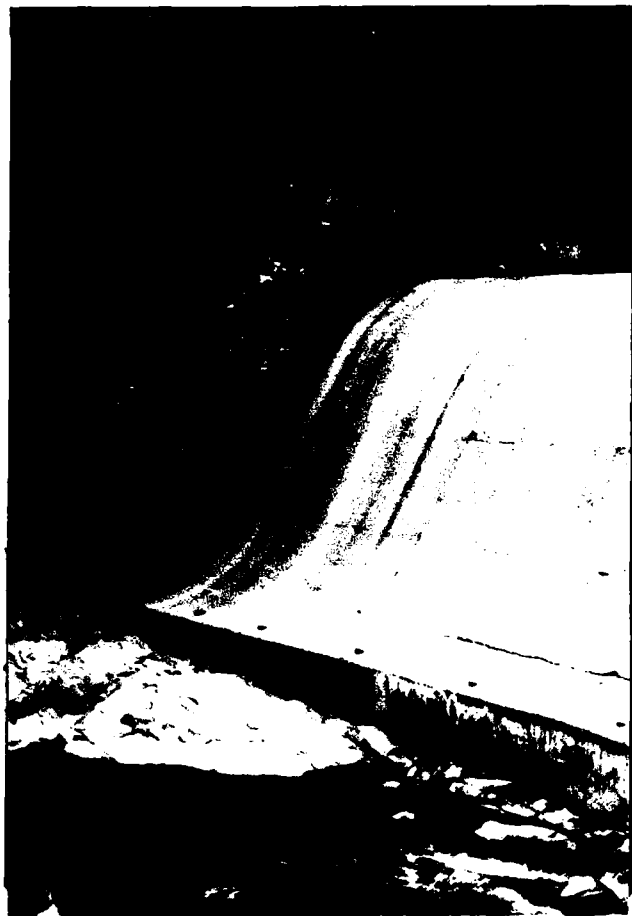
12. DOWNSTREAM FACE OF WEIR WITH NO
FLOW OVER SPILLWAY, PHOTO TAKEN
6 AUGUST 1979.
