SUDBURY RIVER BASIN  
FRAMINGHAM, MASSACHUSETTS

CENTRAL STREET DAM  
MA 00340

PHASE I INSPECTION REPORT  
NATIONAL DAM INSPECTION PROGRAM

FEBRUARY 1980

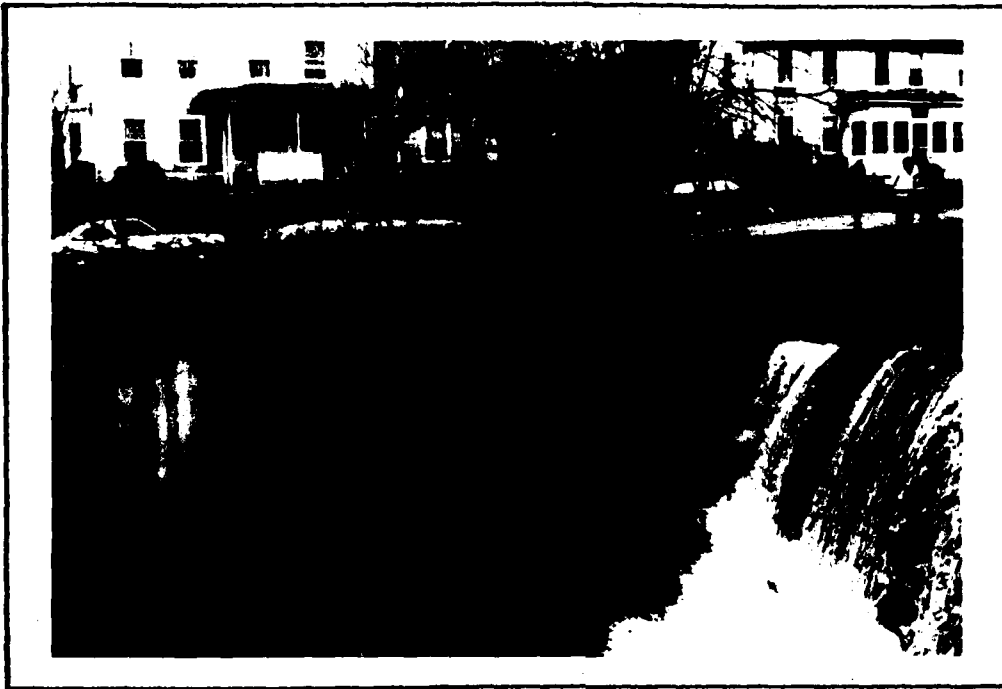
1. The right abutment of the dam consists of a vertical stone masonry wall which extends from a point approximately 30 feet downstream of the spillway to a point several hundred feet upstream of the dam. This wall shows signs of slight settlement, cracking of mortar between the cut granite stones forming its face, and some undermining at its base downstream of the spillway. These features are illustrated on photo 3 of Appendix C.

3. DETAILS OF RIGHT SPILLWAY ABUTMENT. (11/12/79)

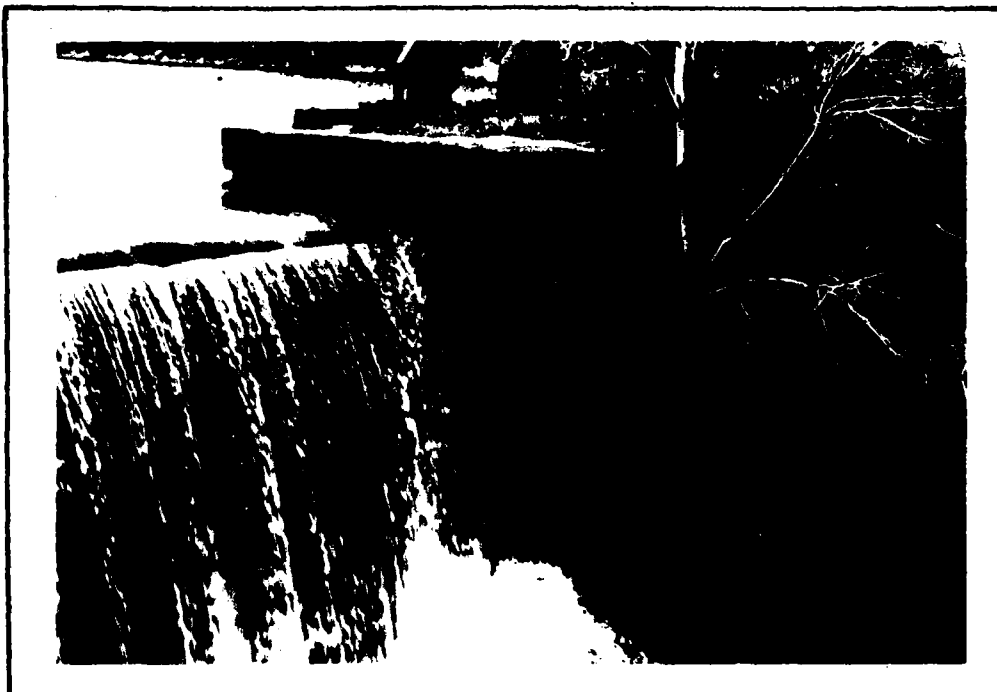
3. The stone masonry spillway abutment wall, the assumed inoperable outlet conduit gate structure and the embankment retaining walls extending to the left (east) of the spillway are in poor condition. Significant cracking and loss of mortar between individual stone blocks is evident. Trees and brush are growing from voids between the blocks in some locations (refer to pgs. C-2, 4 and 5). The spillway abutment wall to the left of the spillway has blocks which are displaced up to 6 inches from their original positions (refer to pgs. C-2, 4, and 5). Spurting seepage estimated at 10 gpm was discharging from the abandoned stone masonry gate structure near its intersection with the Central Street bridge abutment (refer to Pg C-5). It was noted that remedial grouting of the masonry has been performed in the vicinity of the leakage. The embankment section of the dam east of the bridge abutment appears to be in satisfactory condition.

4. CONDITIONS AT THE LEFT SPILLWAY ABUTMENT. (11/12/79)

2. All of the masonry construction, including the spillway and especially the spillway abutment wall and abandoned gate structure east of the spillway, should be inspected during a period of reservoir drawdown to more accurately assess the condition of these structures.

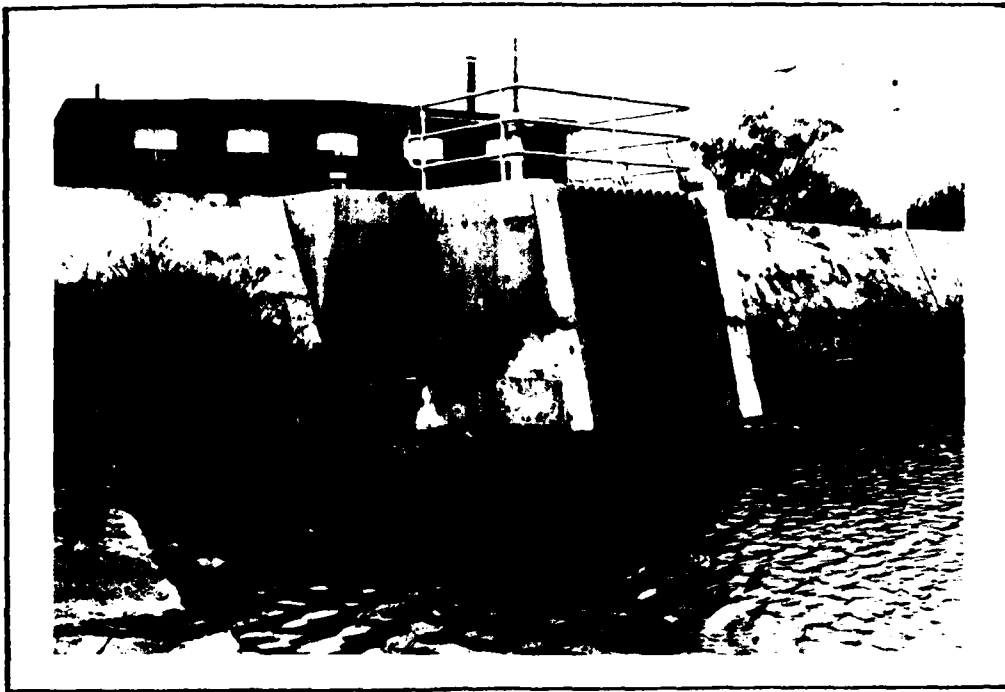
5. INLET DETAILS FOR THE 4-FOOT WIDE BY 6-FOOT HIGH IMPOUNDMENT REGULATING GATE APPROXIMATELY 110 FEET LEFT OF THE LEFT SIDE SPILLWAY ABUTMENT. (11/12/79)
