MASSACHUSETTS COASTAL BASIN
SCITUATE, MASSACHUSETTS

FIRST HERRING BROOK RESERVOIR DAM
MA 00478

PHASE I INSPECTION REPORT
NATIONAL DAM INSPECTION PROGRAM

JULY 1981

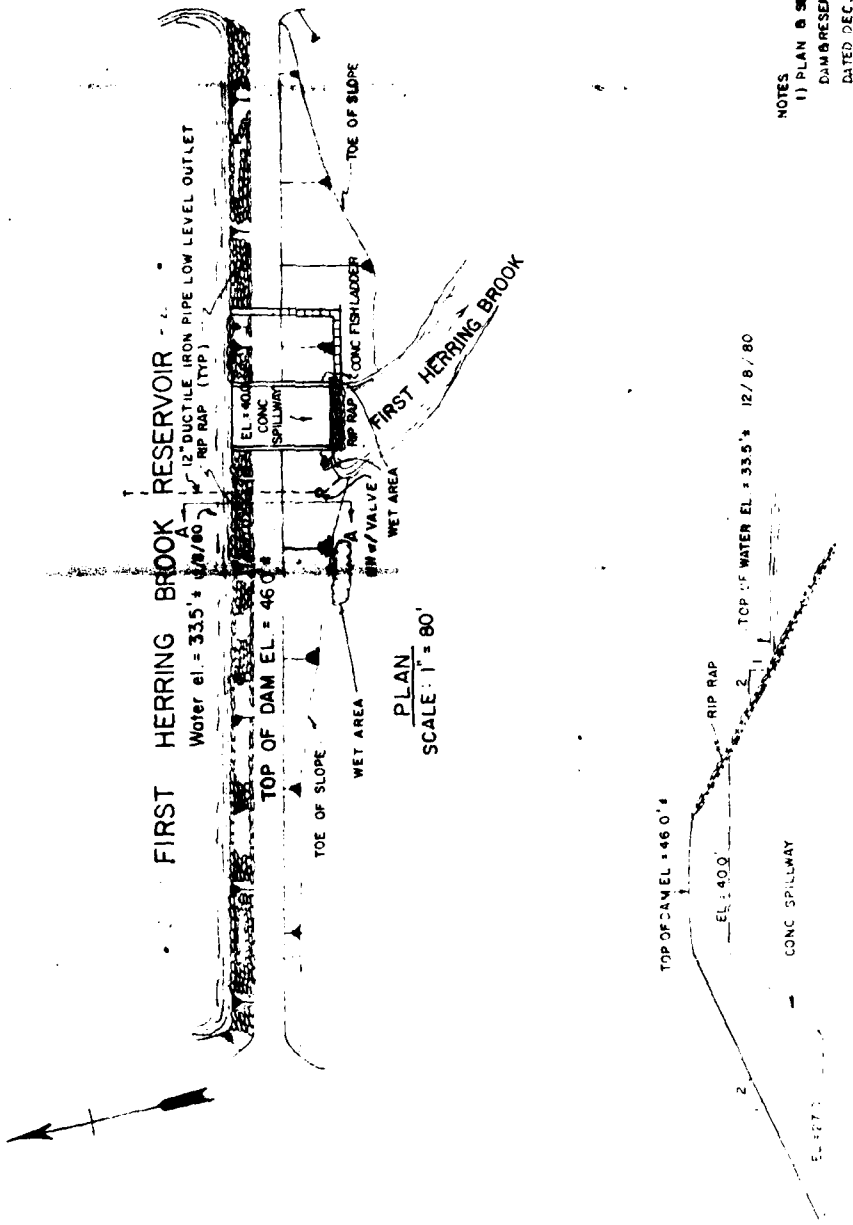
FIGURE 2

The downstream slope is covered with grass, weeds and small brush near the spillway wingwalls. There is one area (shown on Figure 2 page B-1), about 80 feet by 25 feet in size, which is wet and soft but with no visible discharge of seepage water. Several animal burrows up to 12 in. in diameter and 8 in. deep were observed near the toe of the dam approximately 100 feet west of the right spillway training wall.
