MASSACHUSETTS COASTAL AREA  
WINCHESTER, MASSACHUSETTS

## SOUTH RESERVOIR DAM AND DIKES

## PHASE I INSPECTION REPORT NATIONAL DAM INSPECTION PROGRAM

APRIL 1980

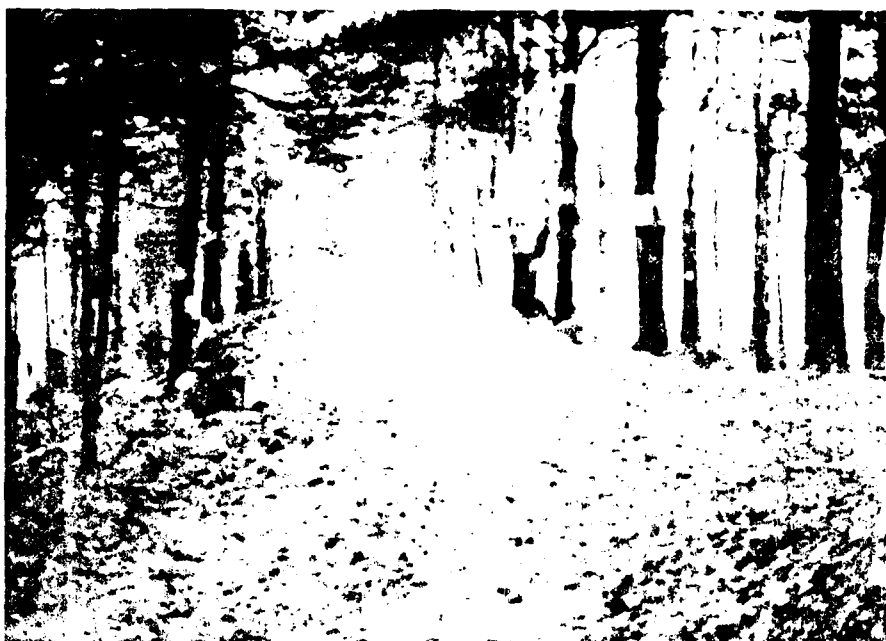
photograph 17. No evidence of cracking or misalignment was observed.

PHOTO NO. 17 - View of crest of west dike taken from left abutment.

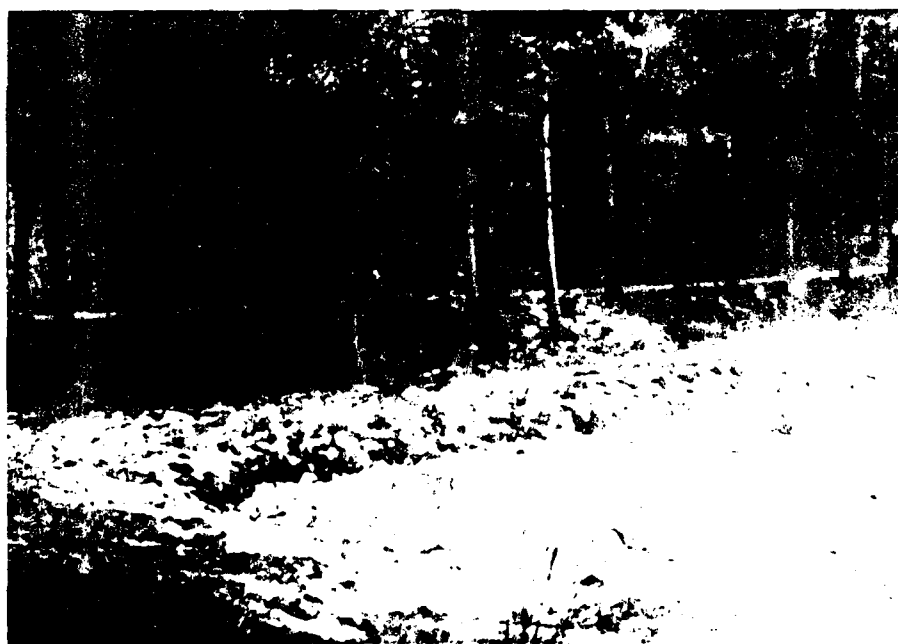
PHOTO NO. 18 - Upstream slope of the West Dike, viewed from a point upstream of the left abutment.
