MERRIMACK RIVER BASIN  
HUDSON, MASSACHUSETTS

MAIN STREET DAM  
MA 00448

PHASE I INSPECTION REPORT  
NATIONAL DAM INSPECTION PROGRAM

MAY 1979

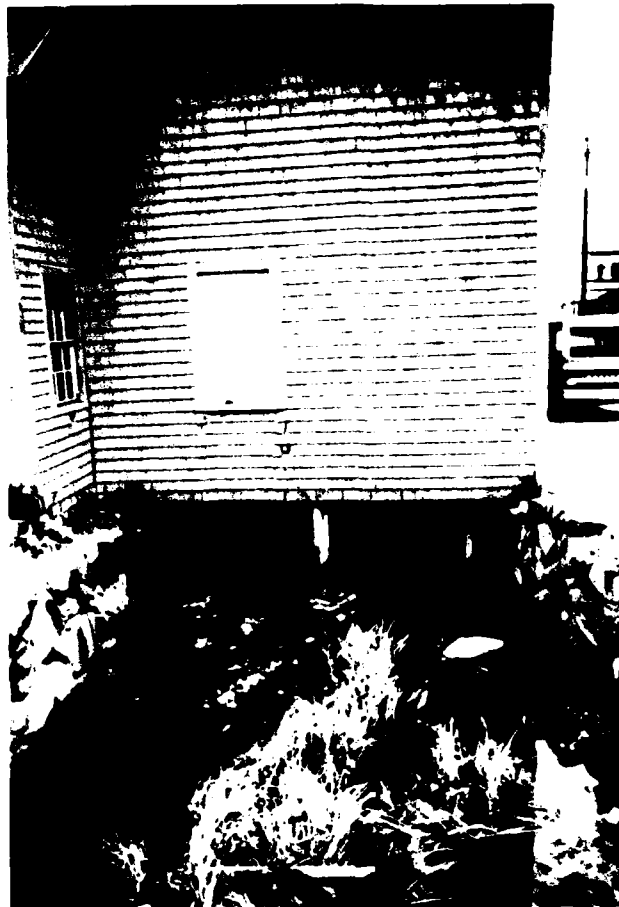
The fieldstone walls of the stilling basin and downstream channel are generally in good condition. Some smaller stones are missing and voids are developing in the joints.

4. View of downstream channel and culvert under building.
