MERRIMACK RIVER BASIN  
MARLBOROUGH, MASSACHUSETTS

FORT MEADOW RESERVOIR DAM  
MA 00449

**PHASE I INSPECTION REPORT  
NATIONAL DAM INSPECTION PROGRAM**

OCTOBER 1978

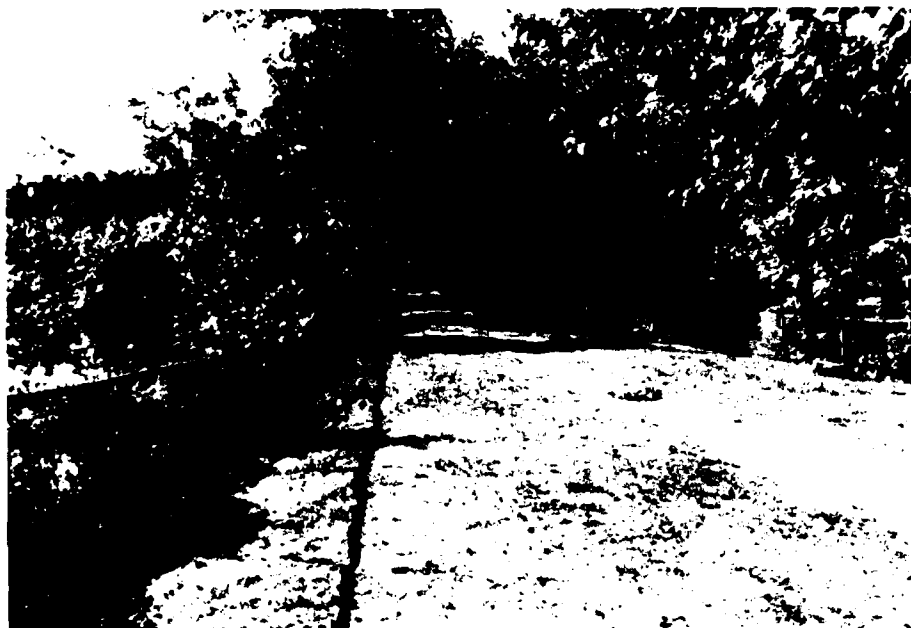
NO. 1 SOUTH VIEW OF CREST OF DAM

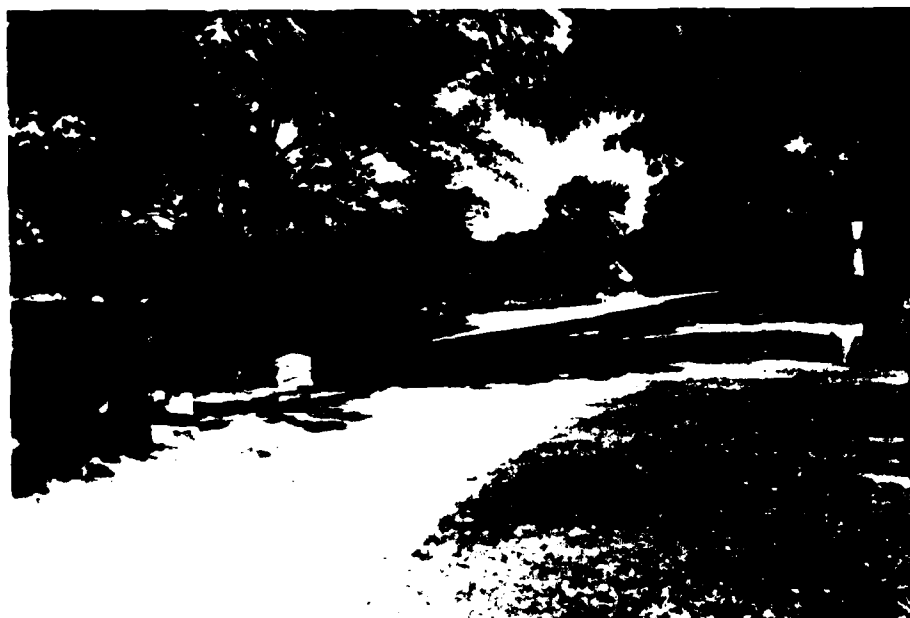
NO. 2 BEACH NEAR NORTH ABUTMENT OF DAM

It is recommended that a more detailed investigation be initiated to evaluate the severe seepage at the downstream face of the north abutment.
