CONNECTICUT RIVER BASIN  
WHATELY, MASSACHUSETTS

NORTHAMPTON RESERVOIR  
(LOWER DAM)  
MA 00520

PHASE I INSPECTION REPORT  
NATIONAL DAM INSPECTION PROGRAM

AUGUST 1978

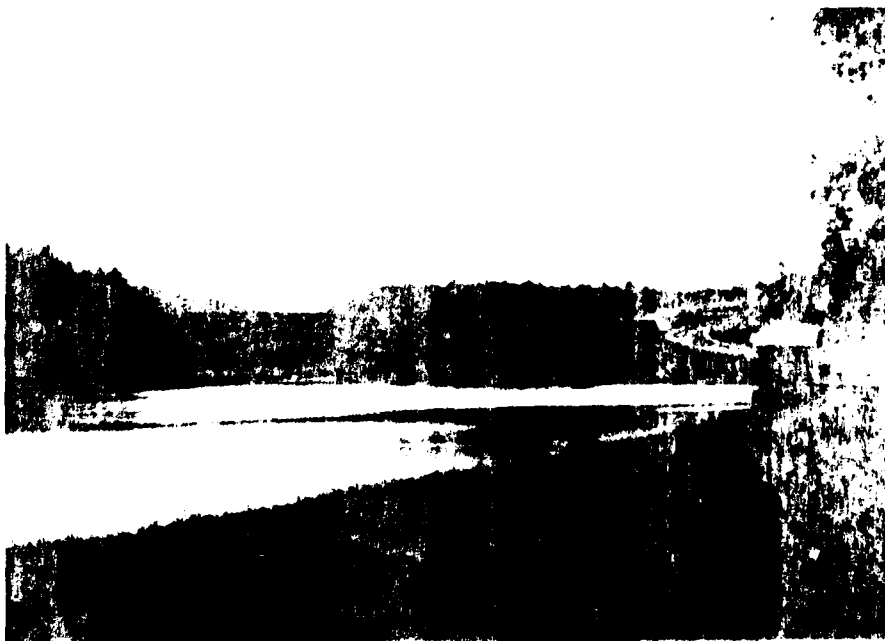
PHOTO NO. 8 - General view of reservoir from right  
abutment.
