CONNECTICUT RIVER BASIN  
BECKET, MASSACHUSETTS

BUCKLEY-DUNTON DAM  
MA 00202

PHASE I INSPECTION REPORT  
NATIONAL DAM INSPECTION PROGRAM

AUGUST 1981

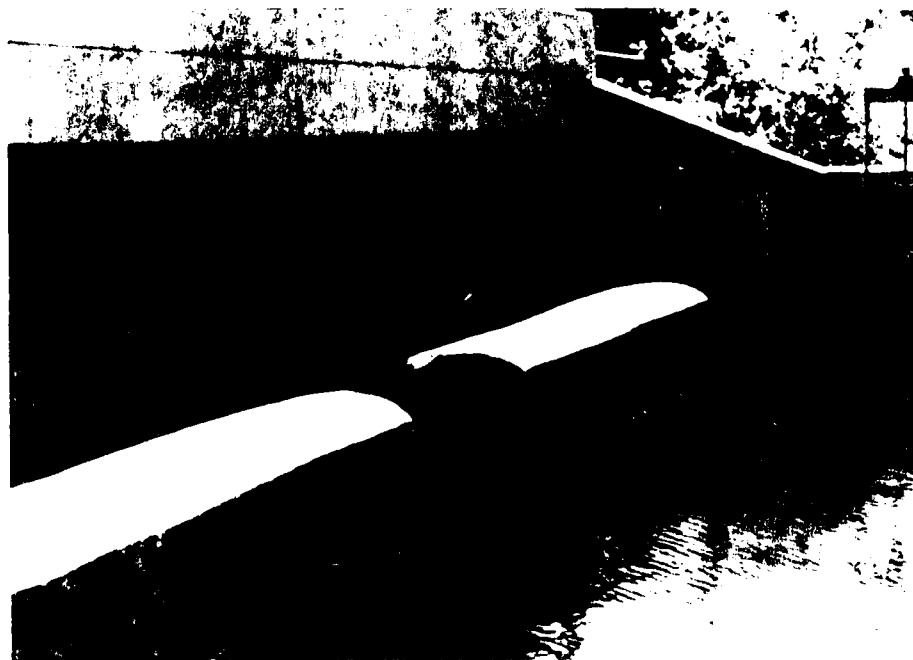
PHOTO NO. 15 - View of spillway weir.

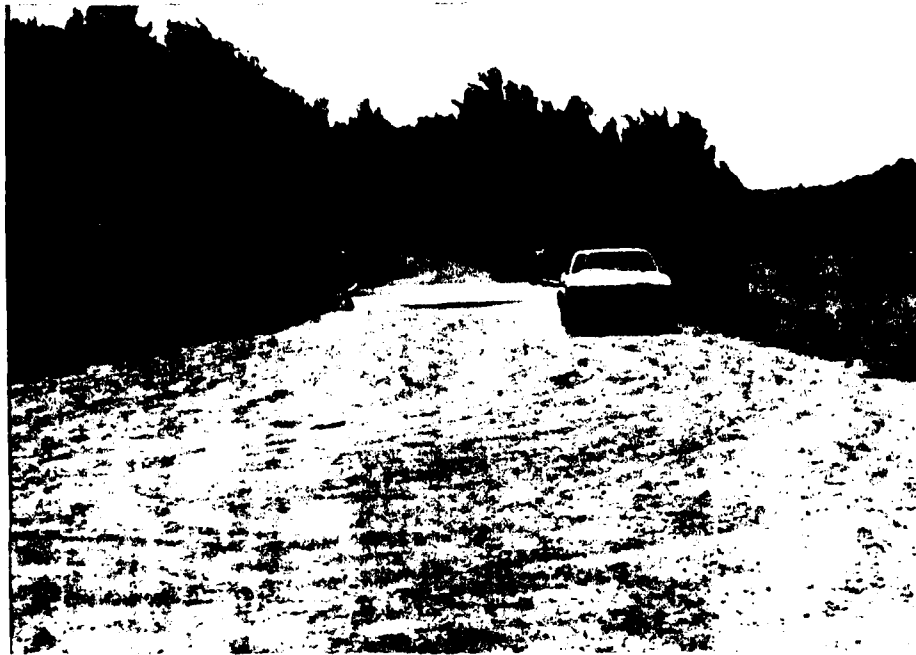
The dam crest is paved with asphalt between the right abutment and the concrete spillway bridge (photograph 1) and is unpaved between the bridge and the left abutment (photograph 12). No misalignment or cracking of the crest was observed.

PHOTO NO. 12 - Dam crest from left abutment, showing minor erosion of crest on left side of concrete bridge deck.

4. The minor erosion on the left side of the concrete road surface should be repaired.

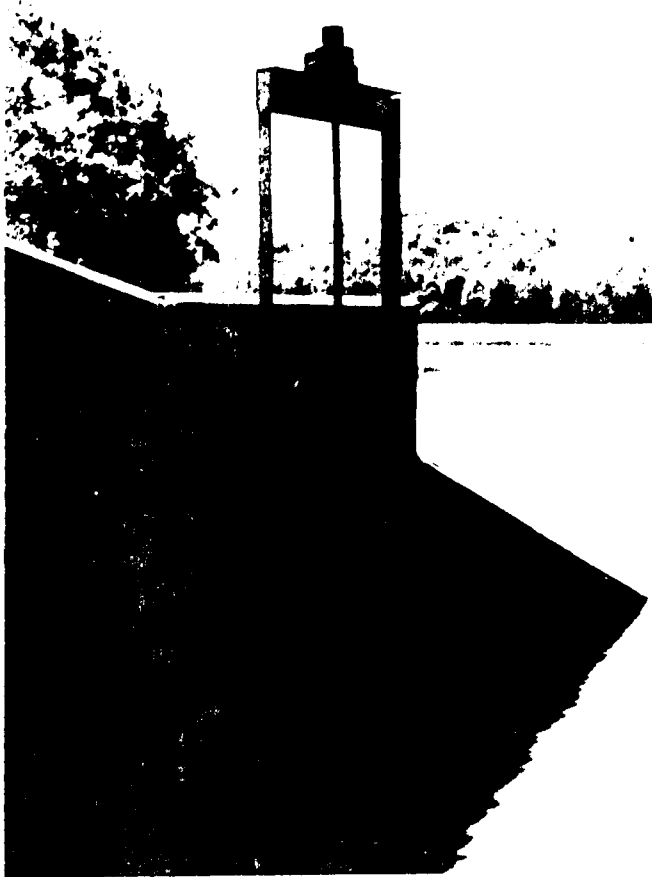
PHOTO NO. 6 - View of manually controlled gate for main drain.

6. The sluice gate should be operated yearly and repaired if necessary to insure continued adequacy.

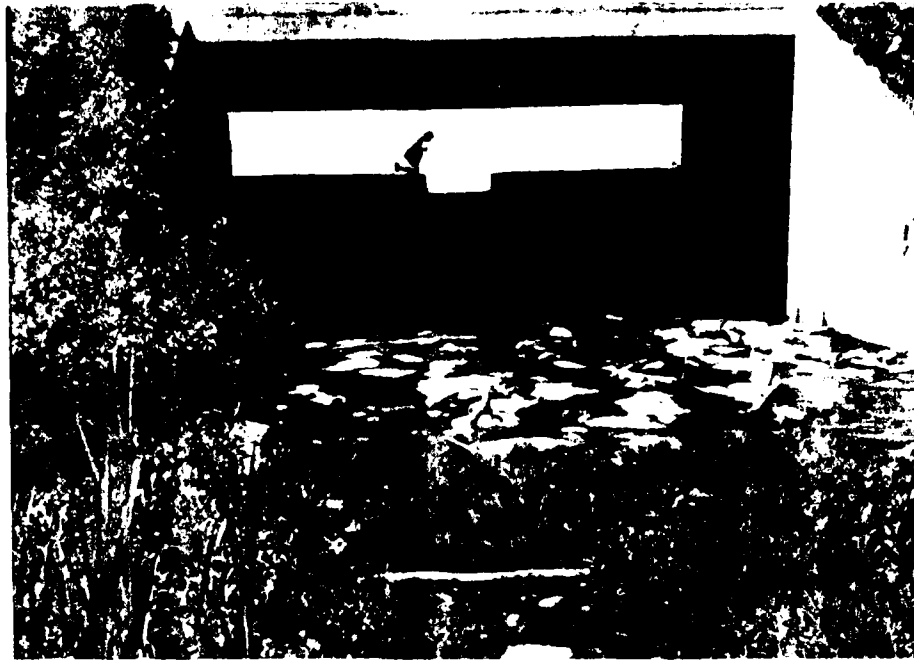
water up out of the apron. One typical spring is shown in photograph 9. In all springs the flow appeared clear. Some minor debris is present in the spillway apron and energy dissipator.

The spillway apron, shown in photograph 4, is lined with concrete and riprap. Several small springs were observed spurting

PHOTO NO. 4 - Spillway apron from discharge channel.

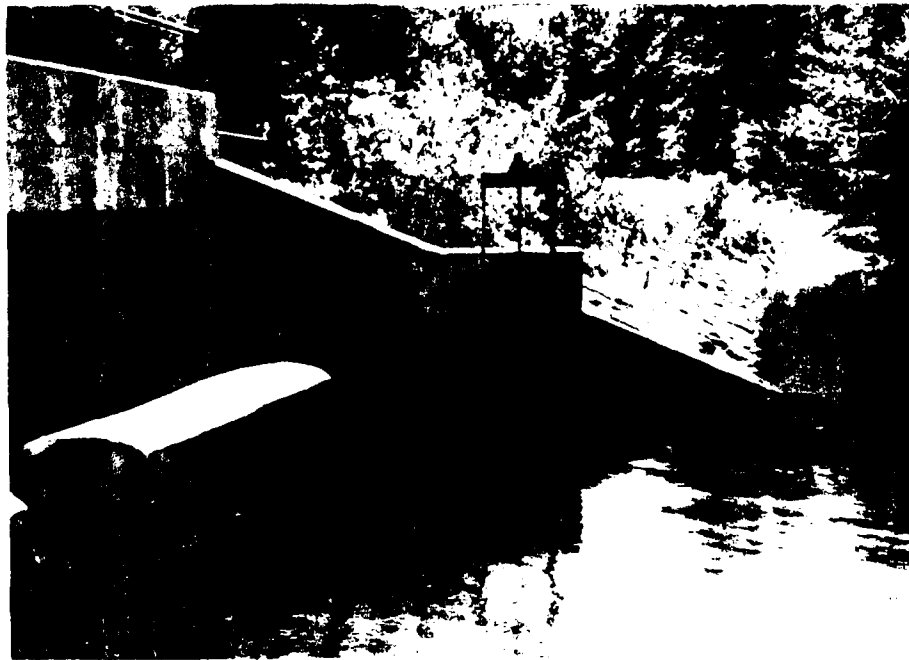
PHOTO NO. 5 - View of upstream face, sluice gate control and spillway weir. Note: 1'-6" drop section in spillway weir in lower left corner of Photo.

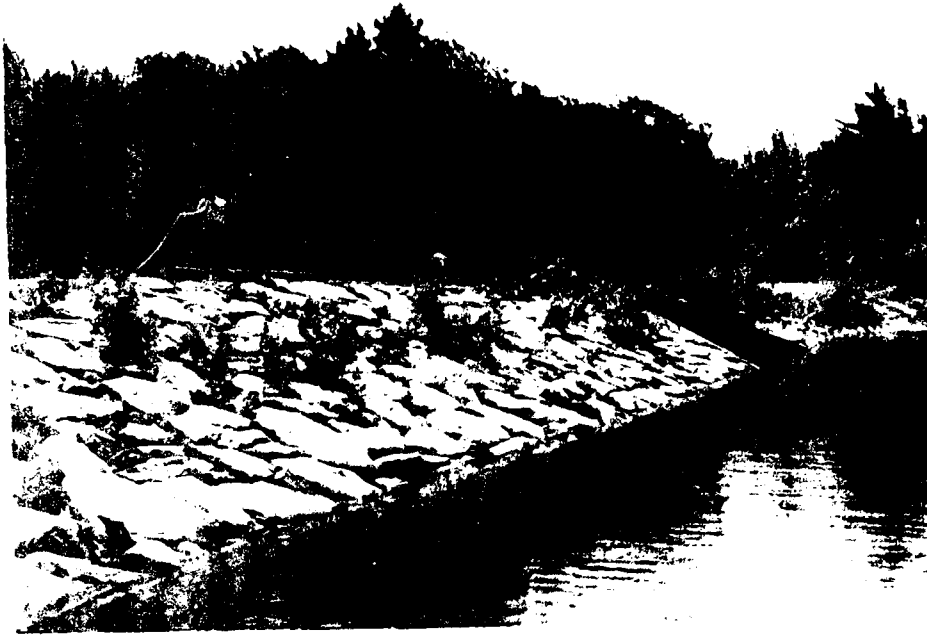
The upstream face of the dam shown on Photograph 2, has a slope of about 2H:1V. Above the waterline, the slope is covered up to the dam crest with hand-placed riprap, in good condition. Some brush up to 4 feet tall is growing on the slope.

PHOTO NO. 2 - Upstream face from left abutment showing riprap and small brush.
