SAUGUS RIVER BASIN
SAUGUS, MASSACHUSETTS

GRISWOLD POND DAM
MA 00292

PHASE I INSPECTION REPORT
NATIONAL DAM INSPECTION PROGRAM

OCTOBER 1979

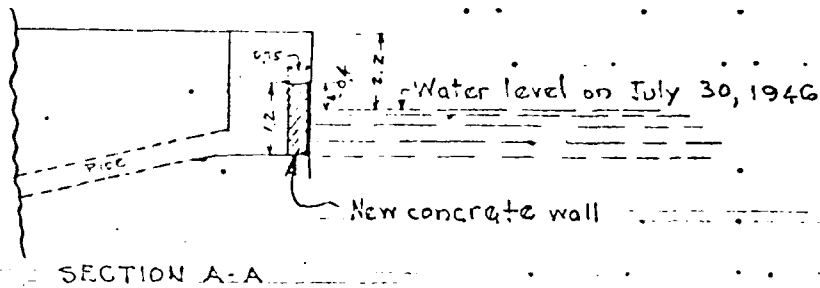
1946 July 30, S.W.Woodbury, Insp. Went to dam alone. Further inspection is needed to see that new 9" concrete wall is removed. A concrete wall 9" wide and 1'-3" high has been built across the upper end of the culvert between the wing walls which decreases the freeboard 1'-3" (see sketch) Conditions below the dam are the same. Water level today is 6.8' above the invert of the pipes. Condition of the dam is the same.

SKETCH SHOWING NEW WALL. Wall built sometime between June 1944 and July 1946
 July 30, 1946
