MERRIMACK RIVER BASIN  
FRAMINGHAM, MASSACHUSETTS

RESERVOIR NO 2 DAM  
MA 00338

PHASE I INSPECTION REPORT  
NATIONAL DAM INSPECTION PROGRAM

JULY, 1981

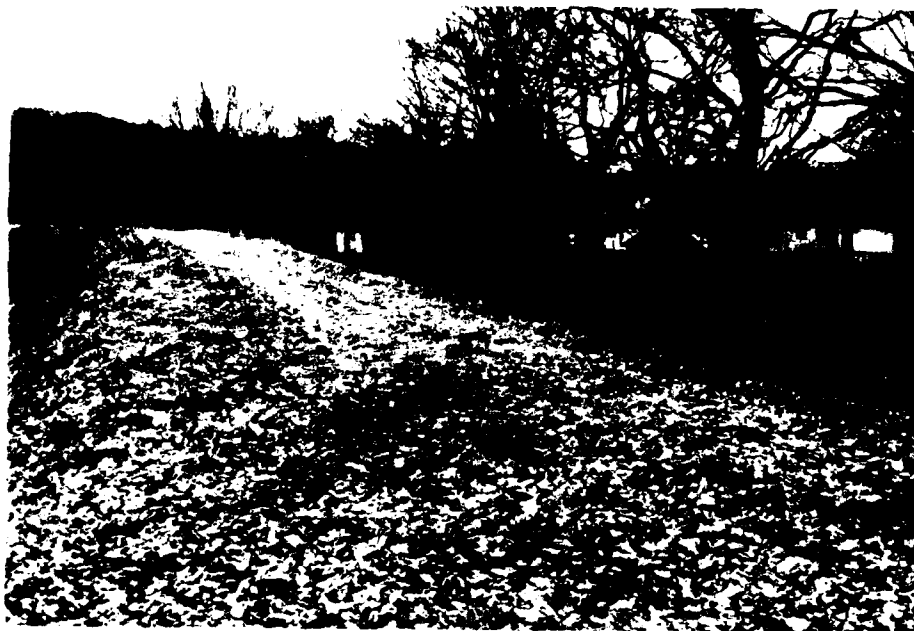
Wheel tracks and inadequate vegetation on the crest of the embankment between the spillway and right abutment render the embankment susceptible to erosion and possible breaching should the dam be overtopped.

Embankment section between spillway and right abutment - The crest of this portion of the embankment is not paved and has a sparse cover of grass which appears to have been mowed. There are wheel tracks on the crest (Photo No. 3). Riprap on the upstream slope extends from an elevation a few feet below the crest to an undetermined elevation below the level of the reservoir at the time of the inspection. The riprap is in good condition (Photo No. 4). Between the top of the riprap and the crest is a sparse cover of unmowed weeds and grass and a very small amount of brush. Unmowed grass and weeds cover the downstream slope, except that there is riprap on the bottom of the slope from a few feet above tailwater level to an undetermined elevation below tailwater level in the deeper section of the valley near the spillway. Next to the gatehouse, which is at the right end of the stone-masonry spillway, the crest, upstream slope (Photo No. 5), and downstream slope (Photo Nos. 6 and 7) are severely eroded. The area downstream of the embankment (Photo No. 8) is well maintained and shows no signs of seepage. The right abutment consists of soil and is in good condition. There is a row of large maple trees about 20 feet downstream of the toe of the dam, but they are not considered a potential problem because of the low height of the embankment and the distance from the toe (Photo No. 8).

- (3) Wheel tracks and inadequate vegetation on the crest of the embankment between the spillway and right abutment render the embankment susceptible to erosion and possible breaching if it should be overtopped.

Photo No. 3 - Top of right embankment.
