CHARLES RIVER BASIN  
HOLLISTON, MASSACHUSETTS

HOUGHTON POND DAM  
MA 00444

PHASE I INSPECTION REPORT  
NATIONAL DAM INSPECTION PROGRAM

JULY 1979

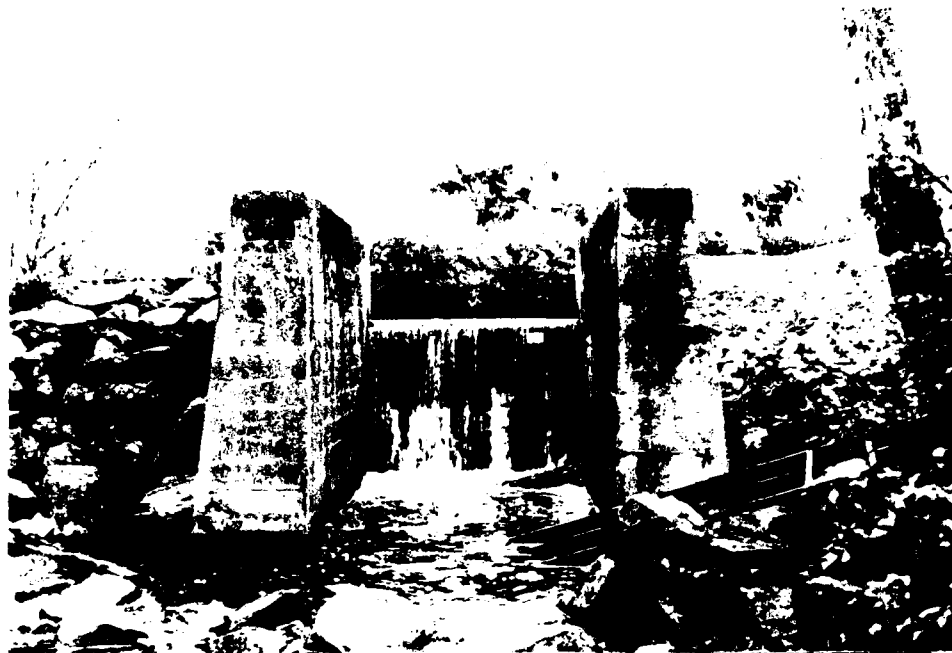
There are blockouts with anchor bolts observed on either side of the stoplog slots at the top of the concrete spillway walls, Photo No. 1. Observation of the stoplogs revealed the remains of two wooden stems bolted to the lower stoplogs. The presence of these stems and the blockouts at the top of the walls would tend to indicate that what appears to be stoplogs may have been a double-stem operated (through rack and pinion gears) wooden gate. The condition of the stoplogs (remains of a wooden gate) are poor, with several leaks observed between the lower stoplogs, Photo No. 10. Remnants of one of the stoplogs could be seen in the channel below.

10. Leakage between stoplogs at main spillway  
(outlet)

6. Replace the existing stoplogs (remains of a wooden gate) which are in poor conditions and leaking in a manner to assure ease of removal.
7. Remove debris in the channel below the spillways.

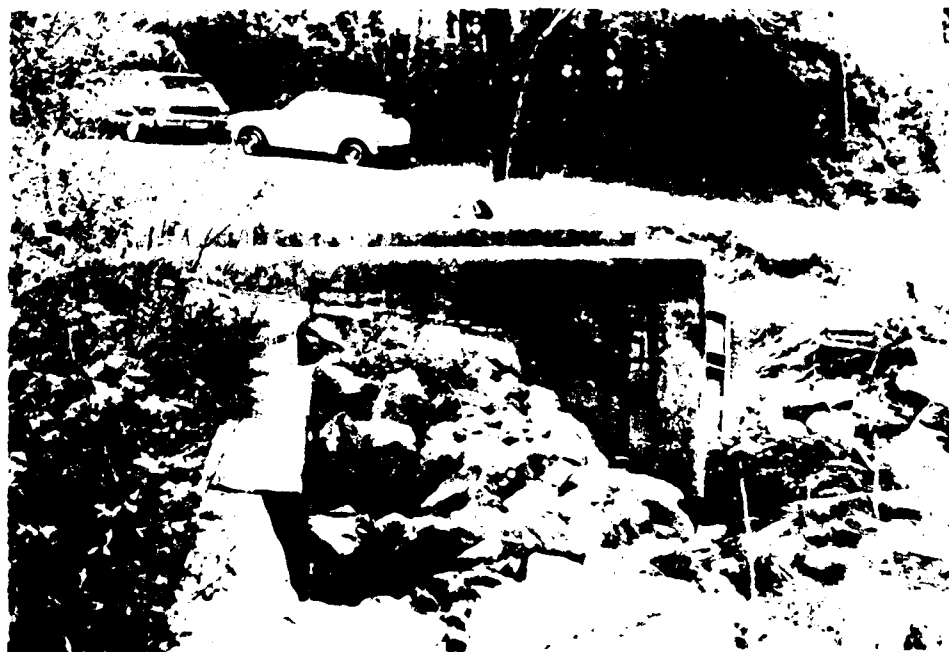
No. 1 and 11. The top of ground adjacent to the granite weir is from 6 to 15 in. below the top of the granite. At present water level, seepage is occurring below the granite cap and dry-laid boulders on the downstream face at a location 6 ft. right of the concrete spillway, Photo No. 12. It was not possible to trace the flow of water from this point to where it exited downstream. Numerous boulders immediately downstream of the granite weir are missing, either having been plucked out or removed by vandals, Photos No. 4 and 11. Otherwise, the stones appear to be relatively well chinked and are mostly present toward the lower part of the weir, Photo No. 13. Some light vegetation is growing on the downstream face.

11. Ogee-shaped, stone masonry auxiliary spill-  
way right of concrete structure

5. Replace the stones missing from the ogee-shaped downstream face of the auxiliary spillway with consideration given to grouting the voids between the stones.

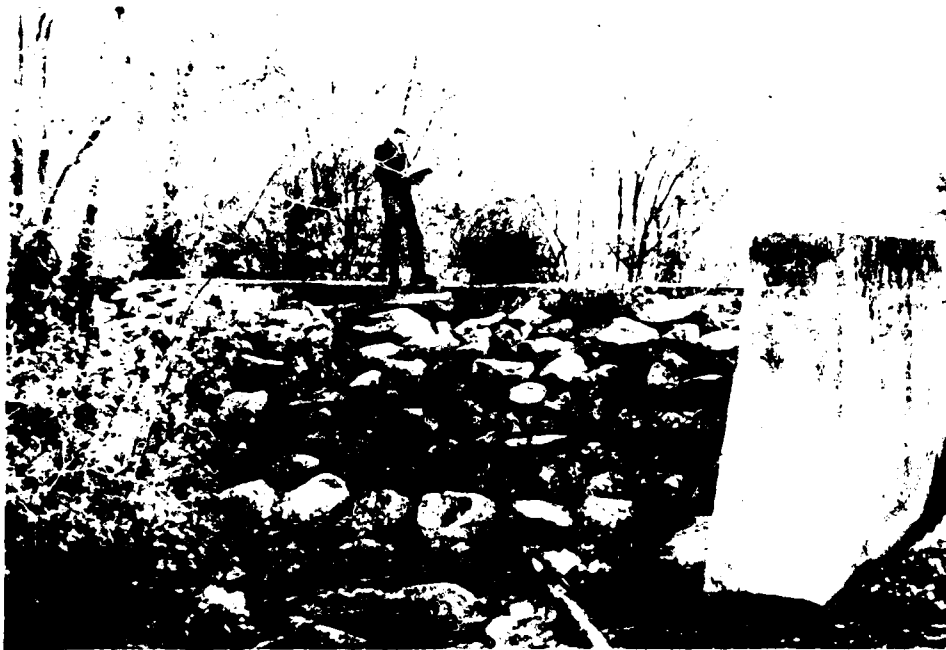
13. Stone facing on downstream side of auxiliary spillway

3. Repair the upstream stone wall in areas where it has collapsed, and replace missing capstones on the downstream wall.
4. Remove the brush and vegetation in the approach channel upstream of the auxiliary spillway weir and on the downstream face of the weir.
