JACKSON PLANT DAM

NH 00121

Feb 1979

| REPORT DOCUMENTATION PAGE | | READ INSTRUCTIONS<br>BEFORE COMPLETING FORM |
|---|---|---|
| 20. ABSTRACT (Continue on reverse side if necessary and identify by block number)<br><br>The dam is a 33 ft. high gravity concrete and gravity stone masonry dam capped with concrete. It is about 400 ft. long. It is small in size with a significant hazard potential. The dam is in fair condition at the present time. There are various remedial measures that the owner should implement. | | |

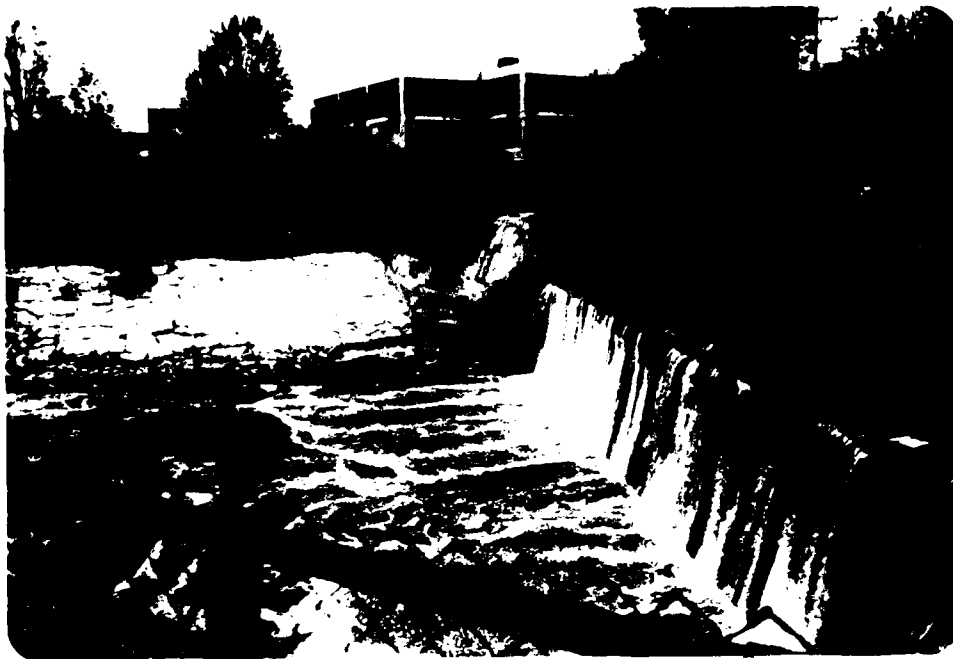
Overview of spillway from pier separating  
spillway and powerhouse

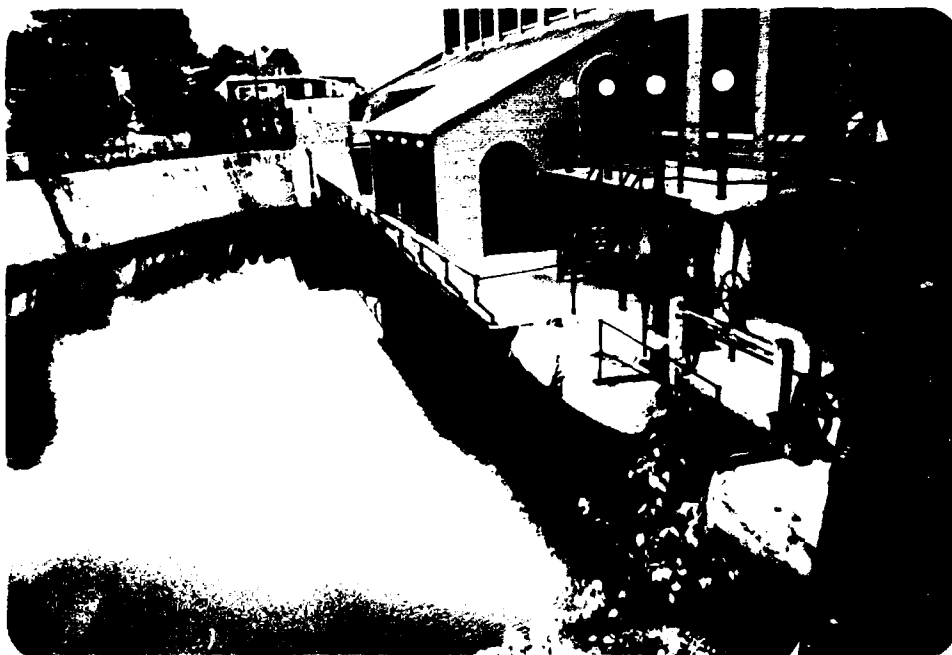
Overview of restaurant (formerly powerhouse)  
from pier

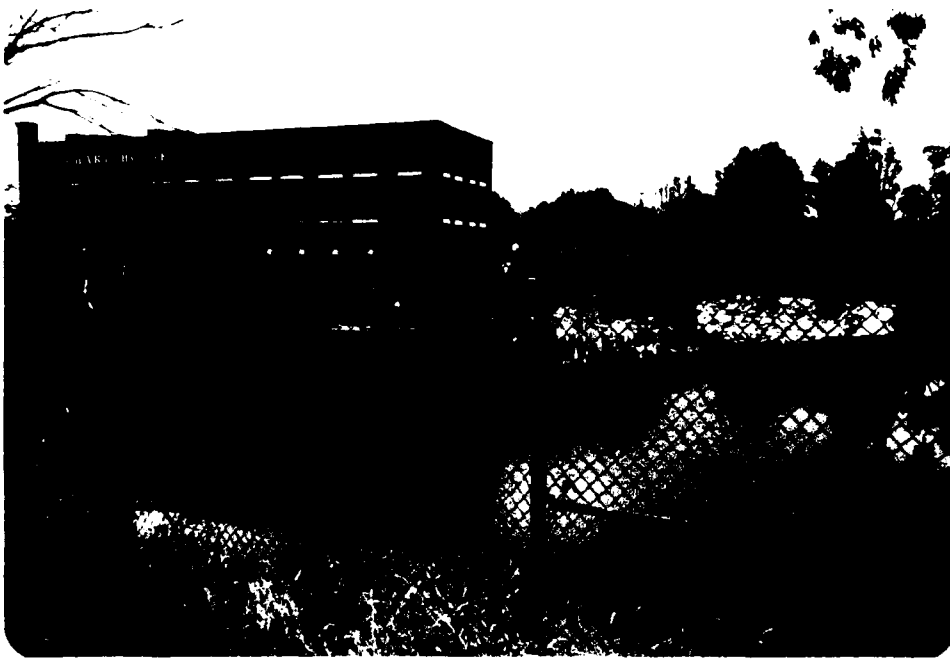
Overview of dam from left side upstream

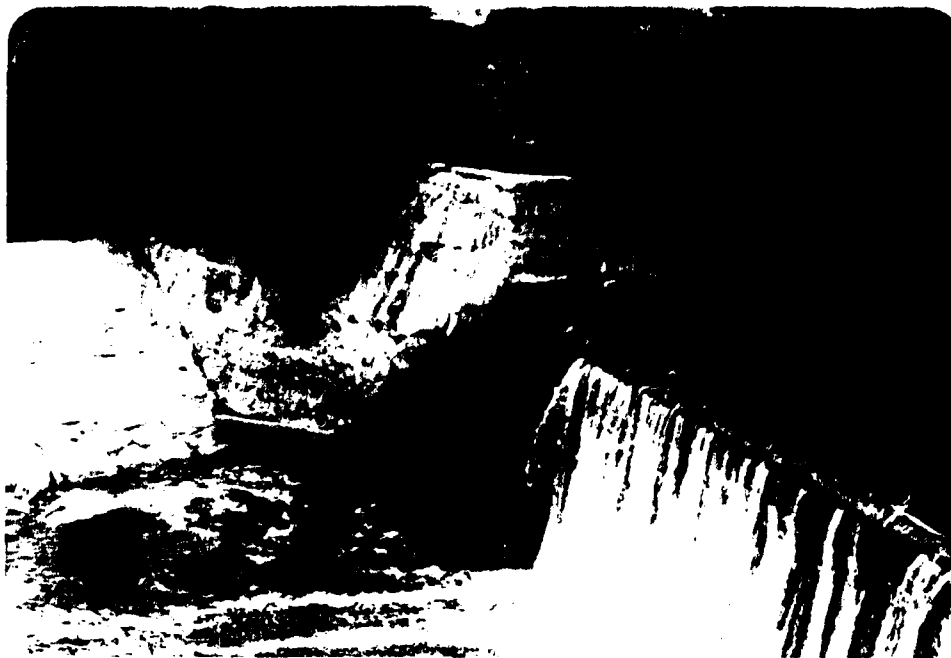
The vertical faces of this structure have spalled over 75% of their surface area to depths of 4 inches. There is considerable patterned horizontal cracking with associated efflorescence. The spalling and cracking reveals a stone masonry structure which has been faced and capped with concrete. The spalling and cracking is attributed to moisture intrusion and alternate freeze and thaw cycles. Vegetation is growing through open joints on the downstream leg of this abutment.

3. View from left side downstream of deteriorated concrete at right abutment

- (1) Repair the deteriorated concrete at the right abutment.
