BLACKSTONE RIVER BASIN  
AUBURN, MASSACHUSETTS

PONDVILLE DAM

MA. 00197

PHASE I INSPECTION REPORT  
NATIONAL DAM INSPECTION PROGRAM

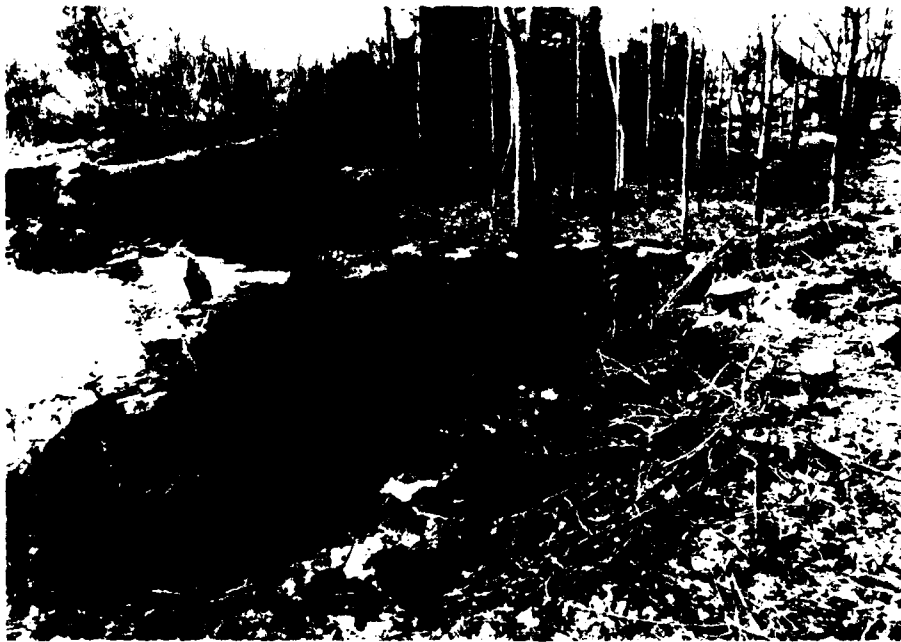
A section on the left side of the embankment adjacent to the right training wall of the spillway has eroded away severely, resulting in a void approximately 6 ft. wide by 10 ft. long, as shown in photo nos 4 and 5. The bottom of the void in the embankment extends downward to the base of the right training wall of the spillway where there is a void in the training wall as shown in photo nos 6 & 10. Clear seepage was noted coming through the dam below this void. It was not possible to make an estimate of the quantity of flow. This section of the dam is in extremely poor condition, as a significant section of the embankment upstream of the wall has eroded away and the remaining portion is "hanging by a thread". Clear seepage was observed in the void but could not be estimated because of heavy brush growth.

4. Void in upstream embankment at right spillway training wall. (Photo taken 2 March 1981).

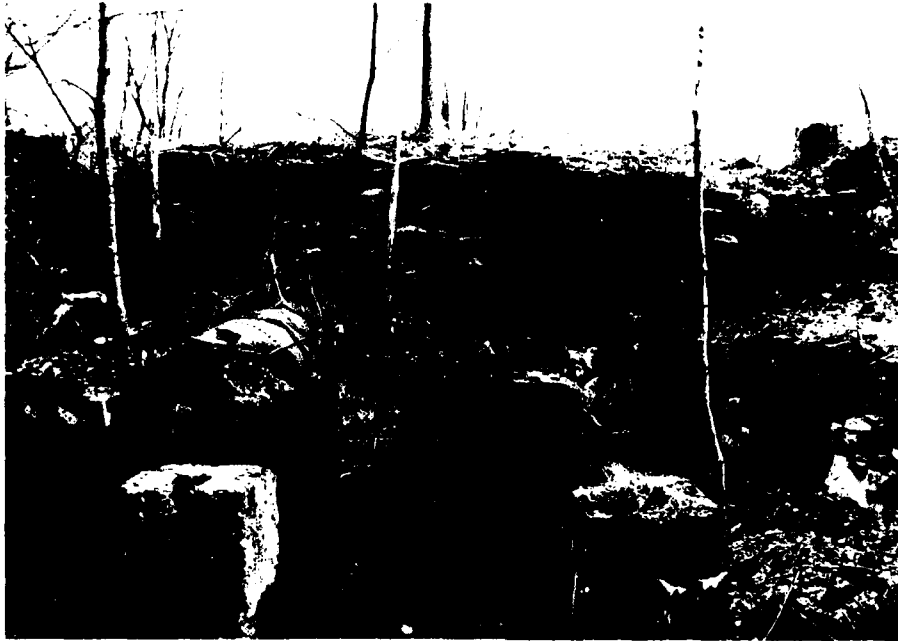
9. Downstream view of 3 ft. dia. pipe extending from downstream face of dam (Photo taken 2 March 1981).

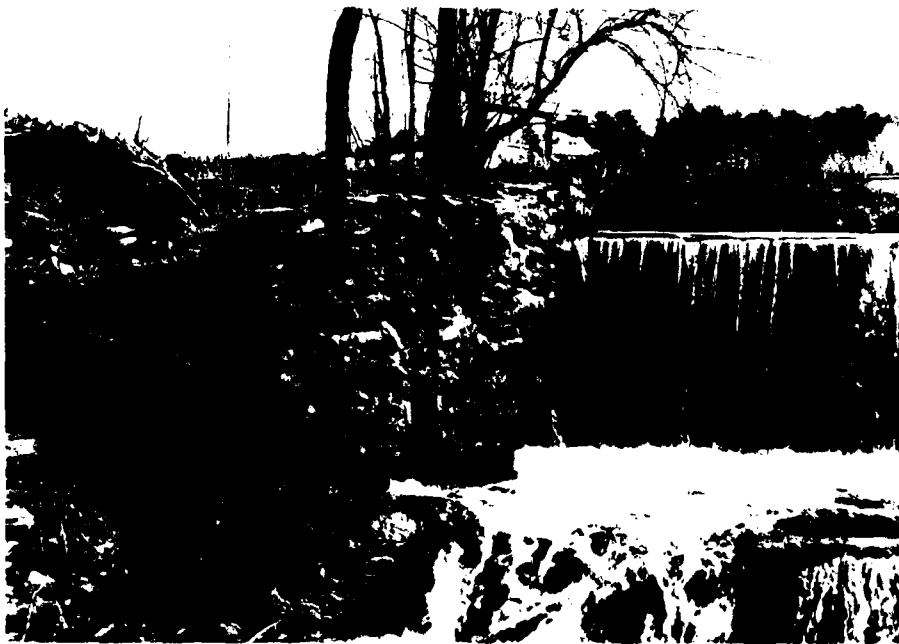
10. Downstream view of right spillway training wall. (Photo taken 2 March 1981)

(3) Repair the training wall on the left side of the spillway.
