WRIGHTS POND DAM  
MA 00454

PHASE I INSPECTION REPORT  
NATIONAL DAM INSPECTION PROGRAM

NEW ENGLAND DIVISION, CORPS OF ENGINEERS

APRIL 1980

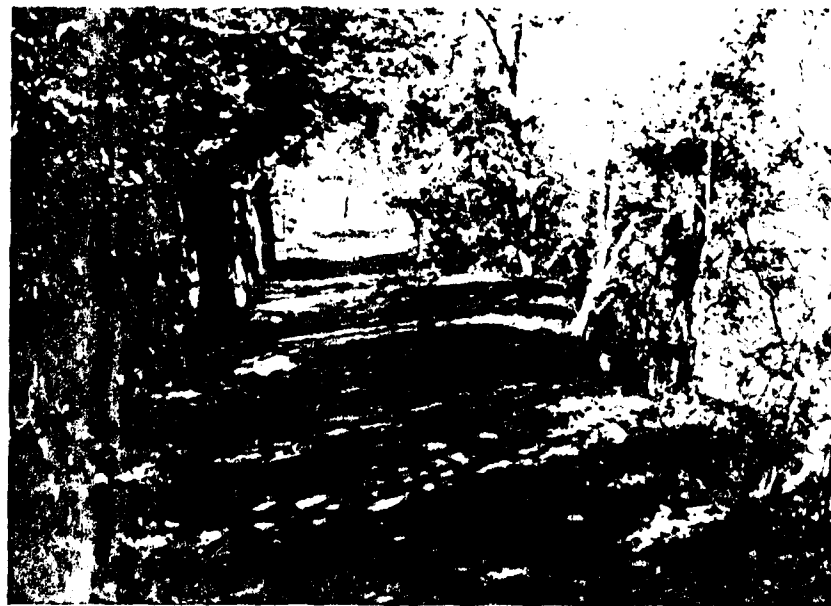
The lack of vegetation on the crest renders it less resistant to erosion by runoff from rainfall or due to overtopping if it should occur. Such erosion could result in failure of the dam.

The crest of the dam is bare soil with no protective vegetation, as shown in photograph 2. The surface of the crest appears uneven, probably due to minor erosion. No evidence of cracking or misalignment of the crest was observed.

PHOTO NO. 2 - Crest of Dam, viewed from the left  
abutment.

2. Minor erosion on the crest should be repaired and grassy vegetation should be established on the crest to protect the soil against erosion.

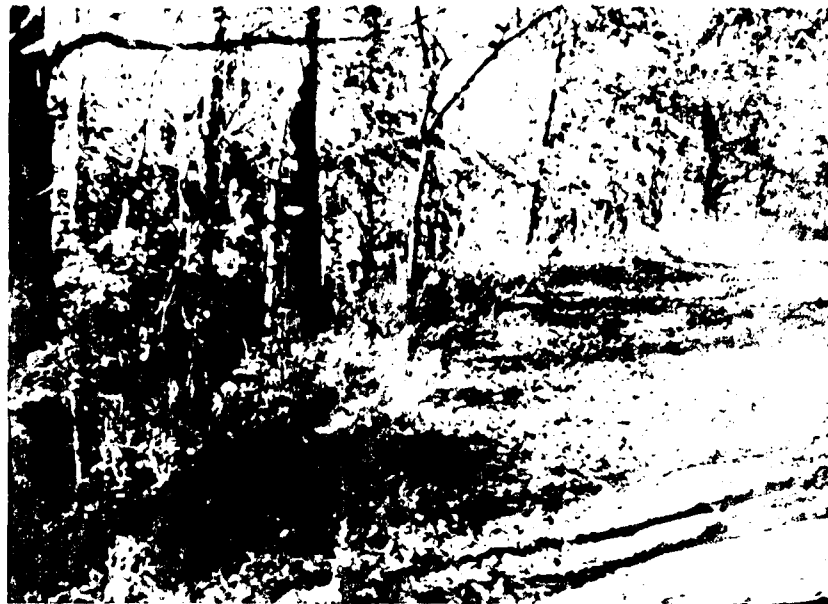
The downstream slope of the dam is inclined at 2H:1V and is covered with extensive tree growth, as shown in photograph 3. A number of trees are quite large and have extensive root systems growing into the embankment. The largest of these trees (6 foot diameter base) is shown in photograph 4. This tree and several others on the slope appear to be dead. The downstream slope appears uneven in some areas, probably due to minor erosion. A relatively large erosion gully was observed on the downstream slope near the crest in the central portion of the dam, visible in photographs 2 and 4. No seepage was observed on the downstream side of the dam.

PHOTO NO. 3 - Trees on downstream slope. Tree near crest in left center of photo appears to be dead.

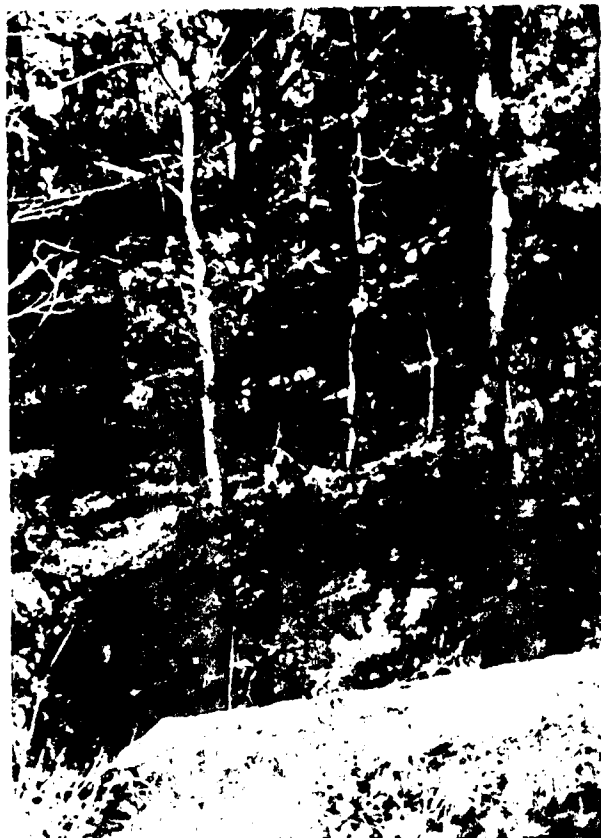
The spillway outlet channel is shown in photograph 7. The channel is not well defined. A few large boulders are lying in the channel floor near the dam. Further downstream, the channel enters a 30 inch metal culvert, photograph 6, and flows into an urban storm drain system. Stones and debris were observed in the channel upstream of the culvert intake. Wood is apparently being stored to the immediate right of the channel. A debris screen located in front of the culvert is in generally good condition.

PHOTO NO. 7 - Spillway outlet  
channel, looking downstream  
from the spillway.

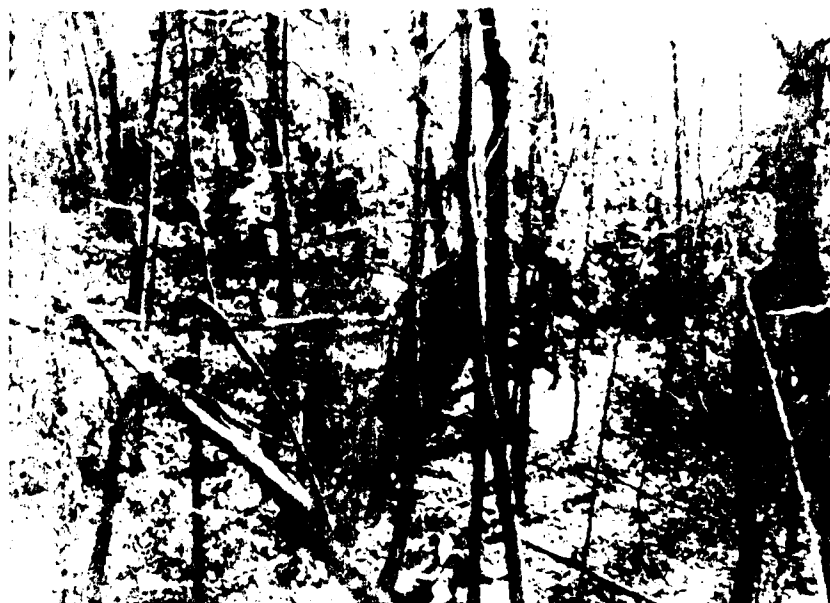
PHOTO NO. 8 - Downstream slope in the central portion  
of the Dam, looking left from about midslope.

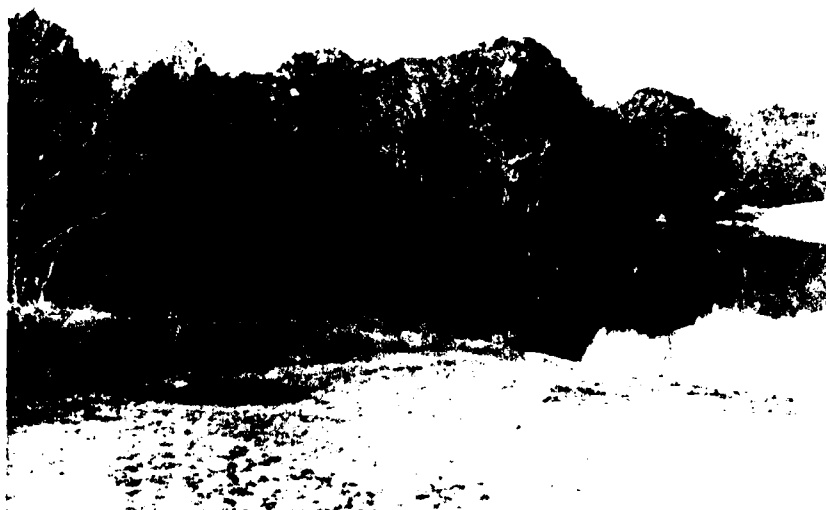
PHOTO NO. 9 - View of Wrights Pond Dam taken looking right from left abutment. Note trees growing along upstream face of dam. The spillway structure is shown in the right center of the photo. Also note ledge outcrop to right of spillway.
