MEGUNTICOOK RIVER BASIN  
CAMDEN, MAINE

SEABRIGHT POND DAM  
ME 00277

PHASE I INSPECTION REPORT  
NATIONAL DAM INSPECTION PROGRAM

AUGUST 1978

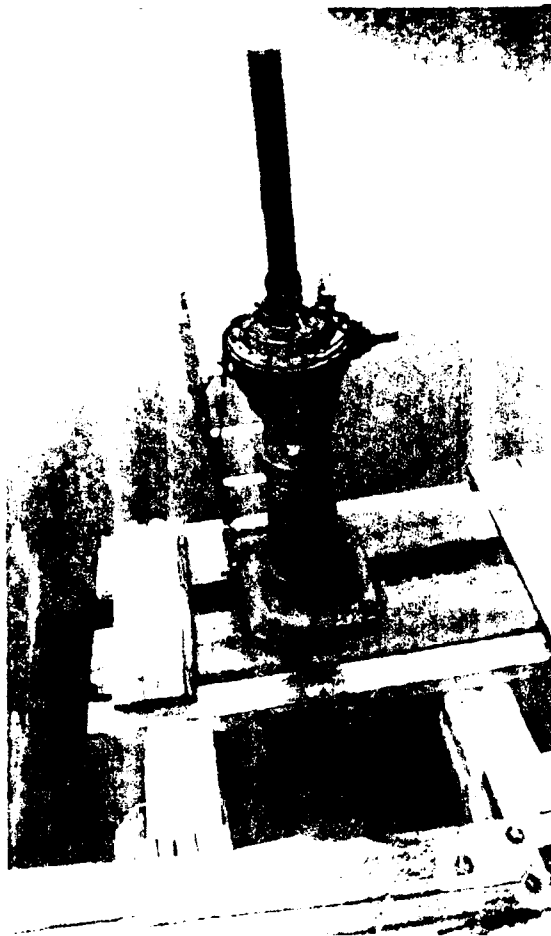
7

2. Operating and Emergency Control Gates. The control gate is a 3 x 4-foot timber gate which is manually operated by a vertical screw. The timber supports for the hoisting screw are badly rotted and one of the concrete supports is badly cracked. The service bridge beams are rotted at the bearings. The gate reportedly cannot be closed unless the reservoir is drained due to hydrostatic pressure on the gate and the inadequacy of the timber hoist supports. A diving board and ladder have been attached to the service bridge and outlet gateworks.

GATE OPERATOR

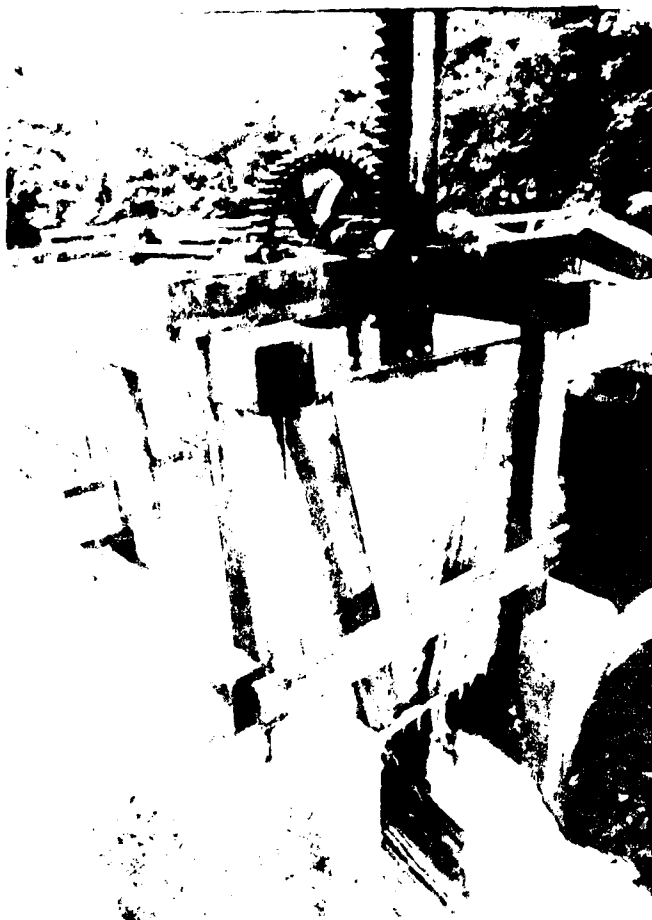
5

- (d) Substantial seepage is occurring through the spillway portion of the dam. See photograph 2.
  - (e) The west concrete support for the spillway gate is cracked. See photograph 5.
  - (f) Apparently some minor erosion of the west embankment has occurred at its junction with the generator room section of the dam.
- (2) Hydraulics - At the time of the visual inspection the pond level was about 1.6 feet below the emergency spillway elevation. The only discharge was from the gated spillway, which was found to be operational.

The spillway gate works consist of a vertical timber lift gate operated manually by a rack and gear. The works are in good mechanical condition. The gate stem has been spliced (apparently adequately) repairing vandalism to the gate works. See photograph 5.

2. Structural Cracking, Concrete. Cracks were observed in the lip of the spillway in several locations, all cracks appear stress related (see photograph 4). The upstream pier at the outlet works is badly cracked. The east training wall is badly cracked, see photograph 4. A large crack exists in the east wall of the generator room, and the dam crest is cracked west of the spillway gate. See photograph 5.

GATED SPILLWAY

5. Repair the crack in the concrete in the west spillway gate slide support.
6. Remove the diving board and ladder from the service bridge area of the dam.
7. The control bridge may act as debris collector during flood flows. Equipment and personnel should be made available to keep the spillway clear during flood flows.
8. Because the dam is upstream of populated areas and is subject to overtopping and subsequent distress, around the clock surveillance should be provided during periods of high precipitation or anticipated run-off (full spillway).
9. A formal warning system which could be used in the event of an emergency should be developed and implemented.
10. The dam should be inspected by a qualified engineer at least once every two years.
