MERRIMACK RIVER BASIN
LAWRENCE, MASSACHUSETTS

STEVENS POND OUTLET DAM

MA 00232

PHASE I INSPECTION REPORT
NATIONAL DAM INSPECTION PROGRAM

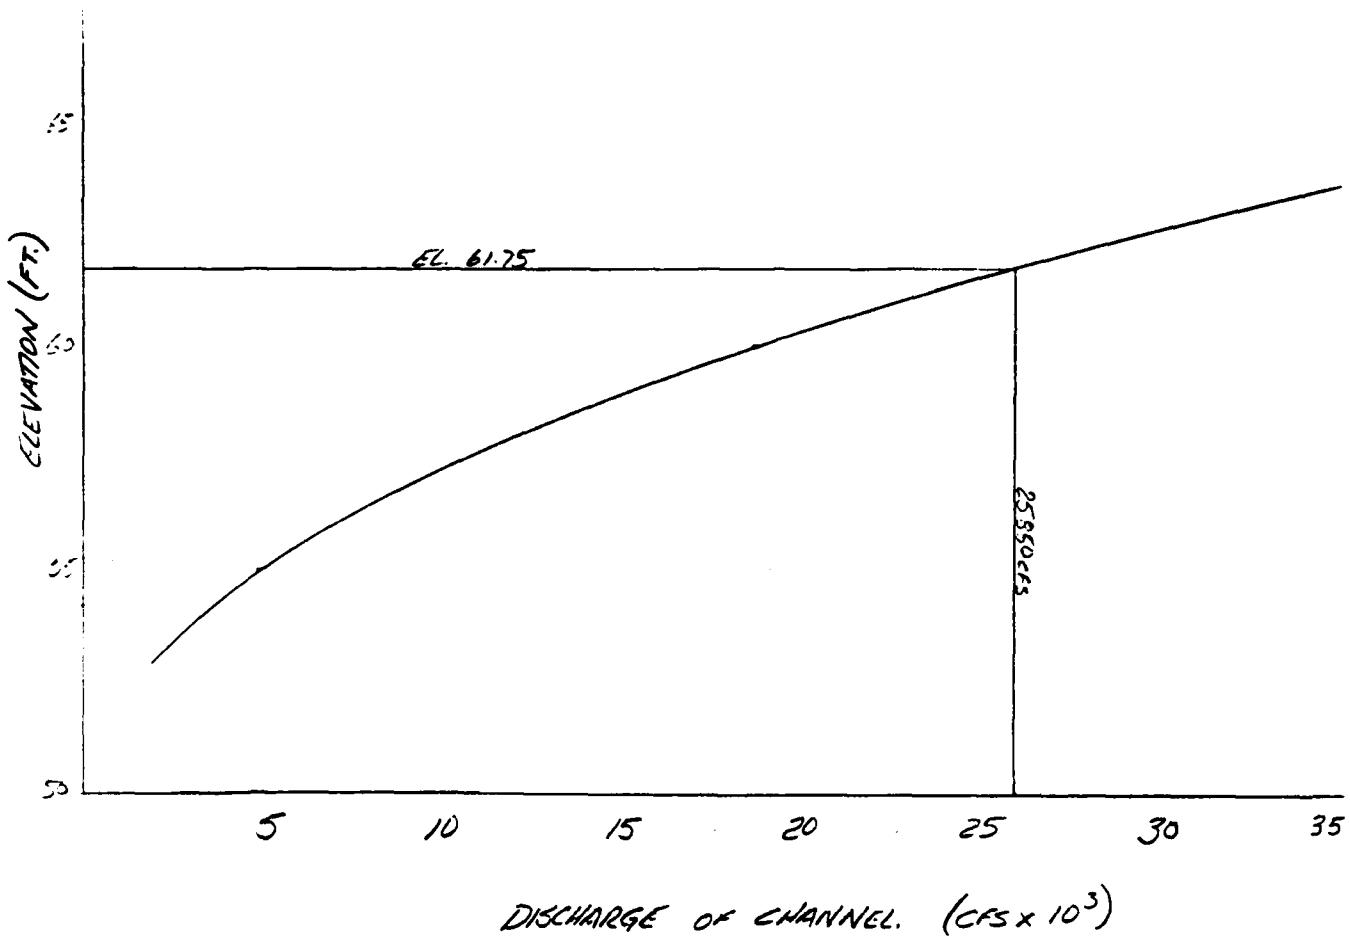
REACH I Q = 25850 CFS. EL. 61.75

RESULTS IN FIRST REACH DISASTROUS - EXTREME FLOODING
THROUGH FACTORY AREA - OVER BROADWAY INTO RESIDENTIAL
AREA. LARGE HAZARD TO LIFE
