COASTAL BASIN
LYNN, MASSACHUSETTS

BIRCH POND DAM

MA 00237

PHASE I INSPECTION REPORT
NATIONAL DAM INSPECTION PROGRAM

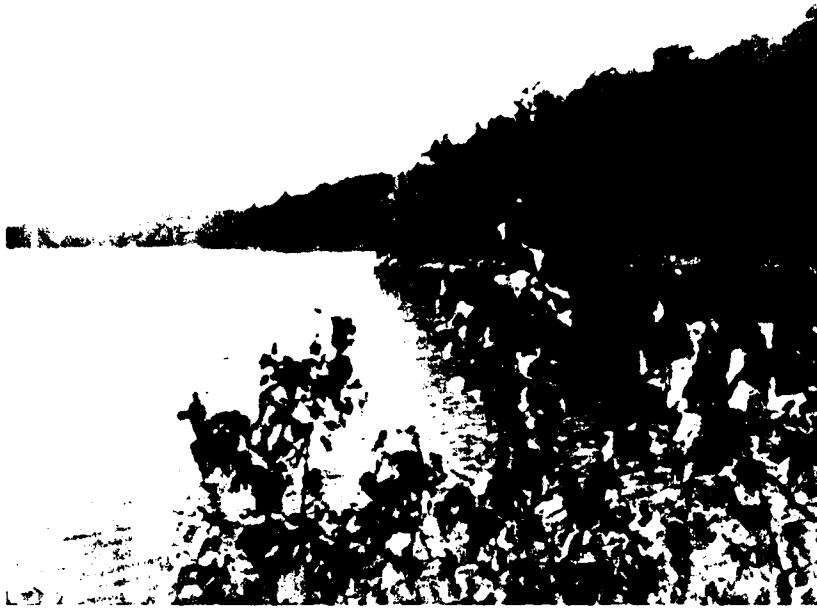
6

View of Reservoir and Shoreline from Dam
