WATER LOOM POND DAM  
NH 00355  
NHWRB 175.09

PHASE I INSPECTION REPORT  
NATIONAL DAM INSPECTION PROGRAM

DEPARTMENT OF THE ARMY  
NEW ENGLAND DIVISION, CORPS OF ENGINEERS  
WALTHAM, MASS. 02154

FEBRUARY 1979

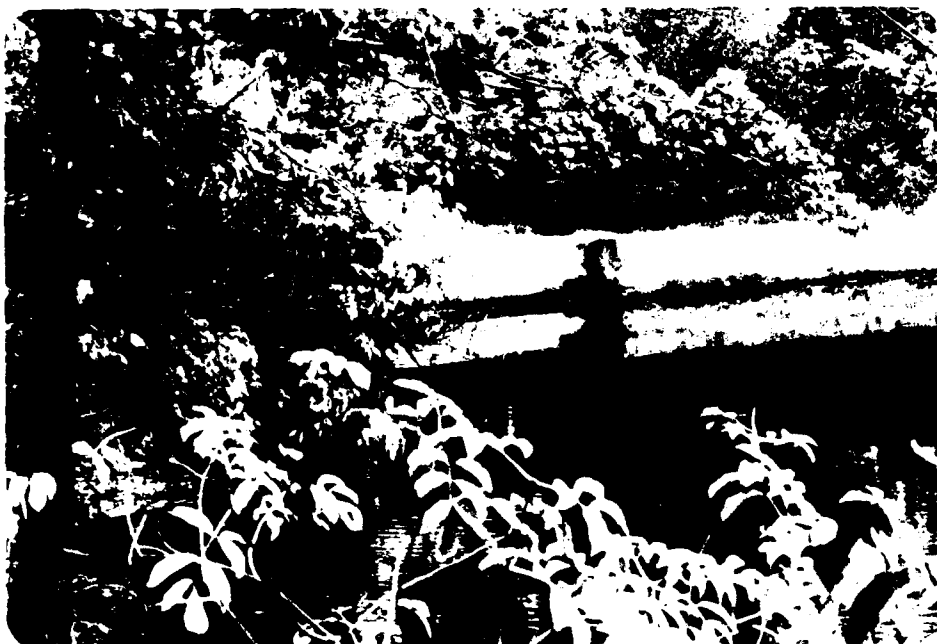
Overview of left side of dam and abandoned inlet  
from upstream left side

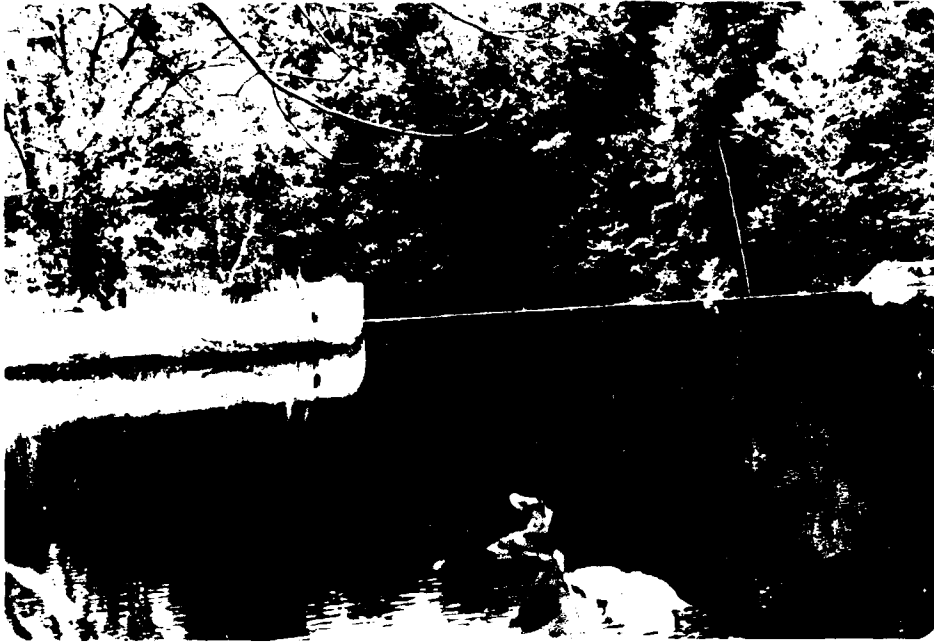
Overview of spillway from upstream left side

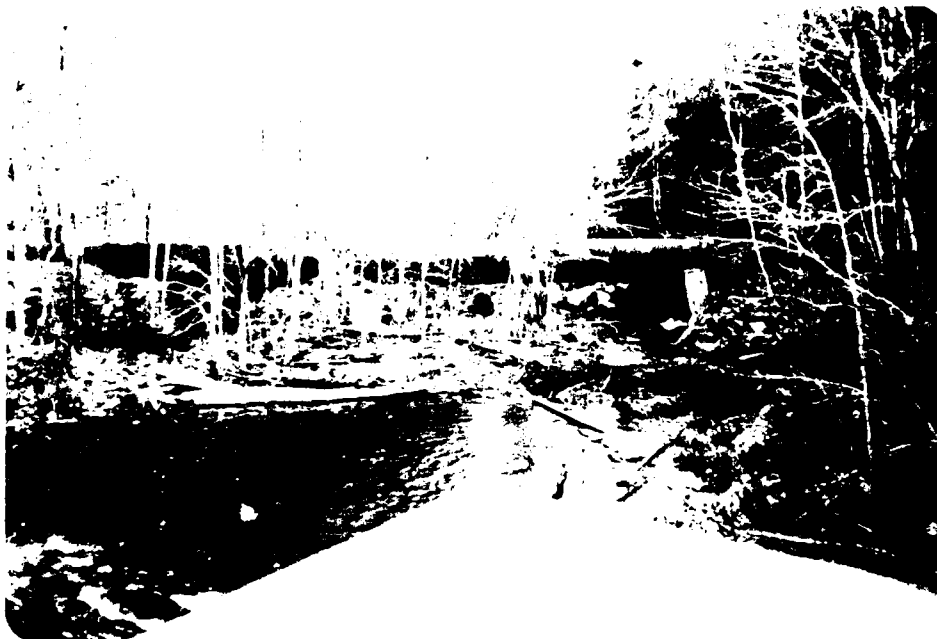
Failure of the supporting piers carrying the penstock over the outlet channel would conceivably increase the rate of seepage through the earth embankment and become a potential hazard. Observations have revealed that the penstock freely spans over the abandoned foundation wall and then over two piers spanning the outlet channel. The right pier, which is approximately 10 feet high, is out of plumb by approximately 6 inches.

1. View of downstream channel from right abutment showing penstock

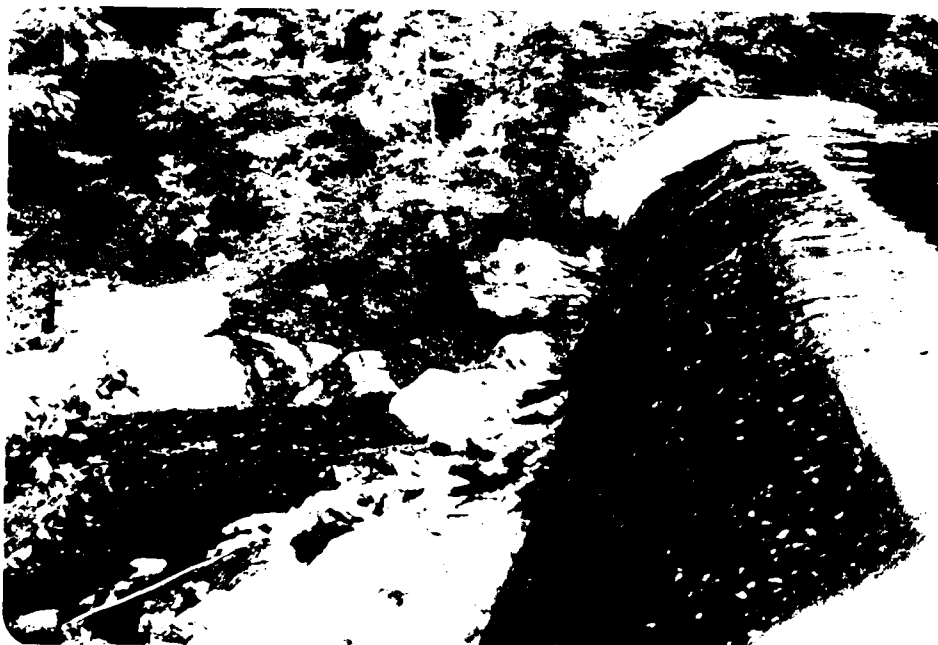
2. View of right abutment from left side of spillway showing bedrock outcrops at abutment and under spillway

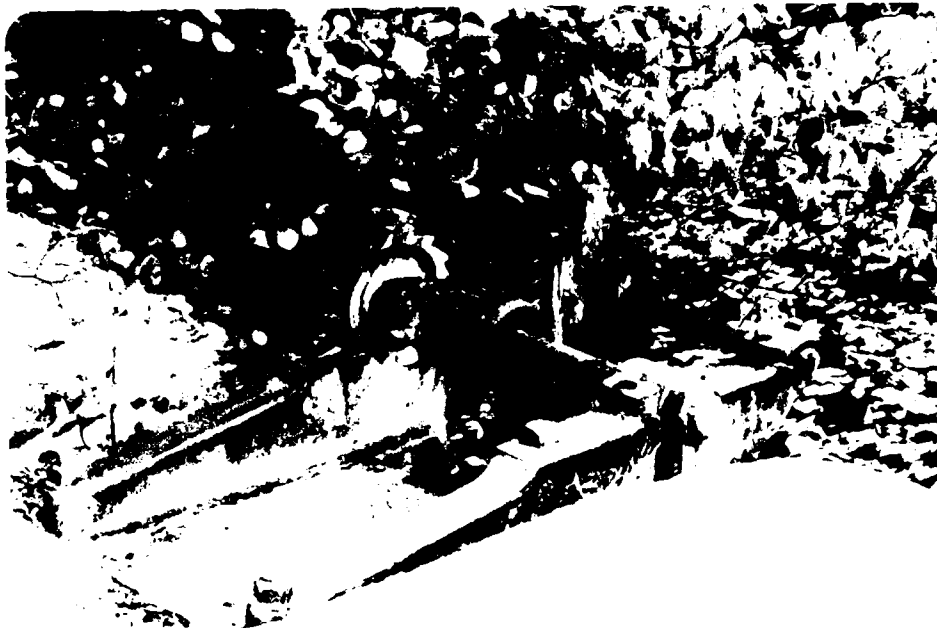
This gate is no longer operable. Observations have revealed that the timber sluice gate has deteriorated to the extent that seepage flows through and around the gate. This seepage is at the rate of approximately 15 to 20 gpm. In addition, the timber gate stem is broken and rotted and the operating mechanism is rusted with no evidence of maintenance.

5. View of deteriorated condition of gate operating mechanism

- (1) Rehabilitate the sluice gate structure, including the gate and operating mechanism, to serve its intended function.
- (2) Repair eroded and spalled concrete on all facing walls, abutment structures, and at the spillway.
- (3) Monitor the seepage at the penstock and right abutment section and determine the necessary remedial measures.

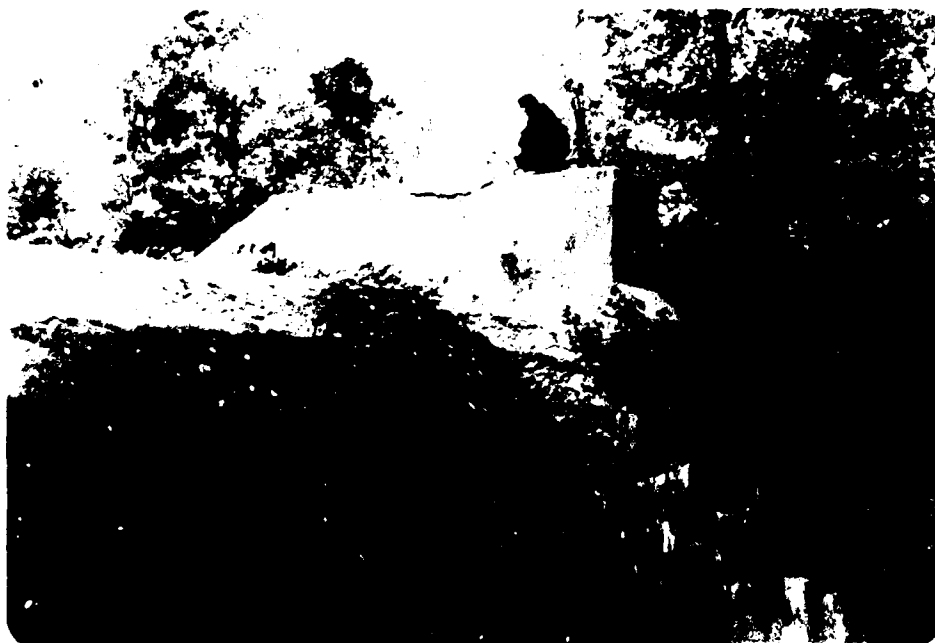
Approximately 25% of the top surface area of the left abutment has spalled. The vertical surface of this wall is extensively spalled and deteriorated over 50% of its surface area. The intersection between the abutment's vertical plane with the spillway crest has eroded along the contour of the crest for a distance of approximately 4 feet. The depth of the erosion is up to 6 inches. This erosion is attributed to ice damage and cavitation. The left downstream training wall has a series of horizontal cracks and points of efflorescence. The randomly placed stone masonry training wall does not have any visual deficiencies.

6. View of left spillway endwall from downstream showing deteriorated concrete

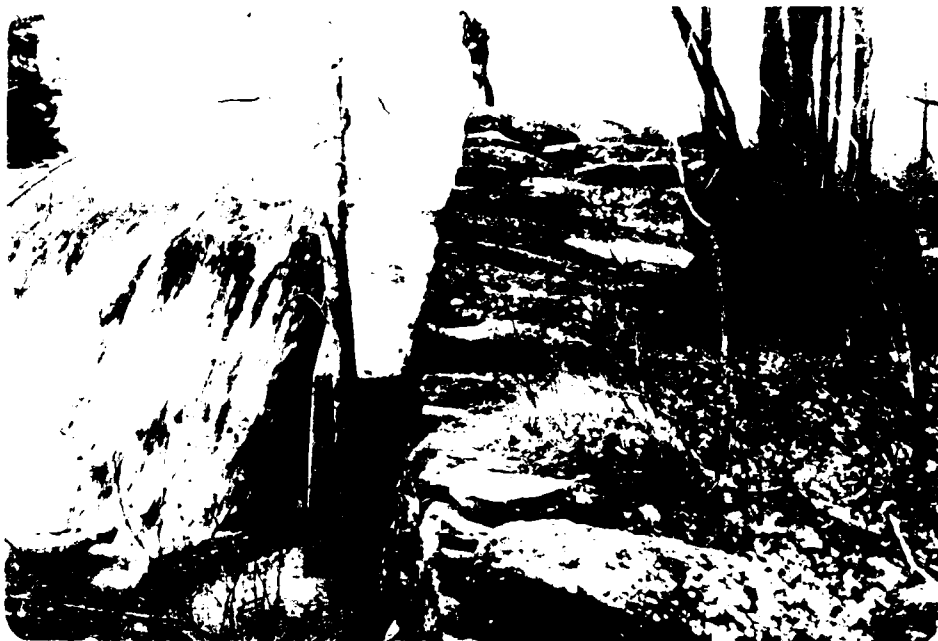
7 View from downstream showing earth filled rock crib forming left side of dam

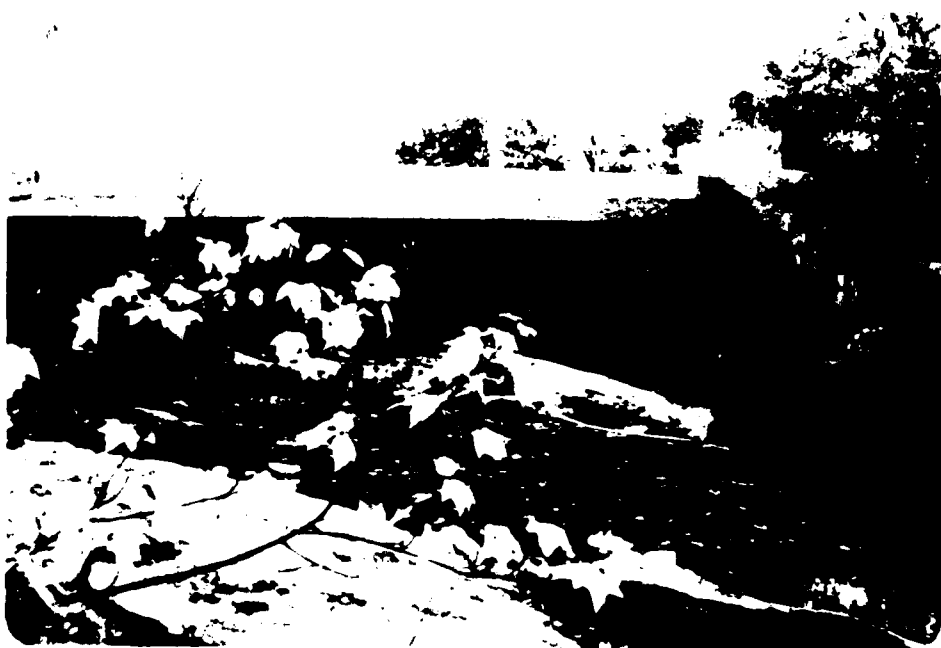
8 View from downstream showing concrete facing

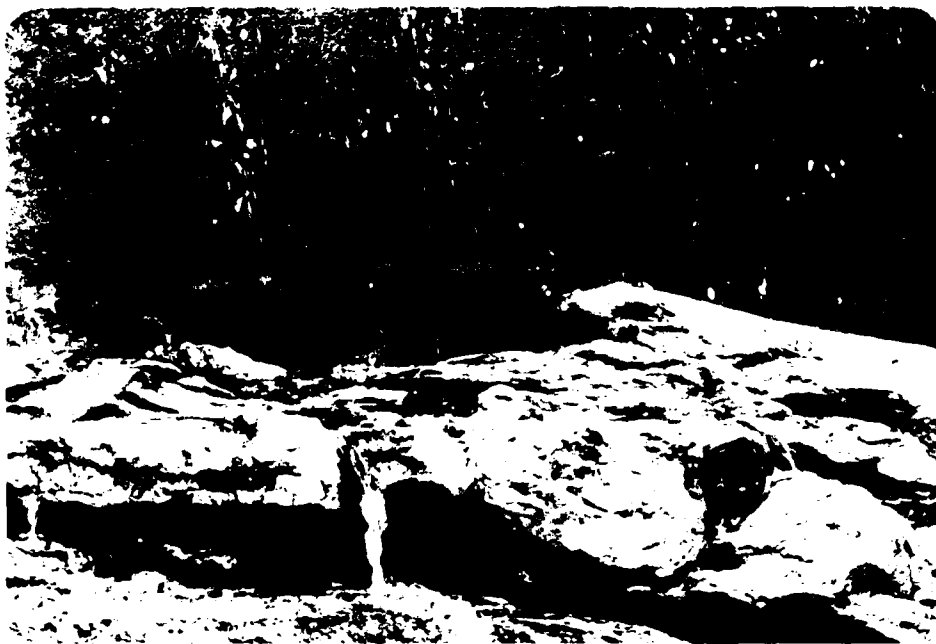
This structure is severely eroded and spalled. The upstream side of this structure has been eroded to depths of 15 inches at the spillway crest elevation, exposing rubble stone masonry from previous constructions. This erosion continues along the interface of the structure and the ogee crest and is about 9 to 12 inches in depth. The vertical faces of the structure are spalled from a depth of approximately 4 inches below the water line to near the top surface of the structure. The erosion and spalling is attributed to ice damage, cavitation, and alternate freeze and thaw cycles. Random cracking and efflorescence is prevalent over the vertical and horizontal surfaces of this structure. A close inspection of this structure has revealed that concrete topping and facing repairs had been instituted in the past which accounts for the uniform depth of spalling.

9. Detail of deteriorated concrete on downstream side of spillway
