PEMBROKE DAM

NH 00377

PHASE I INSPECTION REPORT
NATIONAL DAM INSPECTION PROGRAM

MARCH 1979

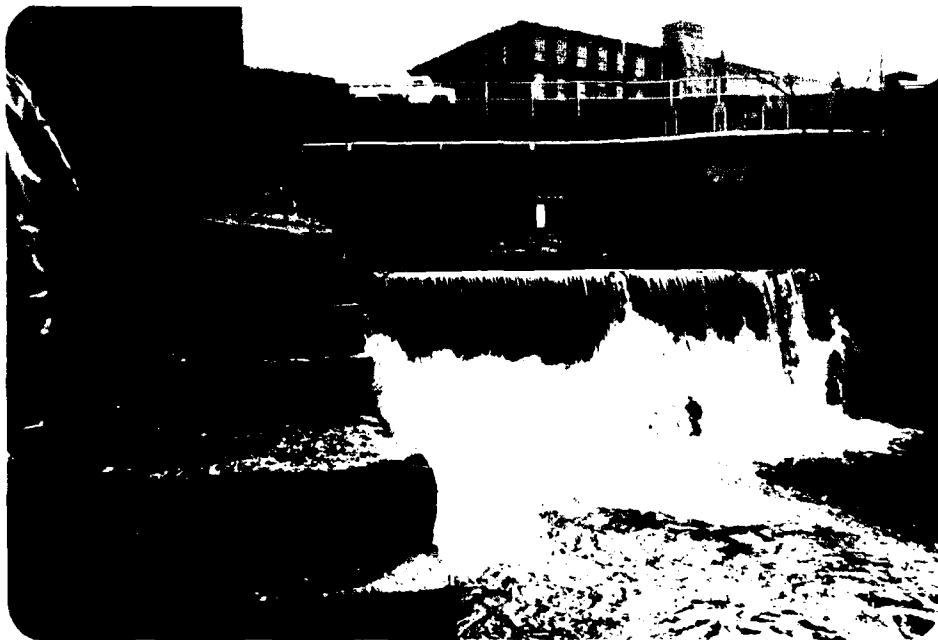
Overview from right side downstream showing
upstream road bridge

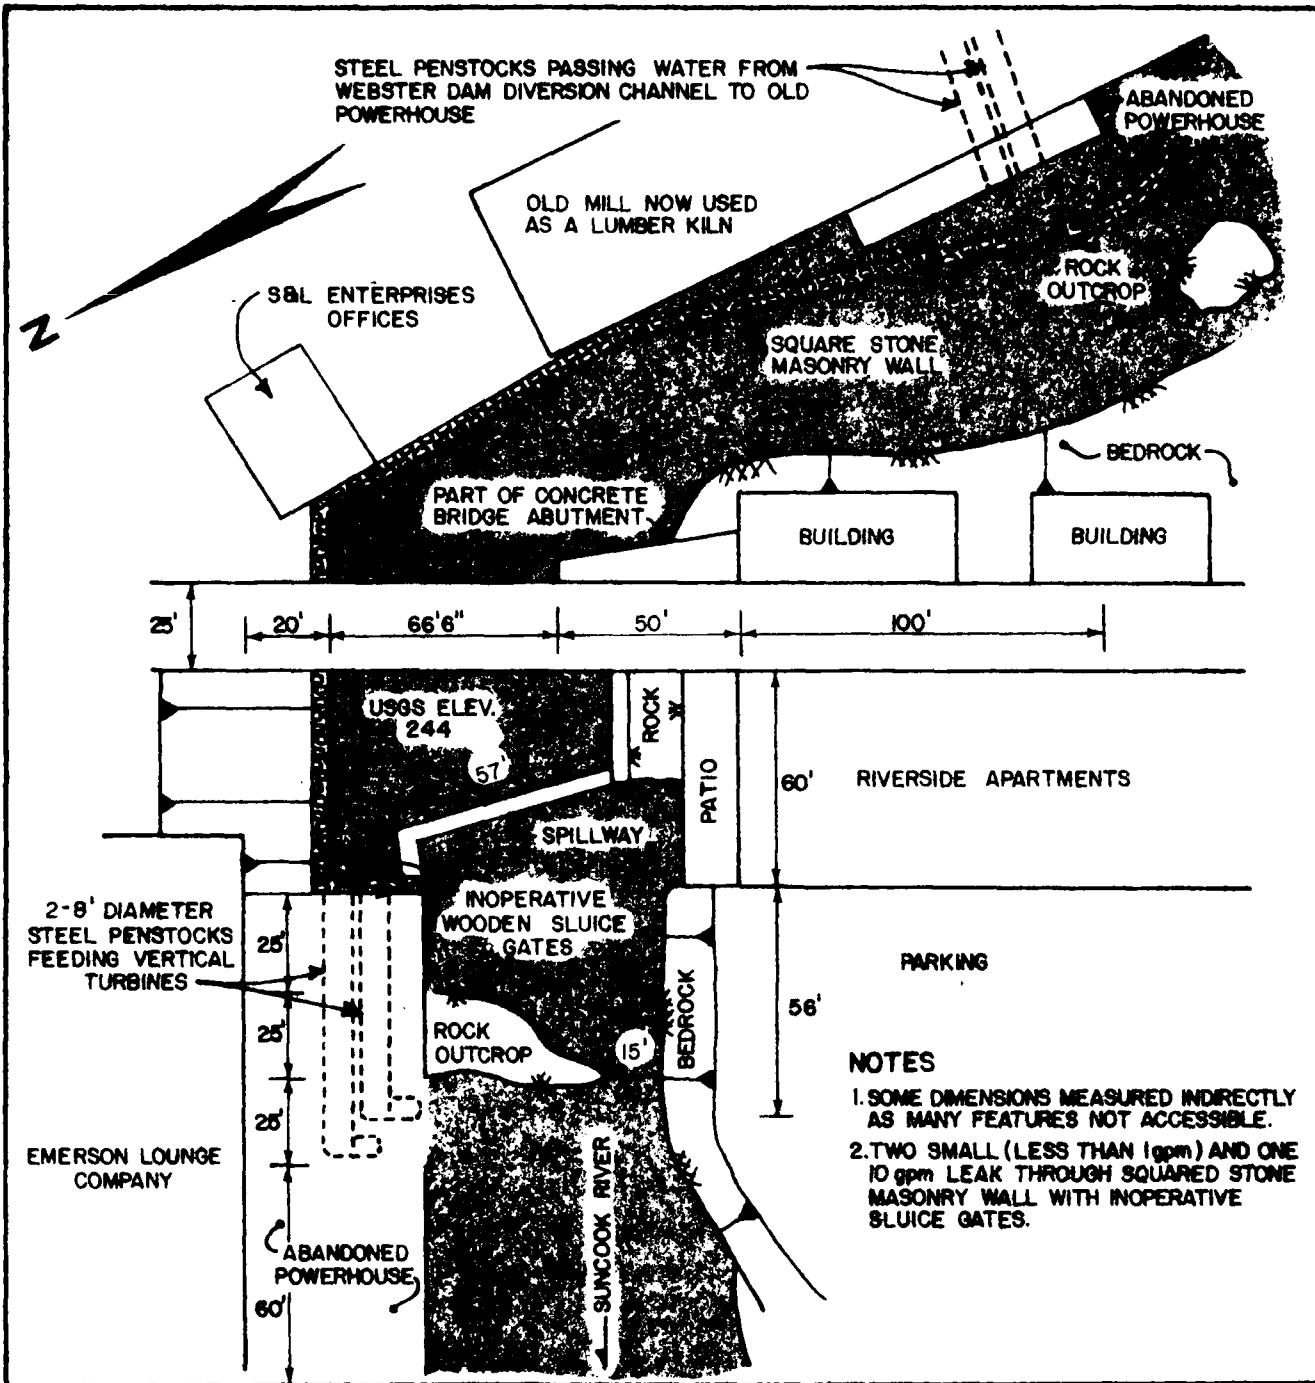
1. SOME DIMENSIONS MEASURED INDIRECTLY AS MANY FEATURES NOT ACCESSIBLE.
2. TWO SMALL (LESS THAN 1gpm) AND ONE 10 gpm LEAK THROUGH SQUARED STONE MASONRY WALL WITH INOPERATIVE SLUICE GATES.
