PEMBROKE COTTAGE MAIN DAM  
ME 00294  
AND  
EAST DAM  
ME 00721

PHASE I INSPECTION REPORT  
NATIONAL DAM INSPECTION PROGRAM

DEPARTMENT OF THE ARMY  
NEW ENGLAND DIVISION, CORPS OF ENGINEERS  
Waltham, Mass. 02154

SEPTEMBER 1981

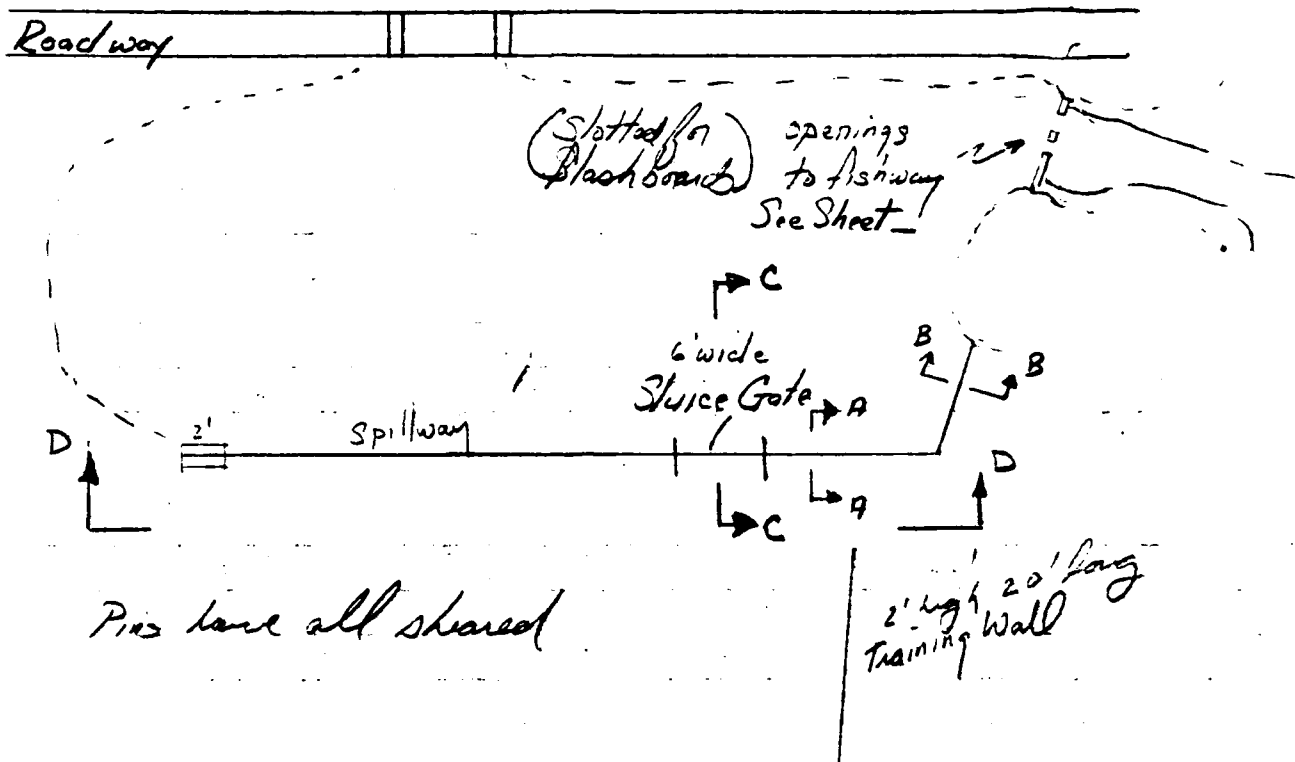
7" Spilling over spillway  
 @ time of inspection

Spillway is only 12" of concrete on bedrock  
 at 7' plunge
