# LYNN RESERVOIR DAM

MA 01285

## PHASE I INSPECTION REPORT NATIONAL DAM INSPECTION PROGRAM

JULY, 1981

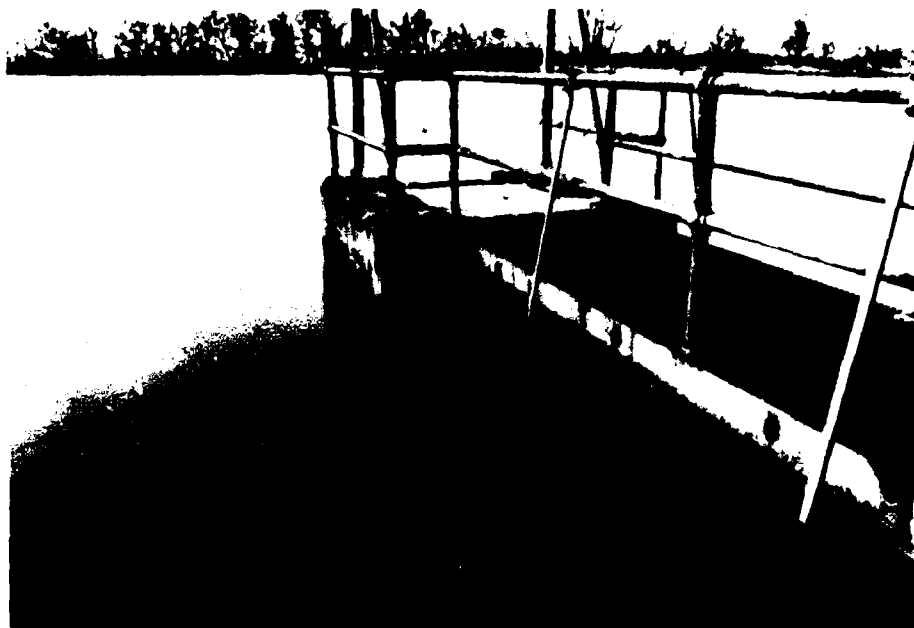
| Longitudinal Members | Webs & flanges are perforated extensively due to rust |

Photo No. 10 - Deterioration of the steel mesh walkway  
of the service bridge to outlet structure.
