CHARLES RIVER BASIN
MILFORD, MASSACHUSETTS

CEDAR SWAMP POND DAM
MA 00628

PHASE I INSPECTION REPORT
NATIONAL DAM INSPECTION PROGRAM

JULY 1978

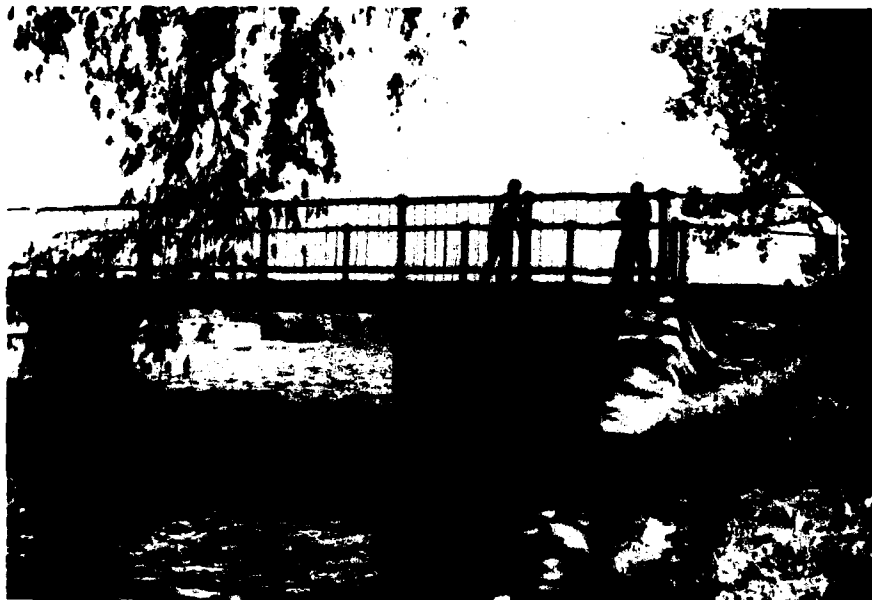
* Sluiceway and slide gates
 control:
 two 4-foot slide gates operated by hand wheels - good condition -
 made of steel

**NO. 4 - VIEW OF EAST ABUTMENT, DOWNSTREAM
FACE, WITH SLIDE GATES IN CENTER OF PICTURE**
