SAINT JOHN RIVER BASIN  
Limestone, Maine

# WEBSTER BROOK DAM ME 00229

## PHASE I INSPECTION REPORT NATIONAL DAM INSPECTION PROGRAM

SEPTEMBER 1981

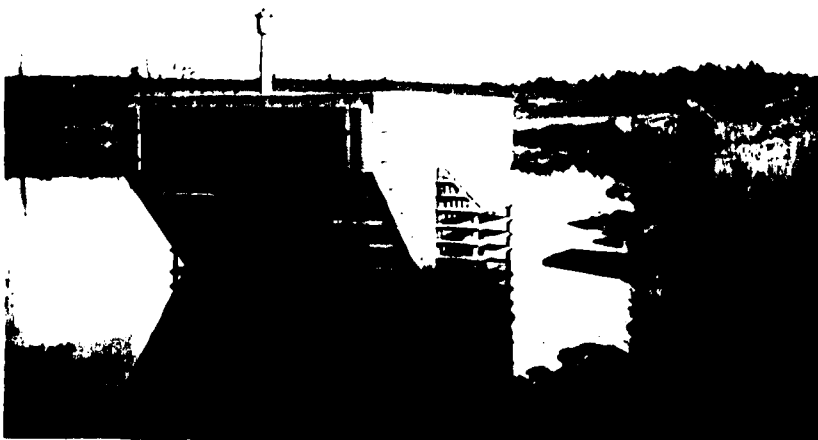
(1) Principal Spillway - The principal spillway intake (Photo 2 and 3) was observed from shore. The exposed concrete and steel trashrack appeared in good condition.

Photo #3  
Close-up view of  
Principal Spillway  
Intake Structure

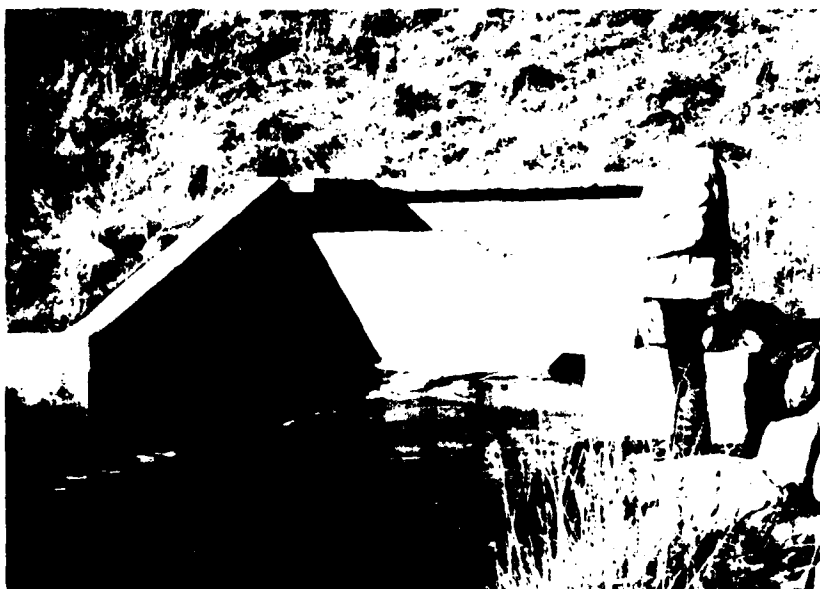
(2) Outlet works - The outlet impact basin (Photo 5) was found in good condition. All construction joints were tight. No spalling was observed. The reservoir drain inlet was submerged and could not be inspected. The outlet conduit could not be inspected. The control mechanism for the drain was reported to have been recently operated without problems by the Limestone Town Manager.

Photo #5

Concrete Outlet  
Structure
