**CONNECTICUT RIVER BASIN
CHARLEMONT, MASS.**

**J. A. WELLS UPPER DAM
MA 01268**

**PHASE I INSPECTION REPORT
NATIONAL DAM INSPECTION PROGRAM**

JUNE 1980

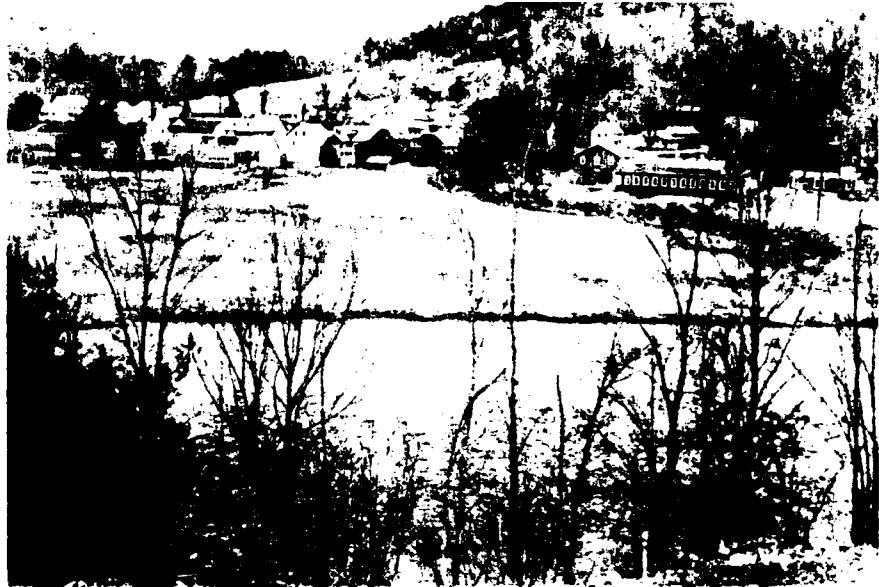
Figure 11 - View of elementary school, town garage (brown building at right) and the fire station (red building at right). This area lies in the floodplain of the Deerfield River (foreground).

This photograph was taken looking across the Deerfield River from its southernly bank.
