MILL POND RESERVOIR MAIN DAM  
MA 01121

PHASE I INSPECTION REPORT  
NATIONAL DAM INSPECTION PROGRAM

NEW ENGLAND DIVISION, CORPS OF ENGINEERS

JANUARY 1980

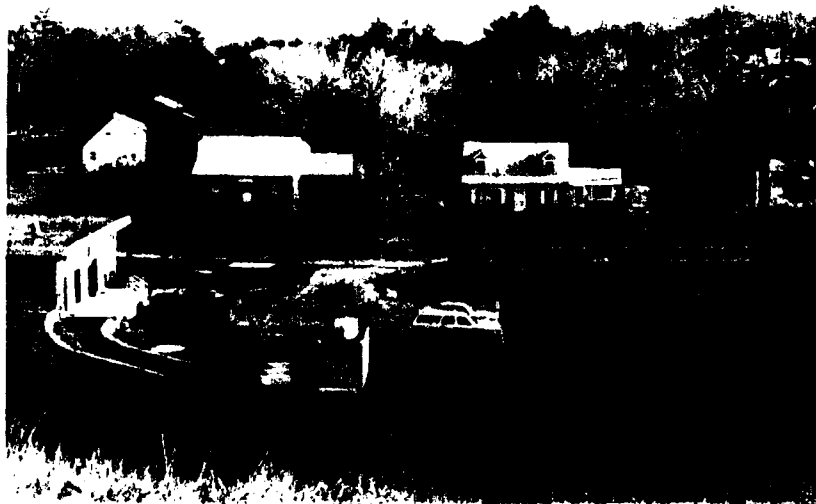
The impact area is separated into two sections which follow Maple Meadow Brook (photograph 13) and Willow Brook (photograph 14). Along Maple Meadow Brook there is substantial residential development. Much of this development has occurred since the dam was constructed. At least 65 homes would be damaged by dam failure flood water.

PHOTO NO. 13 - View of the immediate downstream area showing the Water Treatment Plant and the Maple Meadow Brook Dam Failure Impact Area. Many of the homes, upper right side of photo, are at higher elevations than those in the immediate downstream area.

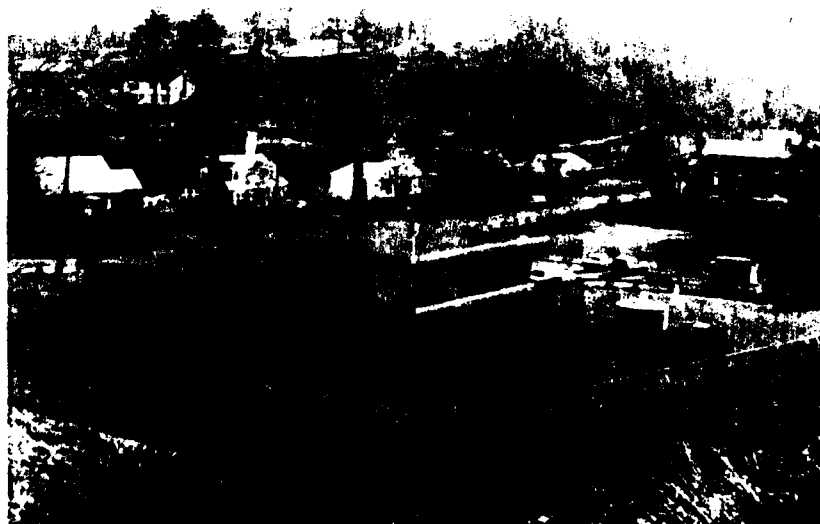
PHOTO NO. 14 - View of the right side immediate downstream area. Upper right side of photo shows the beginning of the Winter Street-Willow Brook-Route 38 Dam Failure Impact Area.
