CONNECTICUT RIVER BASIN  
SPRINGFIELD, MASSACHUSETTS

MONSANTO COMPANY UPPER DAM  
MA 00573

PHASE 1 INSPECTION REPORT  
NATIONAL DAM INSPECTION PROGRAM

OCTOBER 1978

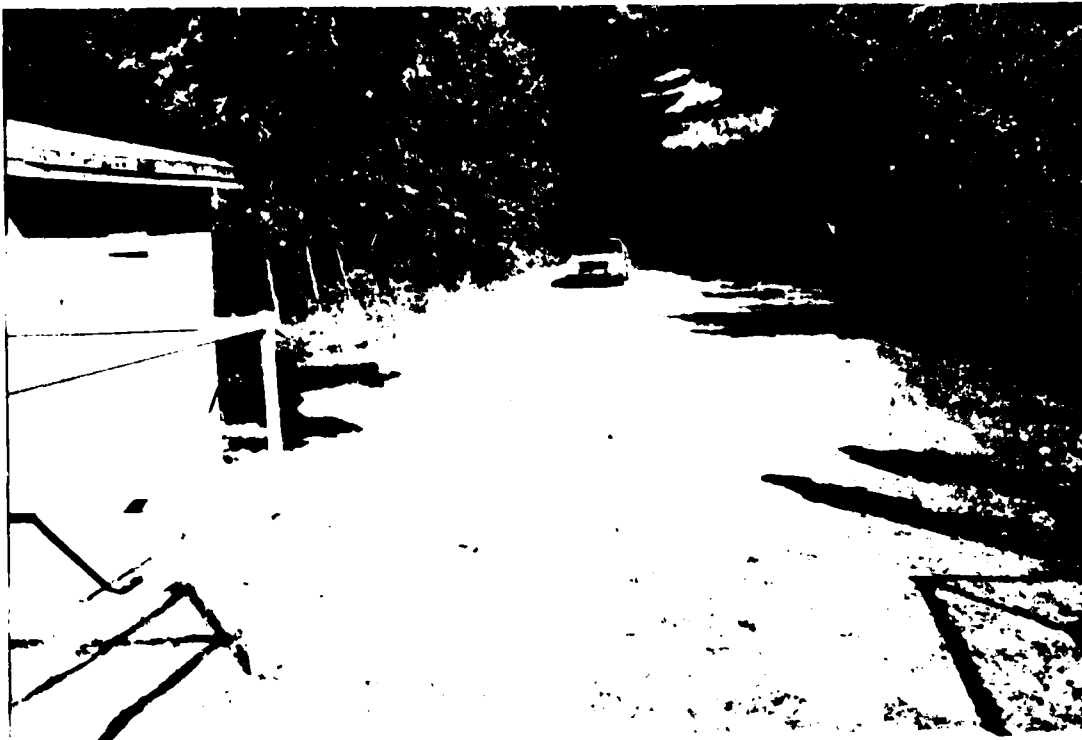
VIEW LOOKING EAST. NOTE ABSENCE OF TURF.

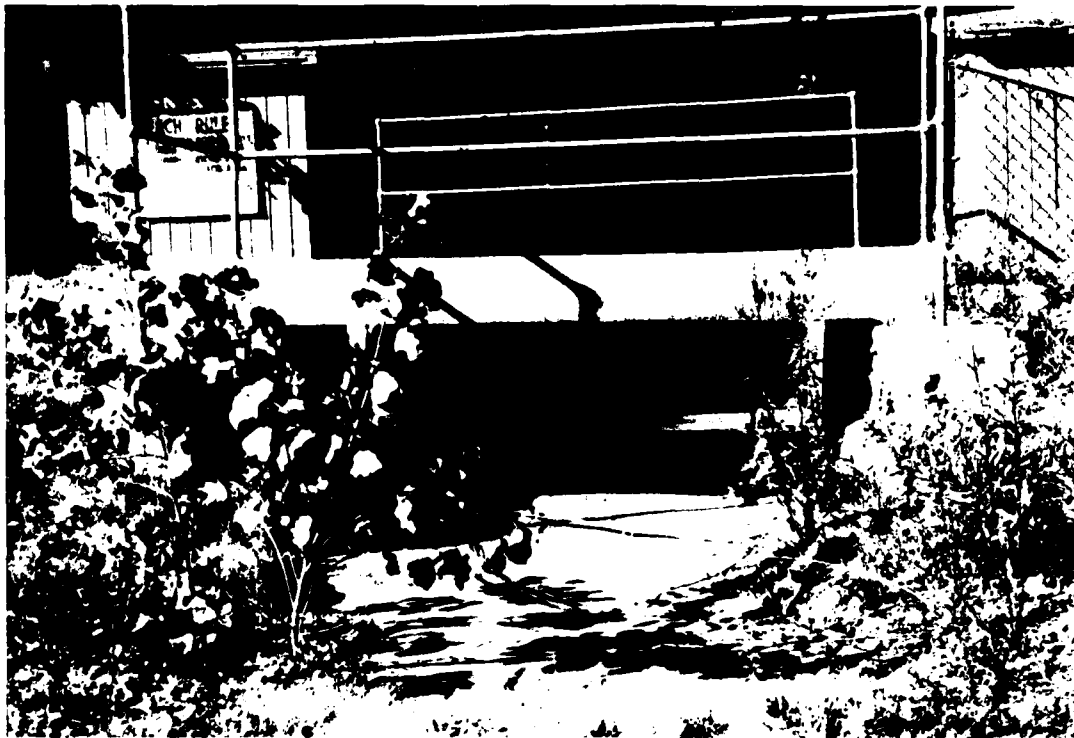
The spillway appears to be generally in good condition. The approach to the spillway apron is covered by sediment, has a few saplings and grass growing. (See Photograph No 4). The approach apron and spillway channel are covered with a bituminous overlay which is in good condition. The concrete floor of the spillway chute is heavily spalled with some minor debris on the floor. An anchor fence spans the entrance to the spillway chute. (See Photograph Nos 6 & 7). The bottom of the fence is 14 inches above the chute floor, but is equipped with a hinged section, which when raised, provides a clear opening of 26 inches. The spillway

4. VIEW OF SPILLWAY ENTRANCE. NOTE VEGETATION.

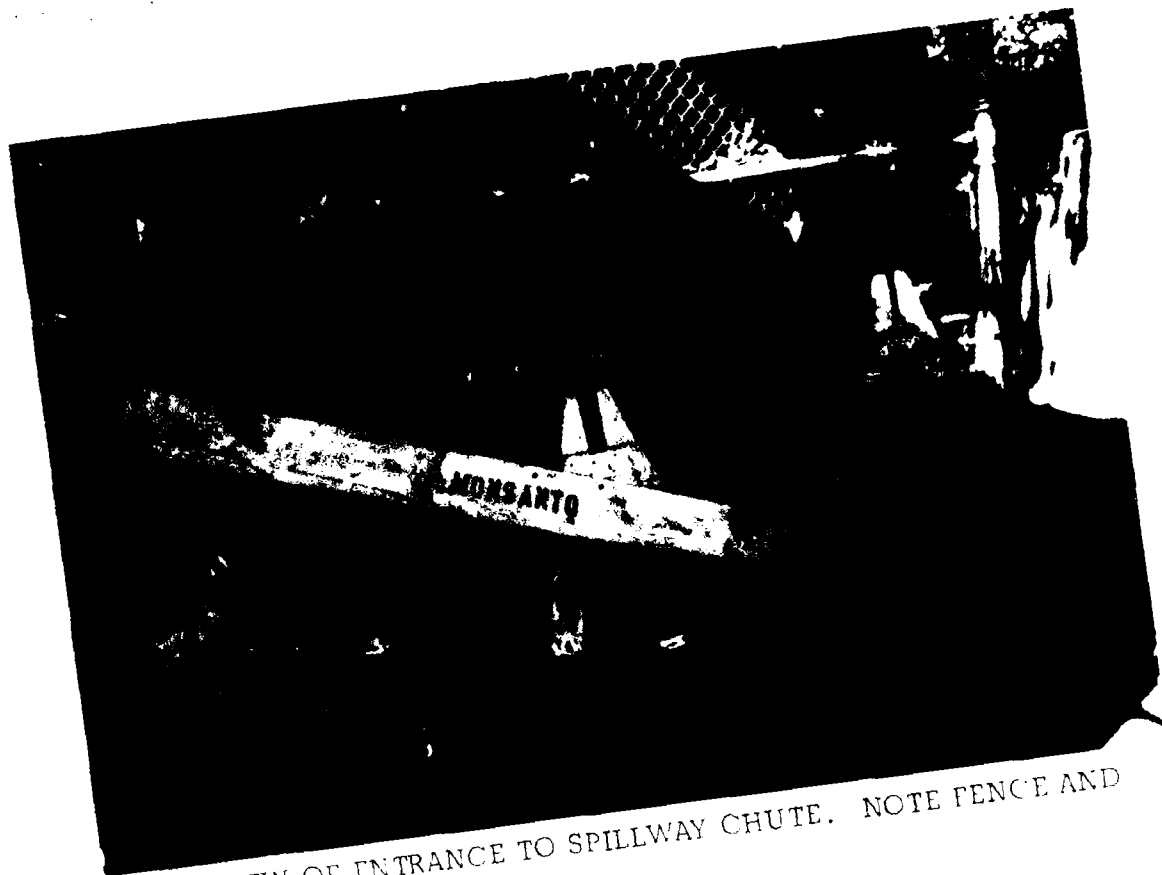
6. VIEW OF ENTRANCE TO SPILLWAY CHUTE. NOTE FENCE AND BARRICADE HORSES.

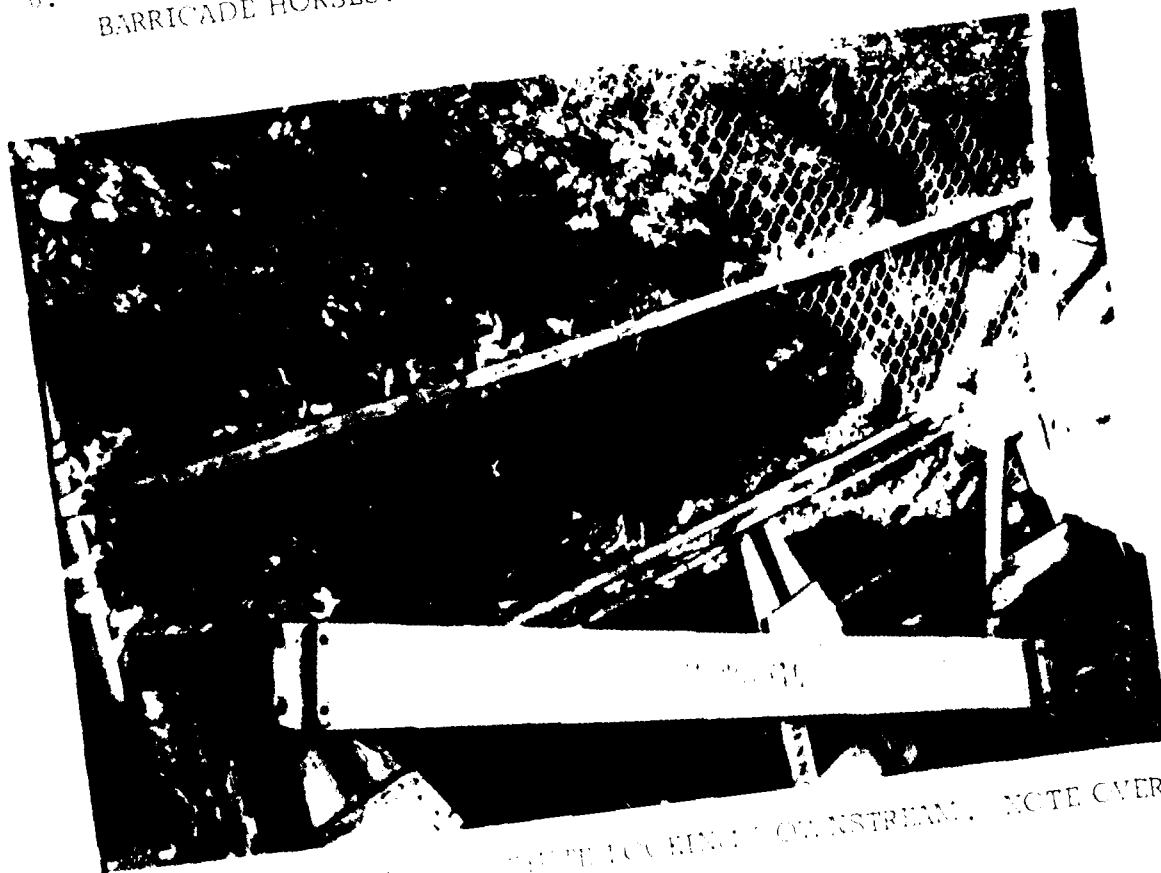
7. VIEW OF ENTRANCE TO SPILLWAY CHUTE. NOTE OVER-

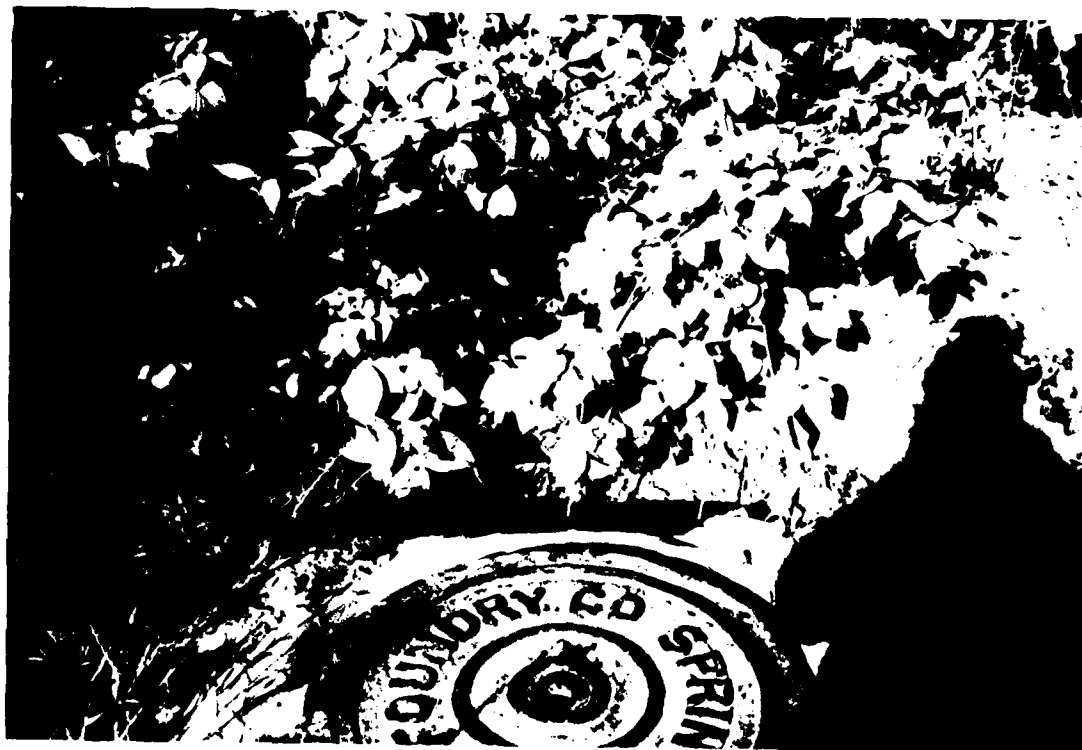
The earth embankment appears to be in generally fair condition. The horizontal and vertical alignments of the crest are good with only minimal erosion caused by traffic. The crest is covered with only a minimal amount of turf and there are several saplings growing adjacent to the anchor fences which run along the edges of the crest. (See Photograph No. 2). In addition, a depression, about 4 feet in diameter and 2.5 feet deep exists adjacent to a manhole at the downstream edge of the crest. (See Photograph No. 10).

10. VIEW OF PIPESTION ADJACENT TO MANHOLE LOCATED ON  
CREST.
