CONNECTICUT RIVER BASIN
WINCHENDON, MASSACHUSETTS

HUNTS POND DAM
MA 00634

PHASE I INSPECTION REPORT NATIONAL DAM INSPECTION PROGRAM

DECEMBER 1979

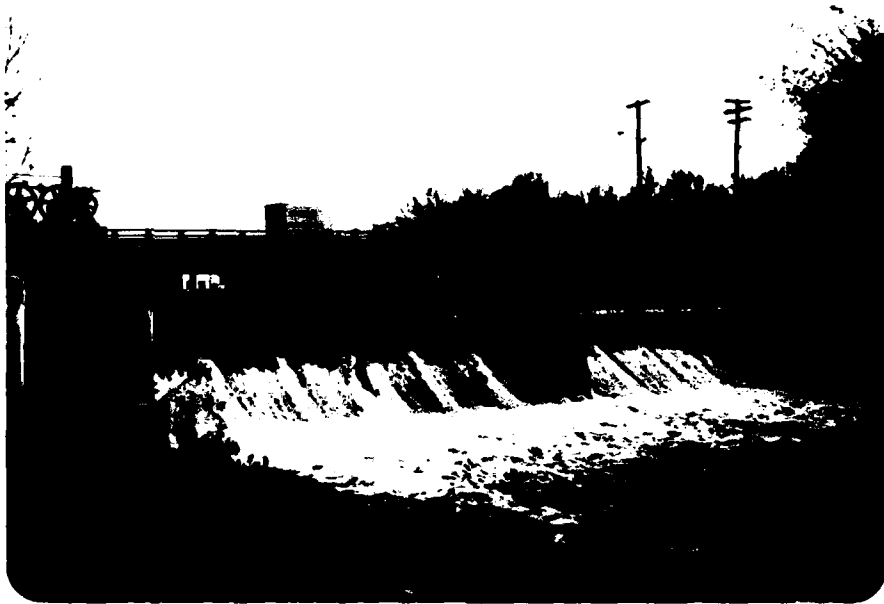
NO. 1 DOWNSTREAM FACE OF DAM

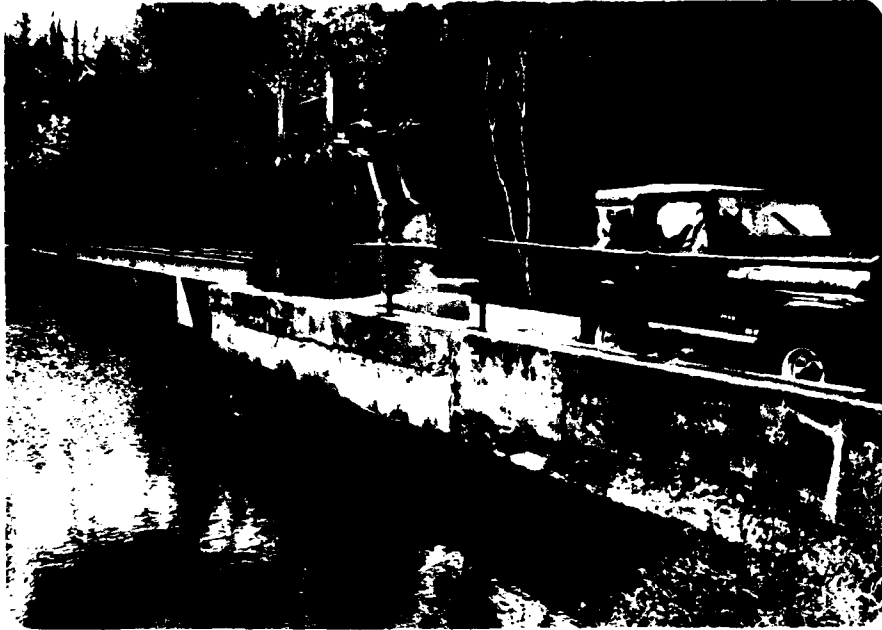
The most obvious deficiency is localized spalling and cracking of the concrete. This was observed on the upstream face of the north retaining wall and outlet headwall (see photo No. 3), on the center pier of the spillway (see photo No. 4), and on the south sidewall of the spillway just downstream of the weir. Slight seepage was observed about midway on the downstream slope below the south retaining wall and next to the spillway sidewall. The seepage appears to be through a vertical crack on the upstream face of the south retaining wall. A significant growth of trees and brush has occurred on the top and downstream slope of the dam below the south retaining wall. The earth fill forming the crest of the dam along the south retaining wall is about 2 feet lower than the top of the wall. Also, a footpath was observed on the downstream slope along the south sidewall of the spillway. The top of the dam along the north retaining wall is clear of trees, and the downstream slope has been filled in to form a parking area.

**NO. 3 SPALLED CONCRETE ON UPSTREAM
FACE OF NORTH RETAINING WALL**

- a. Operating and Maintenance Procedures. It is recommended that the Owner accomplish the following:
 - (1) Repair spalled and/or cracked concrete on the upstream face of the dam, on the center pier and south sidewall of the spillway, and on the upstream headwall and sidewalls of the outlet.

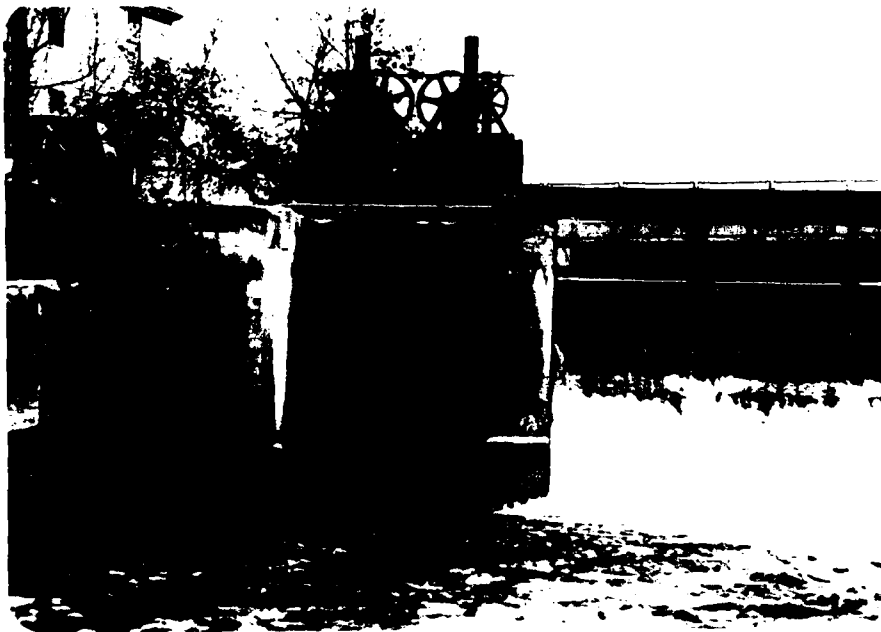
- 4.3 Maintenance of Operating Procedures. In 1978, the wooden slide gate was replaced in the outlet. At the present time, slight leakage is occurring from the sides and bottom of the gate. Also in 1978, concrete was repaired at the base of the sidewalls and on the overhead slab of the outlet. However, the upstream side of the headwall is cracked and spalled. The unrepaired portions of the sidewalls are cracked and show some efflorescence. The rack and pinion mechanism for operating the slide gate is intact and recently painted.

NO. 6 OUTLET GATE
