MERRIMACK RIVER BASIN  
FITCHBURG, MASSACHUSETTS

SNOWS MILL POND DAM  
MA 00878

PHASE I INSPECTION REPORT  
NATIONAL DAM INSPECTION PROGRAM

FEBRUARY 1979

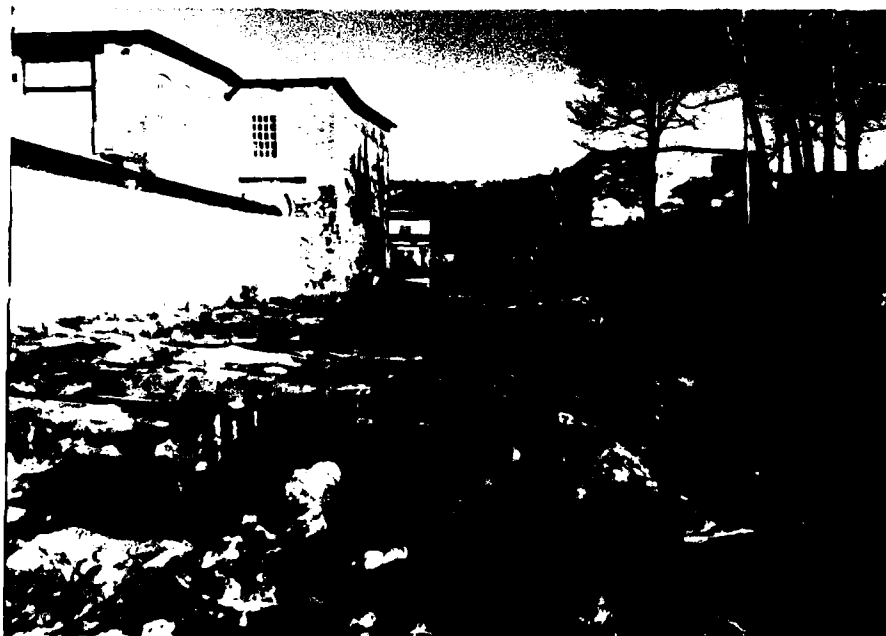
17. View downstream from dam showing exposed bedrock and boulders in channel
