**CHARLES RIVER BASIN
WESTON, MASSACHUSETTS**

**WESTON RESERVOIR DAM
MA 00798**

**PHASE I INSPECTION REPORT
NATIONAL DAM INSPECTION PROGRAM**

FEBRUARY 1980

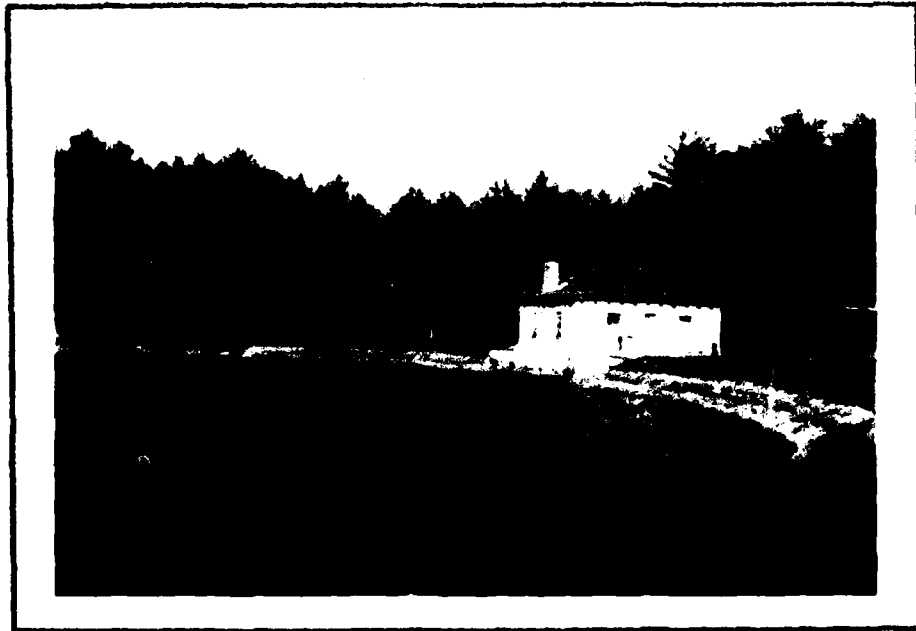
UPSTREAM OVERVIEW OF WESTON RESERVOIR DAM AS VIEWED FROM THE RIGHT ABUTMENT. (10/23/79)
