MERRIMACK RIVER BASIN
LEOMINSTER, MASSACHUSETTS

FALL BROOK RESERVOIR DAM
MA 00869

PHASE I INSPECTION REPORT
NATIONAL DAM INSPECTION PROGRAM

SEPTEMBER 1979

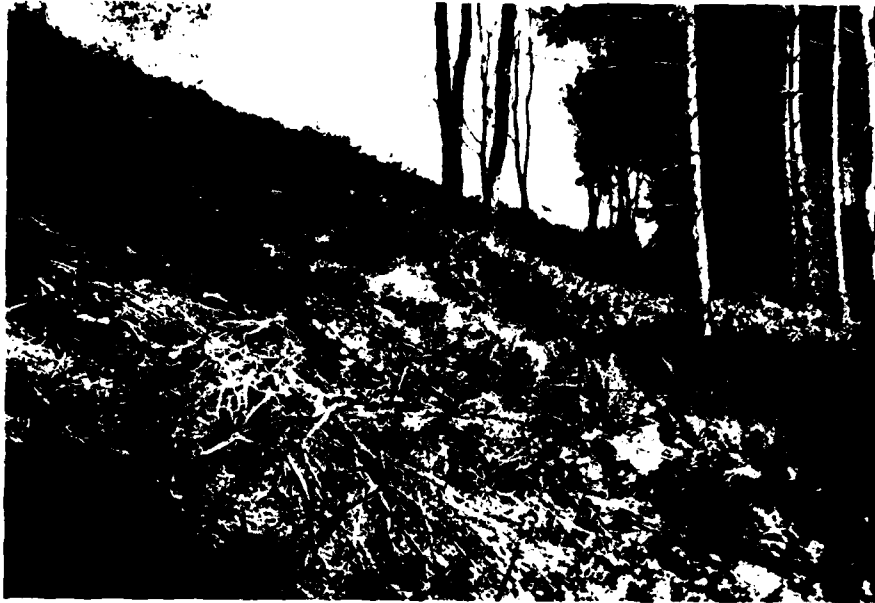
The main dam is in fair condition. The soil on the downstream face and at the toe of the dam is moist and soft. One area of seepage was observed on the slope to the left of the outlet headwall (see Figure B-1). Photographs 5 and 6 in Appendix C show that much of the downstream slope is covered with a heavy growth of bushes, ferns, grapevines, and similar groundcover that prevented a closer examination of the slope. Several large diameter trees are also growing on the downstream slope. There is evidence of recent tree clearing on the slope, north of the outlet. However, the roots and stumps have been left in place.

**NO. 5 PARTIALLY CLEARED DOWNSTREAM SLOPE
(MAY 17 PHOTO)**

It is recommended that the Owner employ a qualified engineering consultant to evaluate the seepage which is occurring through the embankment of the main dam, particularly in the area to the left of the outlet. The engineering consultant should also conduct a more detailed hydraulic and hydrologic study to evaluate spillway capacity and overtopping potential. In addition, the Owner should undertake the following measures to correct the deficiencies observed at the site: selectively clear trees and roots and remove all brush from the slopes of the dam and dike, and from the spillway discharge channel; clear the blocked outlet pipe and repair the outlet gate valve, if necessary; repair the headwall at the outlet and clear trees and debris from the outlet discharge channel; repair the training walls on the spillway; clear all rock, vegetation and debris from the crest of the spillway; backfill the eroded areas on the upstream slope of the dam and replace any missing riprap. In addition, the Owner should repair the deficiencies listed above, as described in Section 7.3. The Owner should also implement a program of annual technical inspections, a plan for surveillance of the embankment during and after periods of high runoff, and a plan for notifying nearby residents in the event of an emergency at the project.

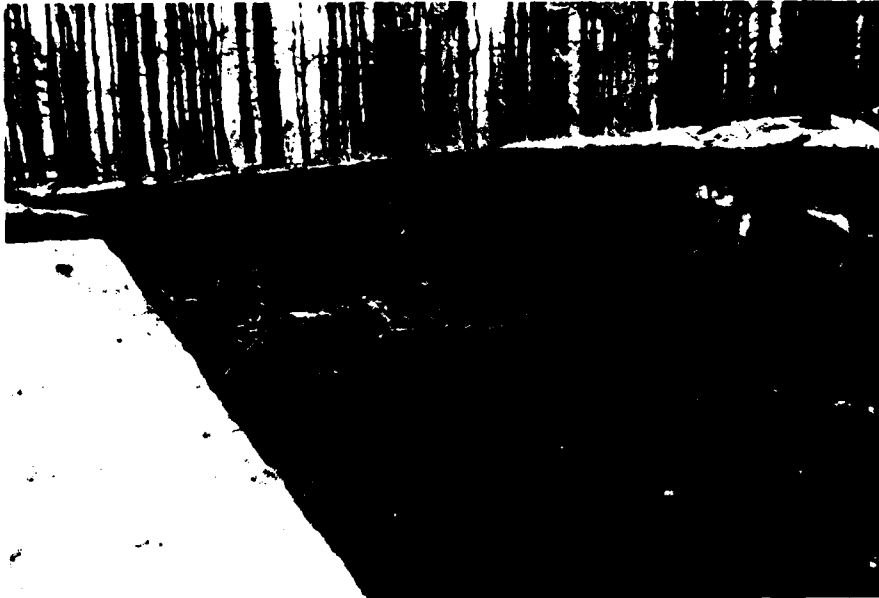
On other parts of the channel the training walls have deteriorated to the point that stones have fallen into the channel, leaving voids in the wall (see photo #7). The dense growth of vines, and roots from the many trees along the discharge channel also contribute to the deterioration.

NO. 7 SPILLWAY CHANNEL AND TRAINING WALLS

- (4) Clear wood, stone and debris from the crest and floor of the spillway.
- (5) Repair the stone masonry training walls of the spillway.
- (6) Backfill the eroded areas on the upstream slope of the dam, and replace any missing riprap.
