NEPONSET RIVER BASIN
WALPOLE, MASSACHUSETTS

BIRD POND DAM
MA. 00804

PHASE I INSPECTION REPORT
NATIONAL DAM INSPECTION PROGRAM

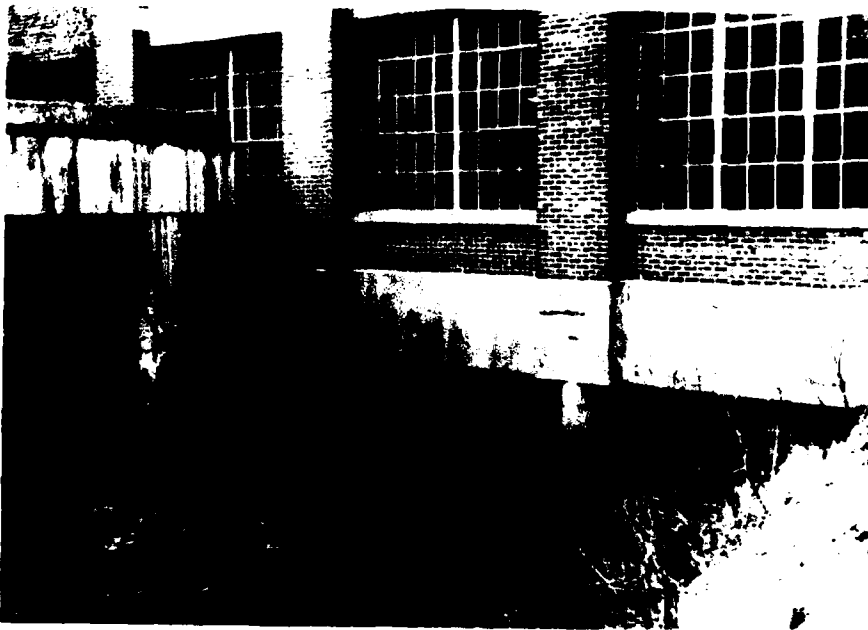
9. Culvert outlet about 300 ft. downstream of dam

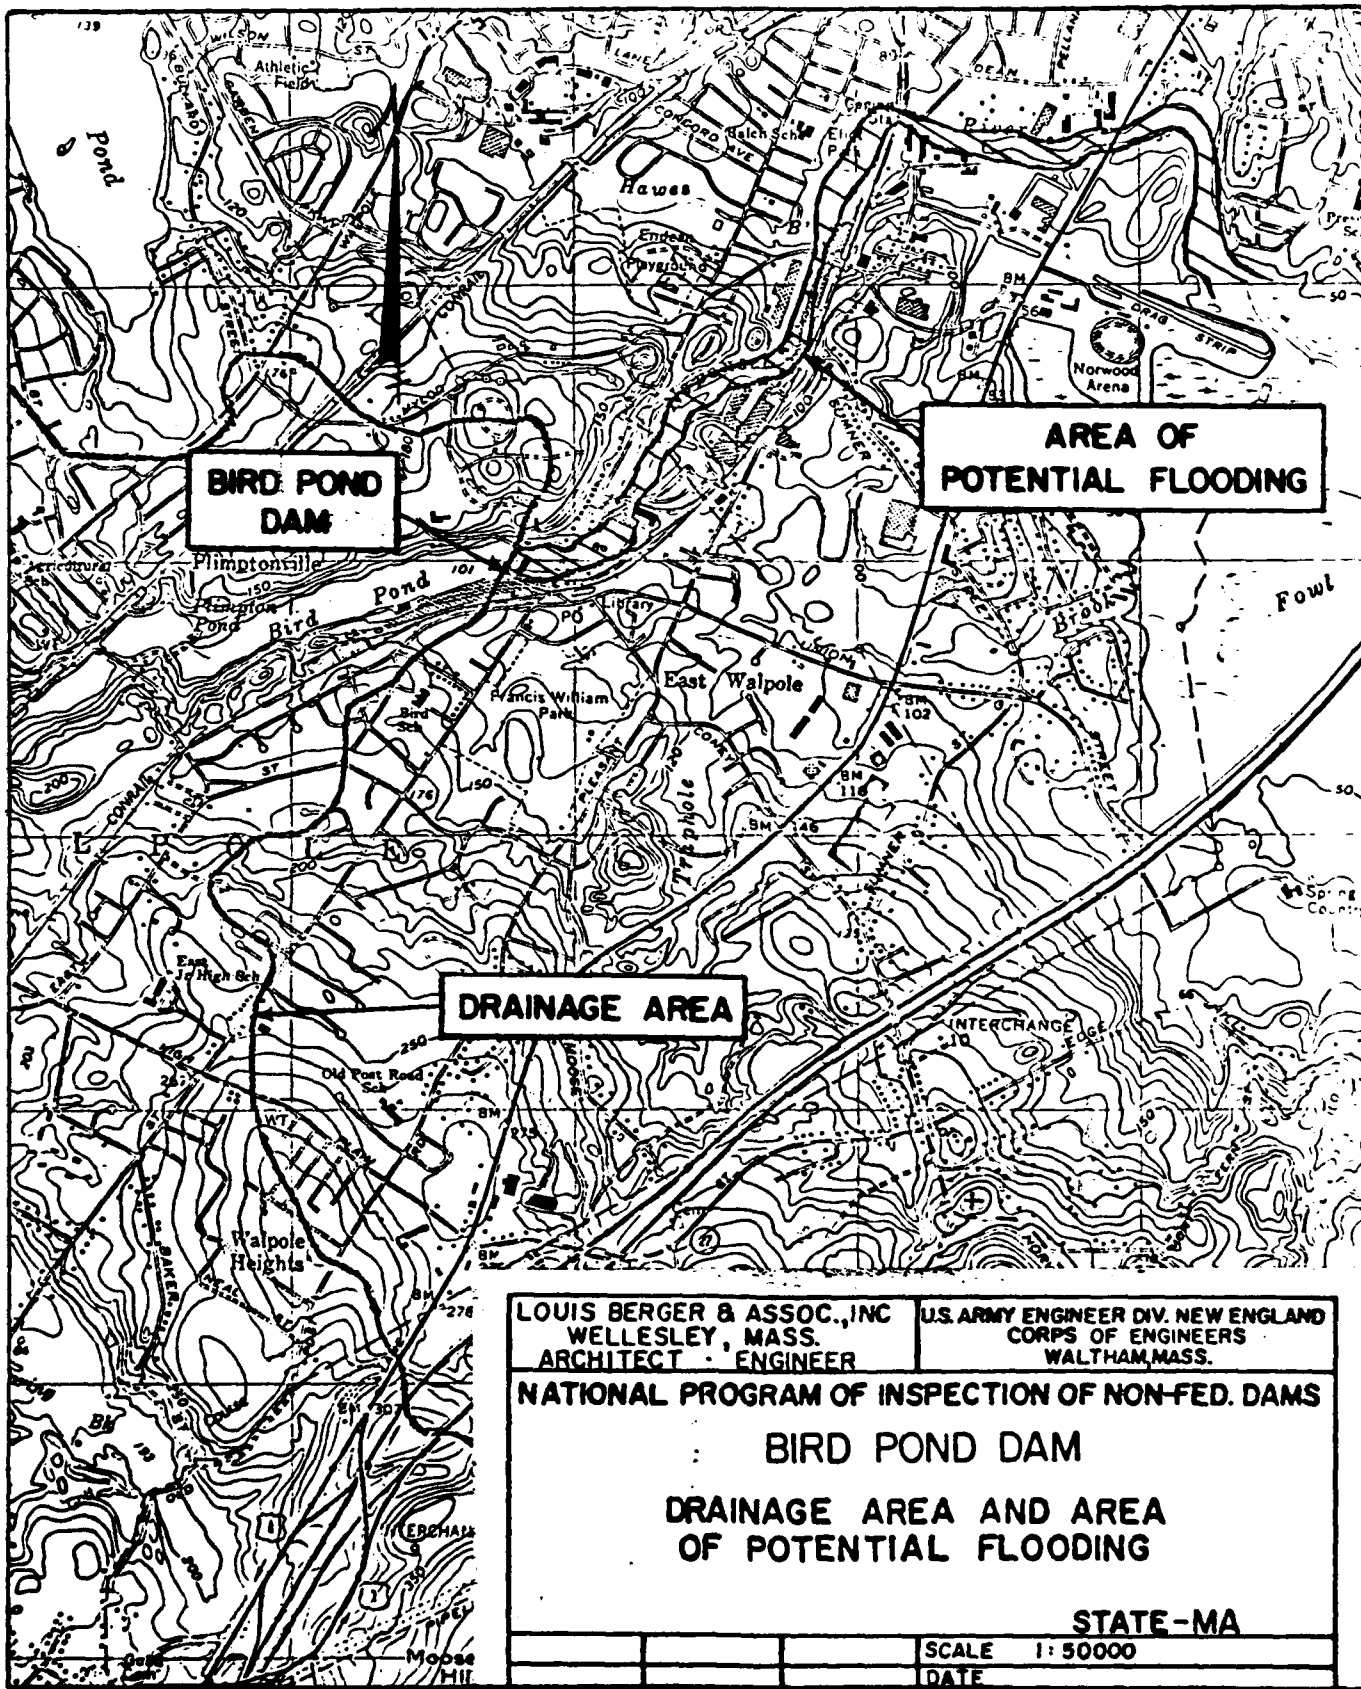
**AREA OF
POTENTIAL FLOODING**

In summary, a breach of the dam could cause flood damage to three industrial complexes, with the possibility of the loss of more than a few lives. (Appendix D, Sheet D-15, shows the area of potential flooding.)
