CONNECTICUT RIVER BASIN  
ASHFIELD, MASSACHUSETTS

ASHFIELD POND DAM  
MA 00523

PHASE 1 INSPECTION REPORT  
NATIONAL DAM INSPECTION PROGRAM

AUGUST 1978

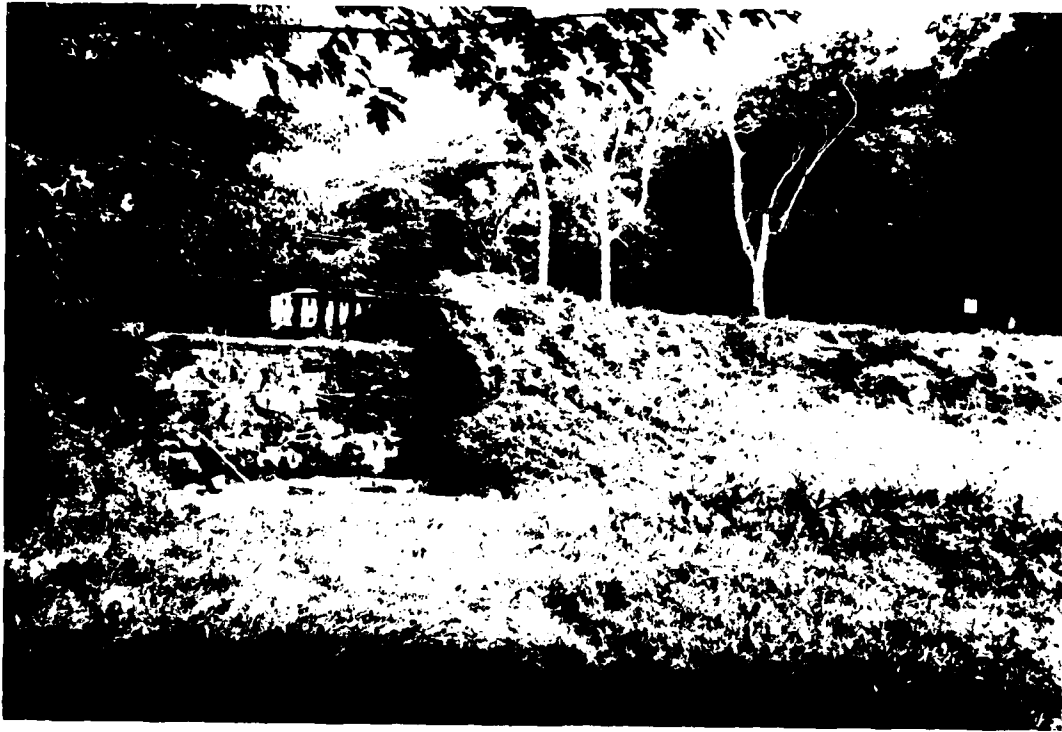
2. VIEW OF SPILLWAY AND DOWNSTREAM SLOPE IN VICINITY OF EAST ABUTMENT.

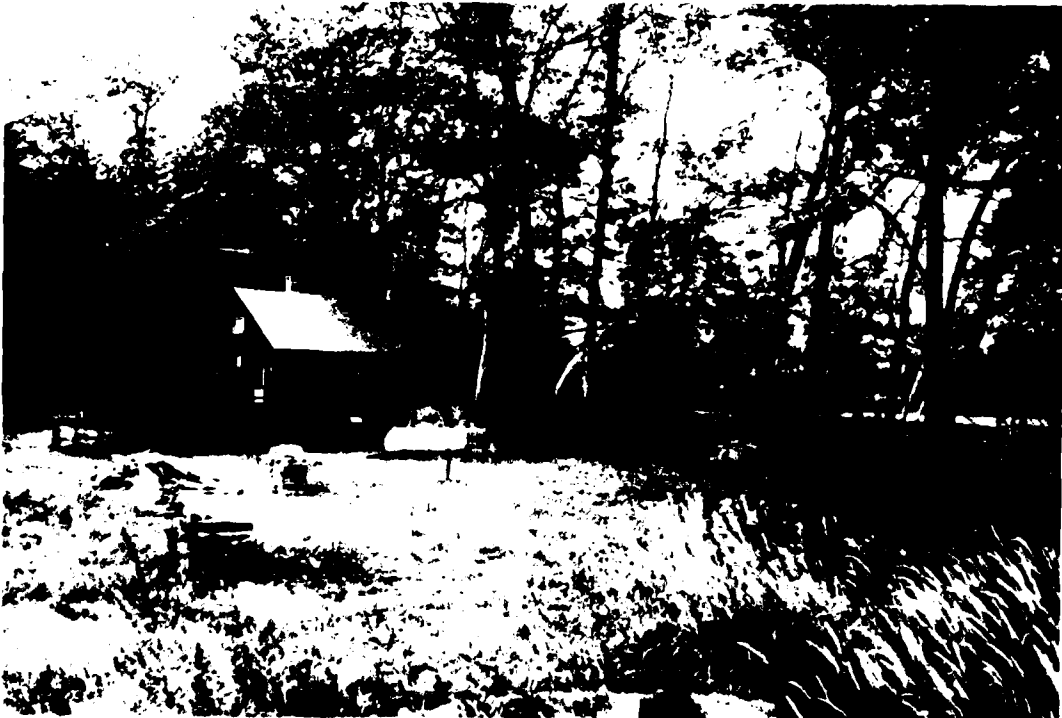
3. VIEW OF DOWNSTREAM SLOPE IN VICINITY OF WEST ABUTMENT. NOTE TREES ON SLOPES AND CLOSE PROXIMITY TO DAM OF RESIDENCE.

11. Heavy brush, shrubs and young saplings should be removed from the embankment, spillway channel and the area immediately downstream of the embankment toe. Large conifers, but not deciduous hardwoods, should be removed and the remaining trees should be inventoried and their condition monitored. If a tree dies, the area around the tree should be closely monitored for seepage.

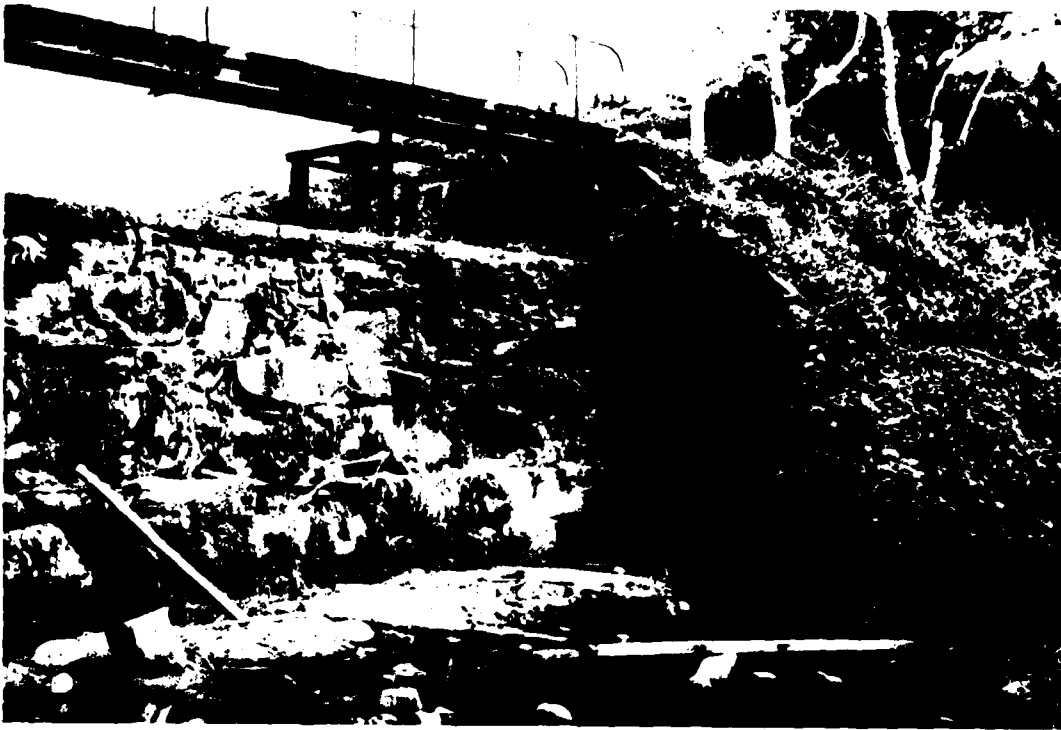
The stone masonry spillway appears to be in good condition with only few stones missing. Mortar pointing is missing over large areas and there is some vegetation growing from the joints. The concrete on the spillway sill is in generally good condition, however, the crest has been sedimented with beach sand and there is some vegetation growing. There are no flashboards in use, and it is reported they have never been used. The stone masonry, the concrete base of the training walls and the spillway

channel floor are in good condition. The wood deck of the pedestrian bridge is in fair condition with only a few boards broken and/or missing. The steel support beams are in good condition, however, they are rusty. (See Photograph No. 6).

6. CLOSEUP VIEW OF SPILLWAY, LOW LEVEL OUTLET AND OPERATING STAND FOR SLUICEGATE. NOTE VEGETATION, CAVITIES AND DEBRIS.

3. Missing stones should be replaced on the downstream face of spillway.
4. Crest of spillway should be cleaned and vegetation removed.
5. Low level outlet gate mechanism should be made operable, greased and painted. The gate shaft should be cleaned and provisions made for preventing a reoccurrence of the silting of the shaft. Consideration should be given to construction of a gate house.

6. The missing and broken wood decking for the pedestrian bridge should be replaced and the steel beams should be painted.
7. The highway drainage channel located along the downstream toe of the embankment should be rerouted. Areas along the toe which have been eroded should be refilled with suitable material.

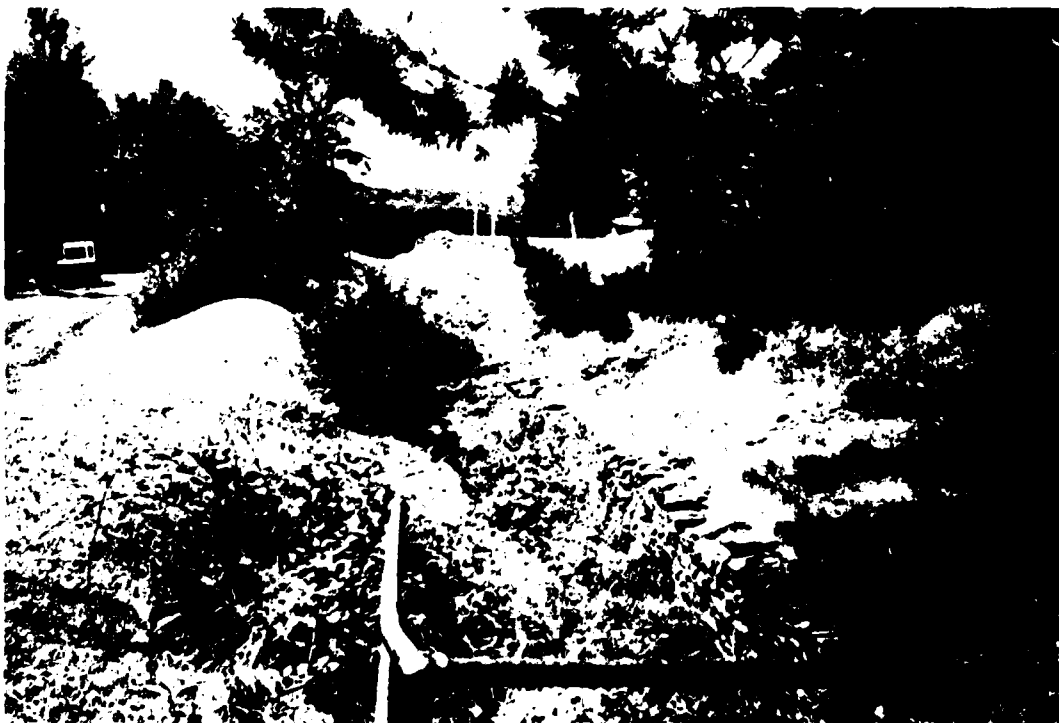
11. VIEW OF SECONDARY CHANNEL LOOKING TOWARD  
SPILLWAY FROM BUCKLAND ROAD BRIDGE. NOTE STONED  
LINED SIDES AND VEGETATION.
