SHAKER MILL POND DAM
MA 00732

PHASE I INSPECTION REPORT
NATIONAL DAM INSPECTION PROGRAM

JULY 1979

Identification No.: MA 00732
Name of Dam: Shaker Mill Pond
Town: West Stockbridge
County: Berkshire
State: Massachusetts
Stream: Williams River
Date of Site Visit: 30 May 1979

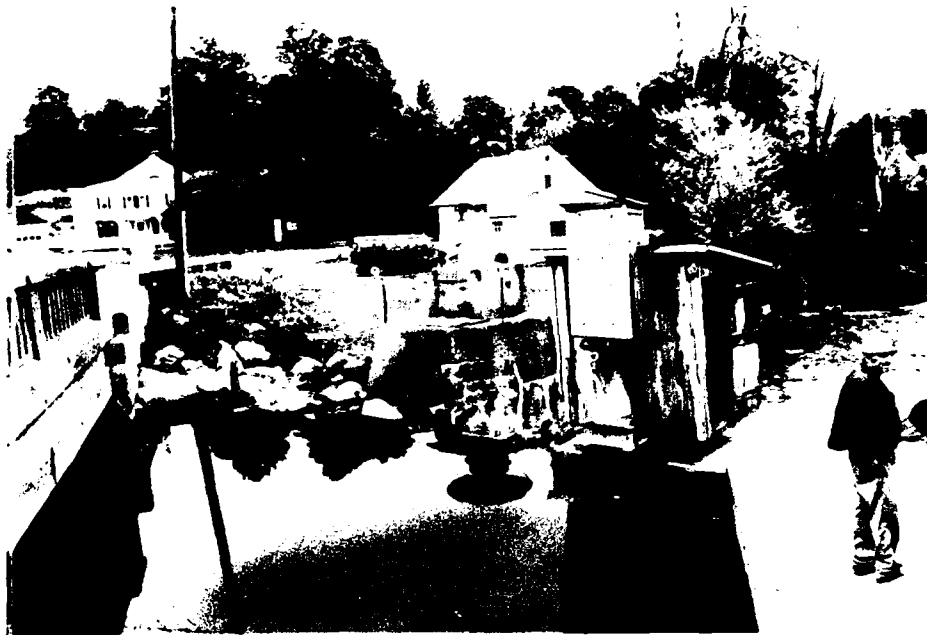
6. Upstream side of dam
