TAUNTON RIVER BASIN  
DIGHTON, MASSACHUSETTS

MUDDY COVE POND DAM  
MA 00793

PHASE I INSPECTION REPORT  
NATIONAL DAM INSPECTION PROGRAM

NOVEMBER 1979

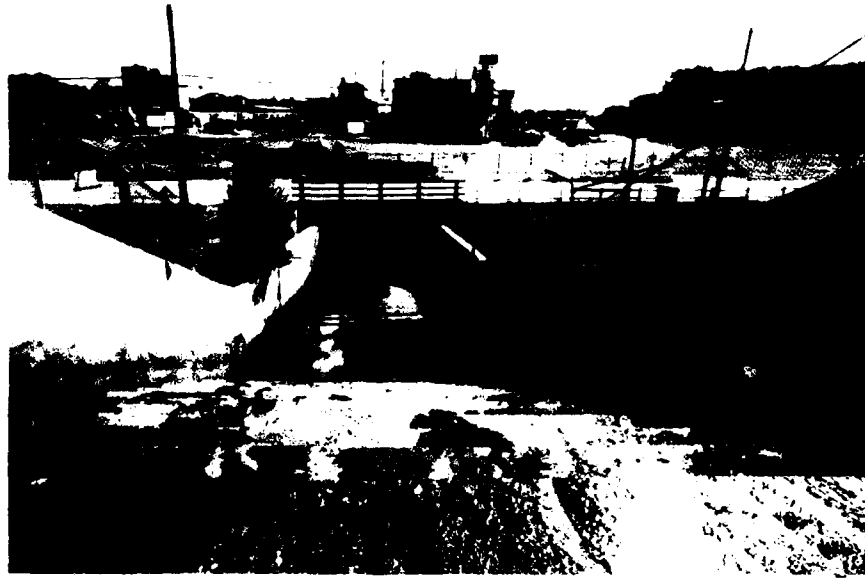
8. VIEW OF DOWNSTREAM CHANNEL FROM SPILLWAY CREST.

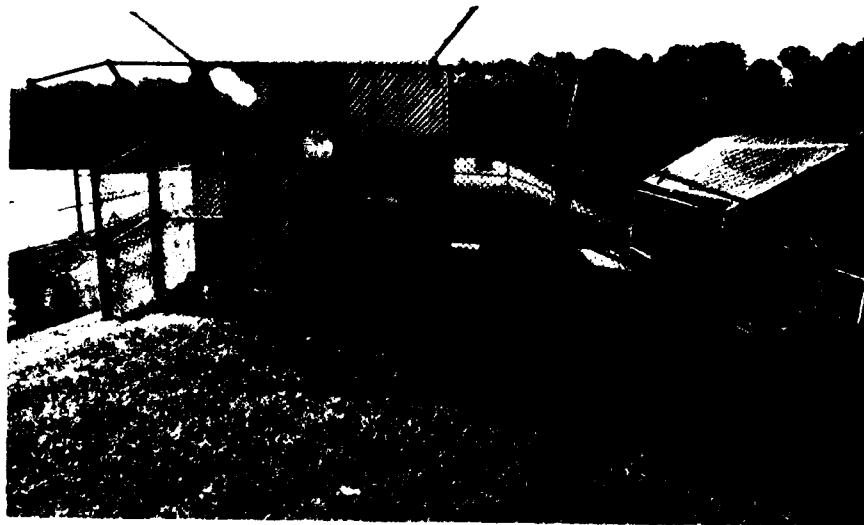
9. VIEW OF OUTLET WORKS GATEHOUSE LOCATED ON SPILLWAY LEFT ABUTMENT.

- (6) Repair gatehouse door locking mechanism and ensure that door may be opened by authorized personnel.
- (7) Check operating condition of 36-in. sluice gate controlling the reservoir drain and perform any work necessary to ensure the reliability of the drain system in the future.
