MERRIMACK RIVER BASIN  
LEOMINSTER, MASSACHUSETTS

## NOTOWN RESERVOIR DAM AND DIKE

### PHASE I INSPECTION REPORT NATIONAL DAM INSPECTION PROGRAM

MARCH 1980

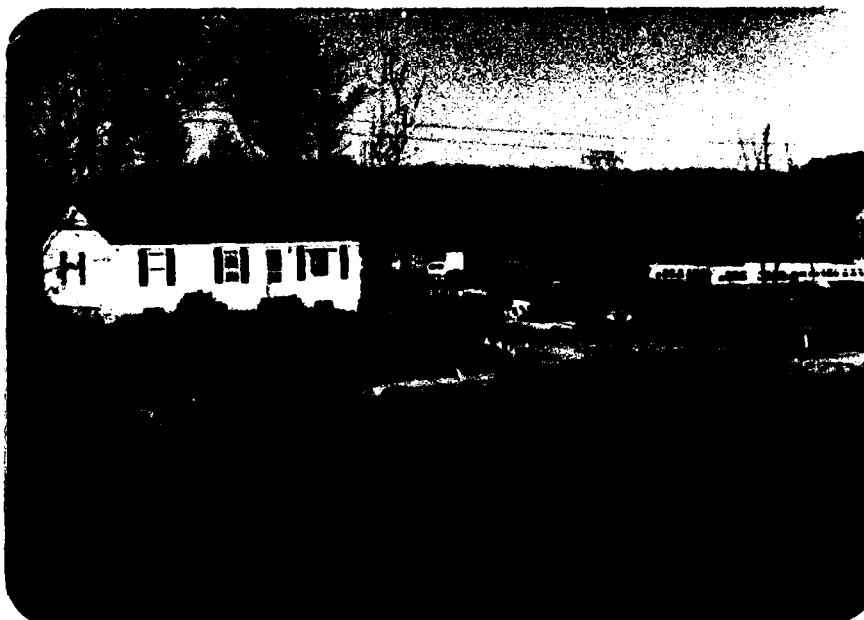
PHOTO NO. 24 - This view shows the downstream area near the left abutment and center of the Dike. This area is within the Dam failure impact area. Flood stage could be 5 feet deep or more.
