MASSACHUSETTS COASTAL BASIN
ARLINGTON - LEXINGTON, MASSACHUSETTS

ARLINGTON RESERVOIR DAM
MA 00771

PHASE I INSPECTION REPORT
NATIONAL DAM INSPECTION PROGRAM

JULY 1981

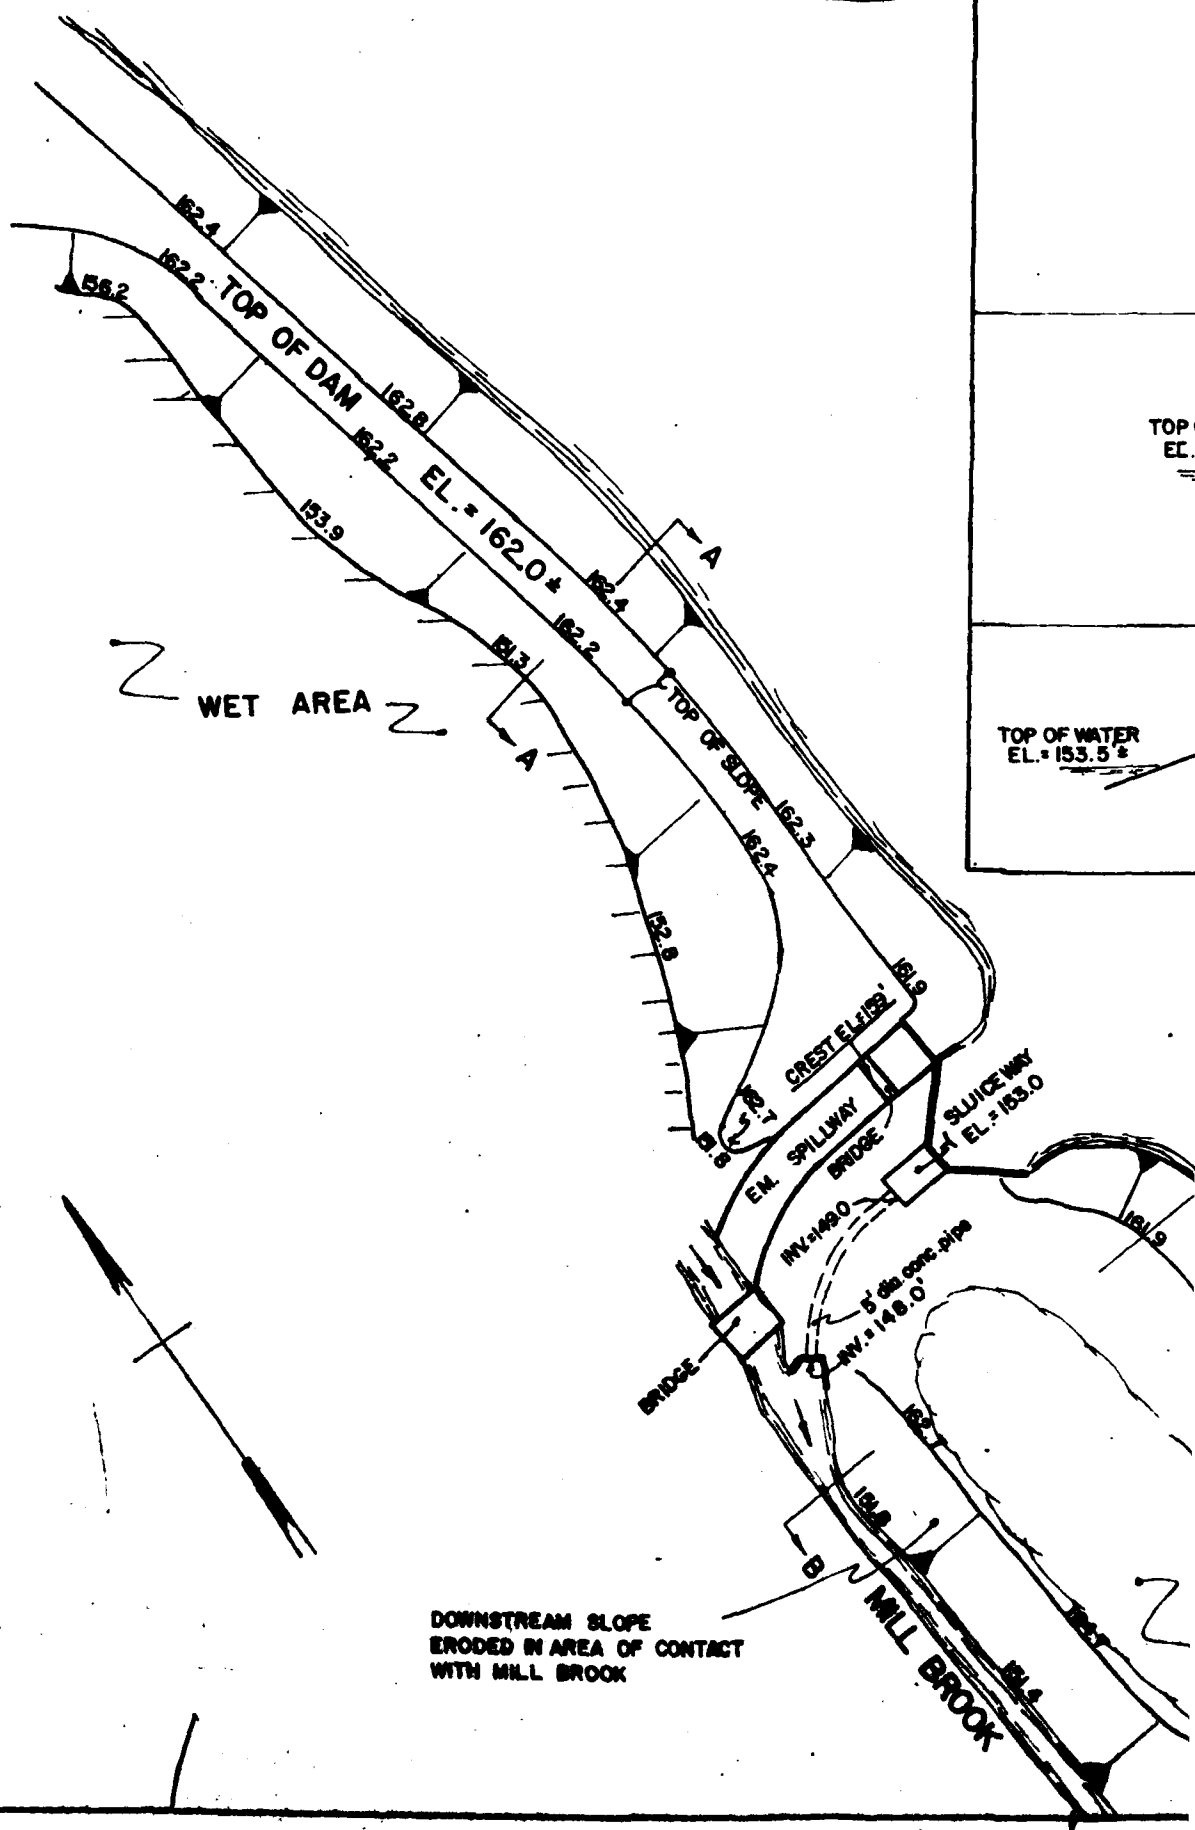
WET AREA

DOWNSTREAM SLOPE
ERODED IN AREA OF CONTACT
WITH MILL BROOK

3. Investigate the cause of the wet area at the toe of the embankment to the right of the spillway channel and design and oversee construction of remedial measures, if required.
