MASSACHUSETTS—RHODE ISLAND COASTAL BASIN
NORTH ATTLEBORO, MASSACHUSETTS

WHITING POND DAM
MA 00859

PHASE I INSPECTION REPORT
NATIONAL DAM INSPECTION PROGRAM

DECEMBER 1978

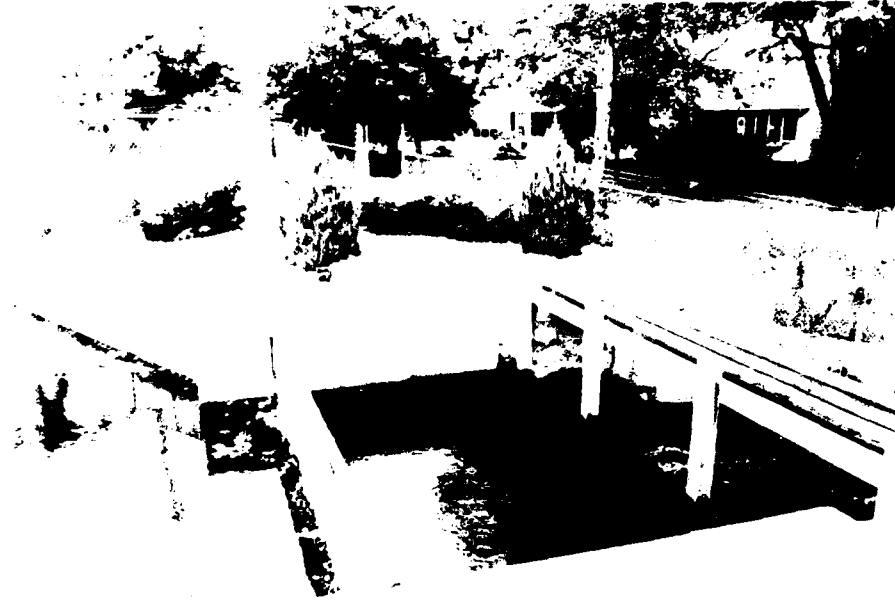
C. Appurtenant Structures. The upstream portion of the spillway walls and the adjacent platform are constructed of relatively recent vintage concrete and are in excellent to good condition, Photos No. 4 and 5. There are some minor shrinkage cracks present within the concrete. The concrete joints were either not sealed or the sealant has been lost. Sealants are required at these joints to prevent future deterioration of the structure. A trash screen constructed of chain-link fencing spans the approach channel.

4. Left spillway walls and adjacent platform

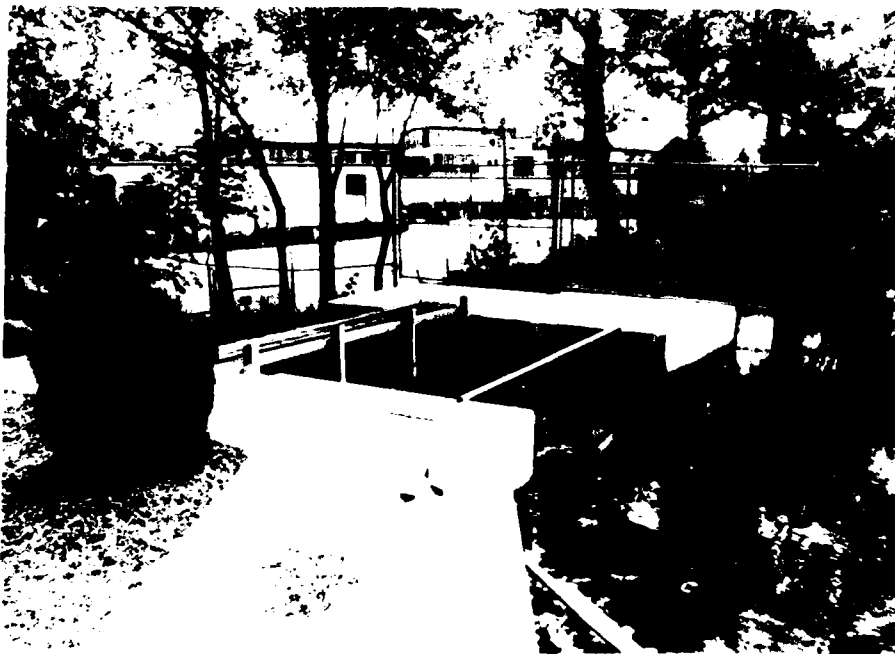
5. Right spillway walls and adjacent platform

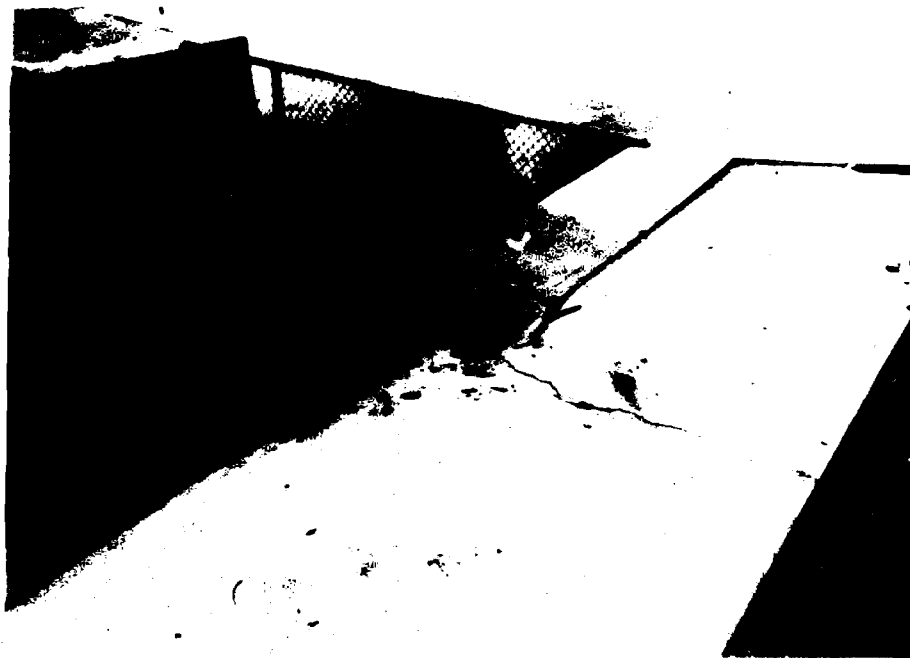
6. Service bridge bolted to older concrete walls

5. Clean and seal all joints in the spillway concrete.
6. Repaint the walkway over the spillway and replace all missing anchor bolt washers and nuts.
