NATIONAL PROGRAM OF INSPECTION OF NON-FEDERAL DAMS
DRAFT REPORT REVIEW COMMENTS

BOULTER DAM, IDENTITY NO. **ME 00194**

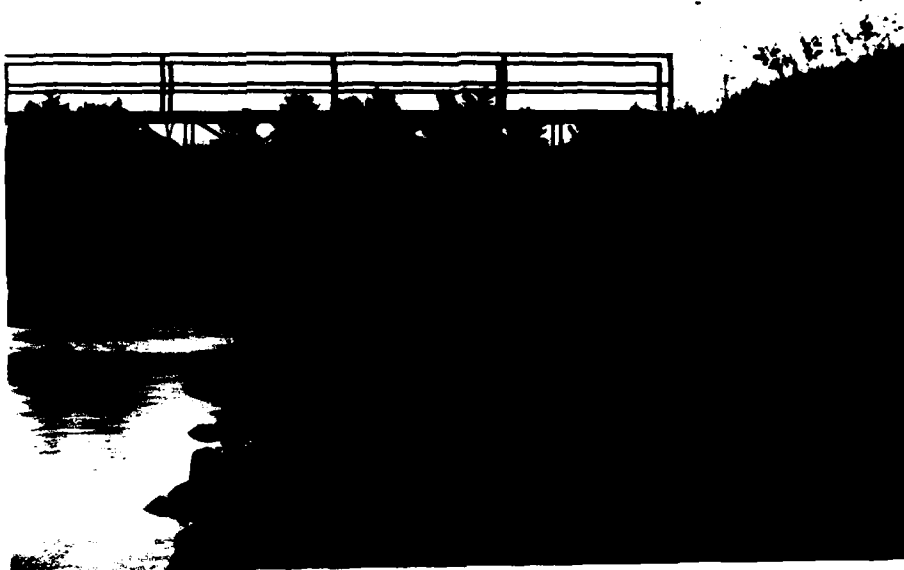
b. Dam. The earth embankment is generally in good to excellent condition. The stone riprap paving on the upstream slope consists of a layer of cobbles and boulders with some broken rock varying from 4 in. to 3 ft. in nominal size, Photo No. 2. Grass, weeds and other vegetation are growing in the riprap along the top 6 ft. of the embankment. The stone riprap beneath the service bridge appears to project out, about 1 foot, perpendicular to the slope over a distance of about 30 ft., Photo No. 3. It is probable that the embankment was constructed with this configuration.

A noticeable bulge occurs in the upstream slope beneath the service bridge. However, it is probable that the embankment was constructed with this configuration. The abutment to the service bridge has moved as described in Section 3.1c. This condition places the structural stability of the service bridge abutment in question.

3. View of riprap near service bridge
