NASHUA RIVER BASIN  
FITCHBURG, MASSACHUSETTS

McTAGGARTS POND DAM  
MA 00879

PHASE I INSPECTION REPORT  
NATIONAL DAM INSPECTION PROGRAM

DECEMBER 1979

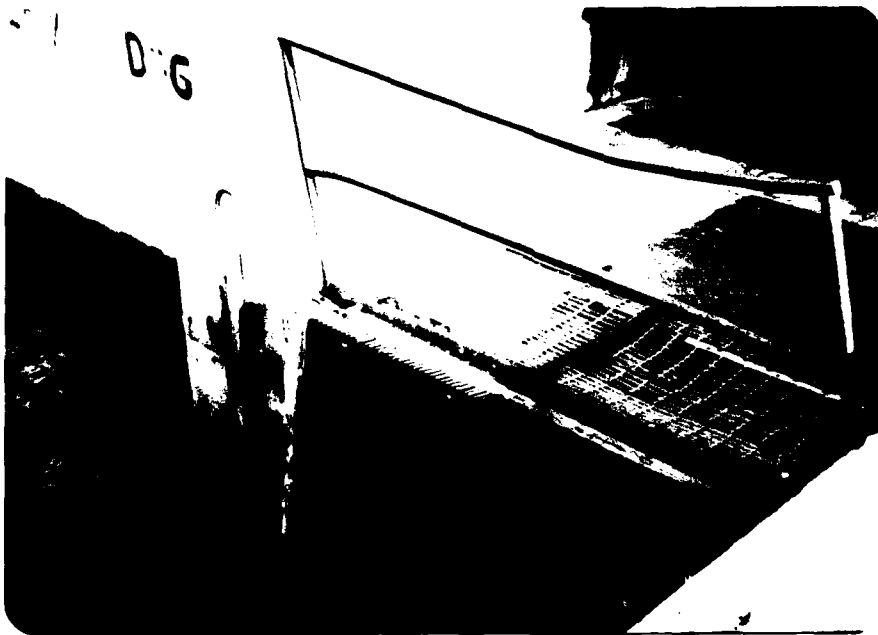
- 4.3 Maintenance of Operating Facilities. Only the downstream end of the outlet conduits, the slide gate operating mechanism, and the pulling ring and beam for the low level outlet were visible at the time of the inspection. The discharge pipe appears to be in good condition. The slide gate operating mechanism is slightly rusted but is reportedly operable. The low level outlet pulling ring and beam is heavily weathered wood with a steel loop bolted to the top. This outlet has not been used since 1956 (see photograph No. 5).

**NO. 5 VIEW OF LOW LEVEL OUTLET  
CONTROL AND MAIN INTAKE TRASH RACK**

- (1) Repair the spalled concrete on the spillway sidewalls.
- (2) Maintain the low level gate in operating condition and provide a channel from the outlet to the stream channel.
- (3) Remove all brush and debris from the spillway discharge channel.
- (4) Replace missing or dislodged riprap from the upstream face of the dam.
- (5) Remove all brush from the dam and backfill any excavations with selected material.
- (6) Institute a written definite plan for the surveillance and warning system during periods of unusually heavy rains and/or runoff.

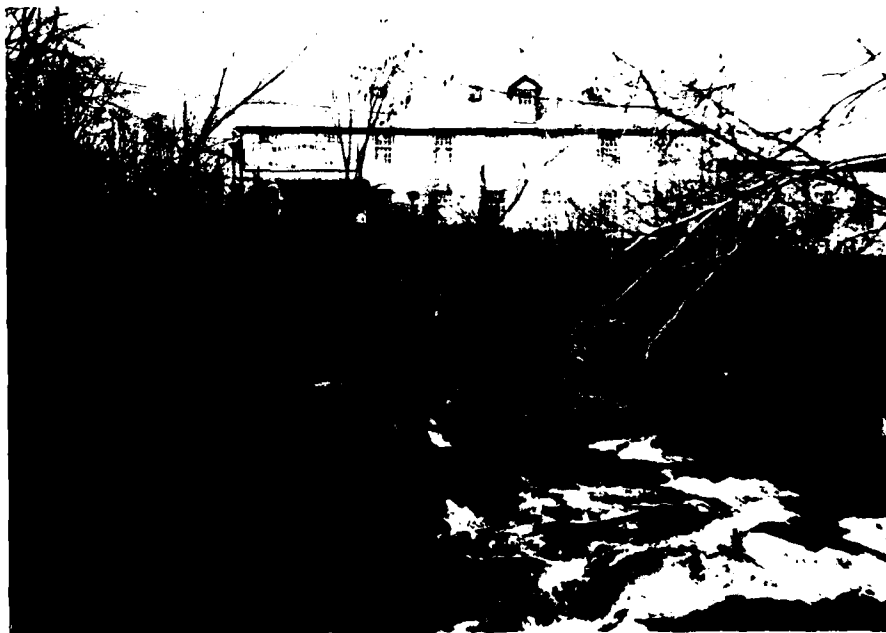
**NO. 12 UPSTREAM VIEW OF CHANNEL RESTRICTION BENEATH MILL**
