MOUSAM RIVER BASIN
SANFORD, MAINE

RIVER STREET DAM
ME-00184

PHASE I INSPECTION REPORT
NATIONAL DAM INSPECTION PROGRAM

OCTOBER 1978

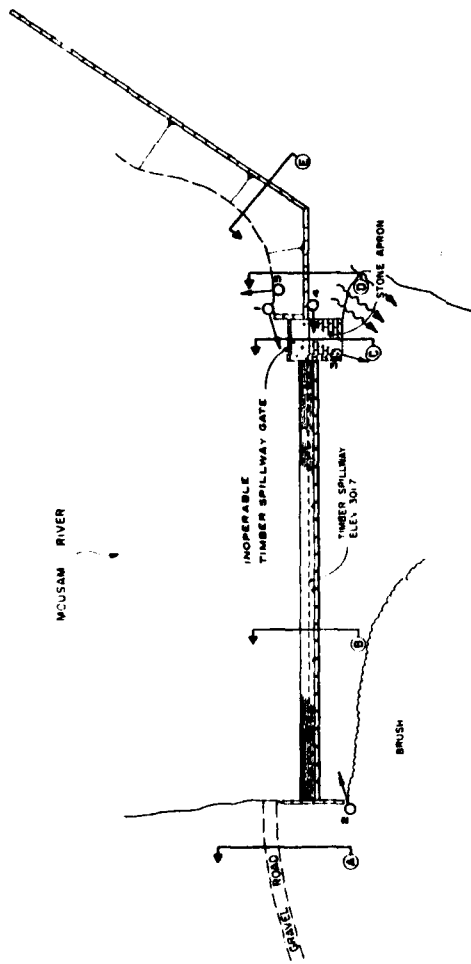
RIVER STREET DAM
PLAN A PROFILE

a. Visual Observations. Based on the visual observation, the River Street Dam appears to be in poor structural condition. The timber spillway deck is seriously deteriorated. Several of the support timbers of this spillway deck are missing and others are displaced and the ends of several are seriously deteriorated. The top of the downstream face of the dam has deflected downstream somewhat, such that the slope of the downstream face is approximately a 1 to 12 batter, the top being out of plumb, downstream.

Seepage was observed through the east abutment and wing wall of the dam and erosion features were noted both upstream of this wing wall and on the downstream toe of this embankment section of the dam.
