THAMES RIVER BASIN  
LEICESTER, MASSACHUSETTS

SARGENT POND DAM  
MA 00986

PHASE I INSPECTION REPORT  
NATIONAL DAM INSPECTION PROGRAM

MAY 1980

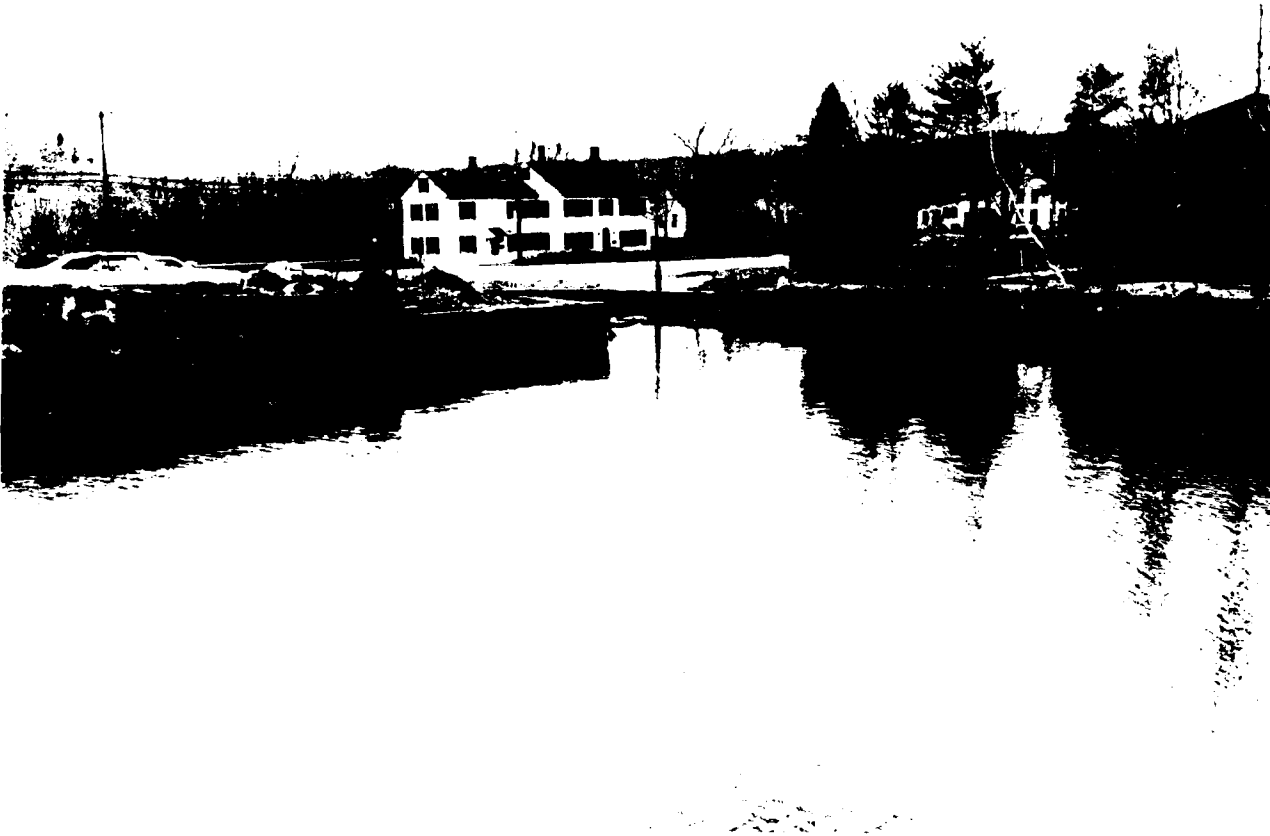
OVERVIEW FROM LEFT ABUTMENT

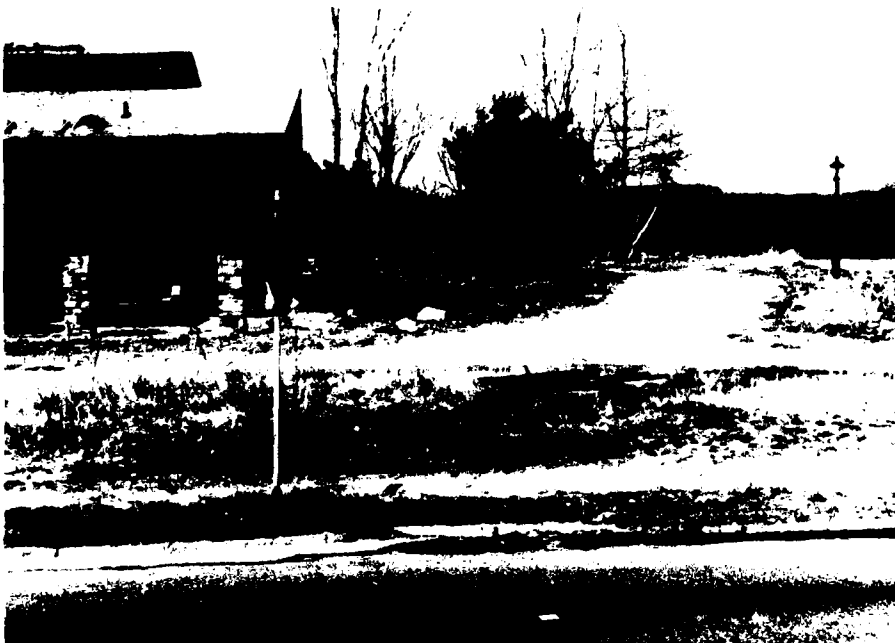
The right embankment is about 136 ft. long and has a crest width of about 300 ft. A private home is located on the upstream part of the crest. State Route 9 crosses the downstream end of the sloping crest. A vertical rubble masonry retaining wall extends along the portion of the embankment immediately adjacent to the spillway. Mortar is missing from some of the joints of this wall. The remainder of the upstream slope is irregular, with random rock riprap along some areas. Along other areas there is gravel or grass. There are also many mature trees and some light brush growth on the upstream face of the embankment. In general, the right embankment appears to be in good condition (see Appendix C, Photo Nos. 1, 3 and 4).

4. Downstream slope of right embankment.
