FRENCH RIVER BASIN  
LEICESTER, MASSACHUSETTS

STILES RESERVOIR DAM  
MA 00983

PHASE I INSPECTION REPORT  
NATIONAL DAM INSPECTION PROGRAM

APRIL 1979

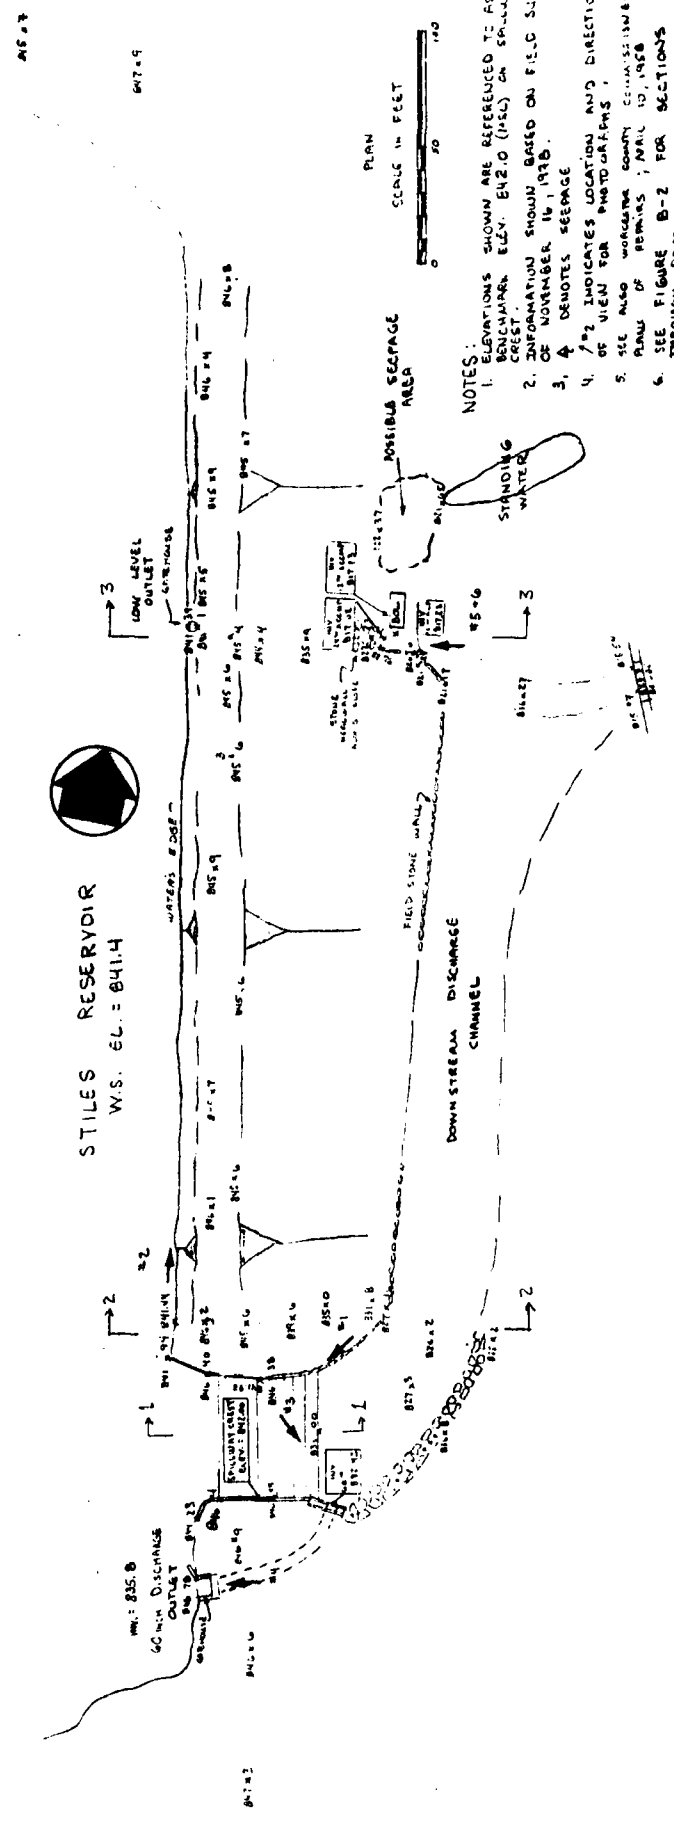
PROJECT: STILES RESERVOIR DAM AND OUTLET	DATE: JANUARY 1979
DESIGNED BY: METCALF & EDDY, INC.	SCALE: AS SHOWN
NATIONAL PROGRAM OF INSPECTION OF NON-FED. DAMS	
STILES RESERVOIR DAM	
FIGURE B-1 PLAN OF DAM	
TRIBUTARY: FRANCIS RIVER	STATE: MASSACHUSETTS
SECTION: B-1	DATE: JANUARY 1979

Riprap on the upstream slope appeared to be in fair condition. Some slight depression along the crest at the downstream side was noted as well as some small holes less than 12 inches in diameter and 6 inches deep. There were trees and small brush along some areas of the downstream slope. The toe of the dam had many trees and saplings growing. A large area of standing water was noted in the downstream area to the north of the outlet discharge channel (see Figure B-1).

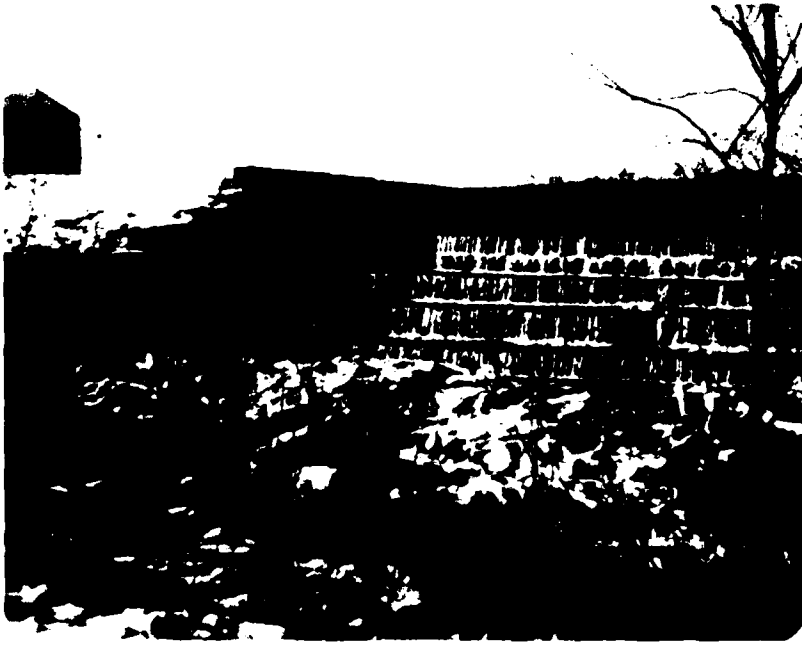
- d. Visual Observations. The spillway appears in good condition except for the leak within the south abutment. The training walls have been repaired in the past and consist of concrete and mortared stone masonry. There is a concrete cap on top of the walls. Some cracks at the joints of the stone wall were noted.

**NO. 1 VIEW OF SPILLWAY FROM DOWNSTREAM AREA**
