LITTLE RIVER LOWER DAM  
ME 00288

PHASE I INSPECTION REPORT  
NATIONAL DAM INSPECTION PROGRAM

NOVEMBER 1979

Identification No.: ME00288  
Name of Dam: Little River Lower Dam  
Town: Belfast  
County and State: Waldo, Maine  
Stream: Little River  
Date of Inspection: September 17, 1979

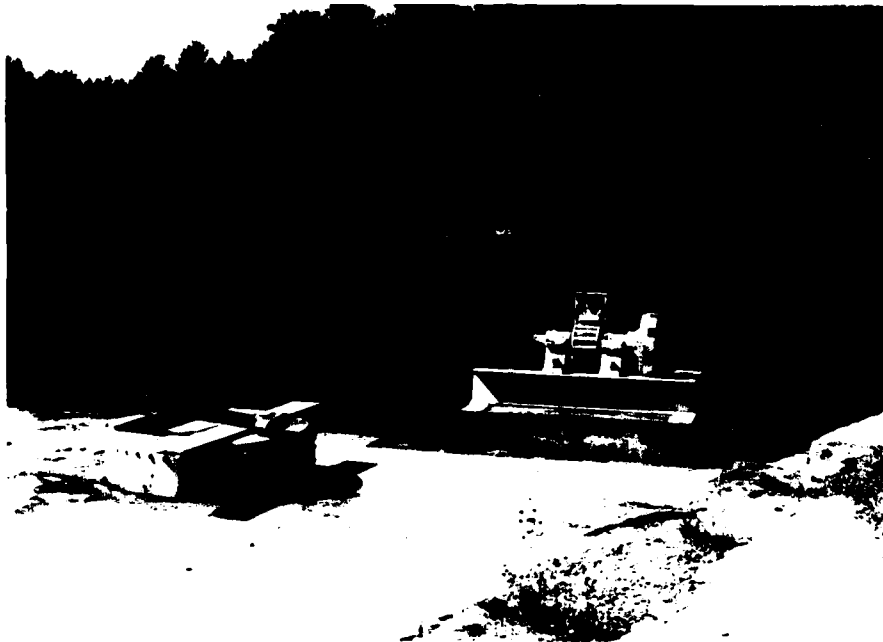
| AREA EVALUATED | CONDITION |
|---|---|
| Air Vents | Gate operating mechanism is in poor condition-no indication of maintenance, lubrication or operation. Belfast Water District Superintendent indicated that gate hasn't been operated in 24 years. |

September 17, 1979  
Figure 4 - Gate mechanism at the north abutment.

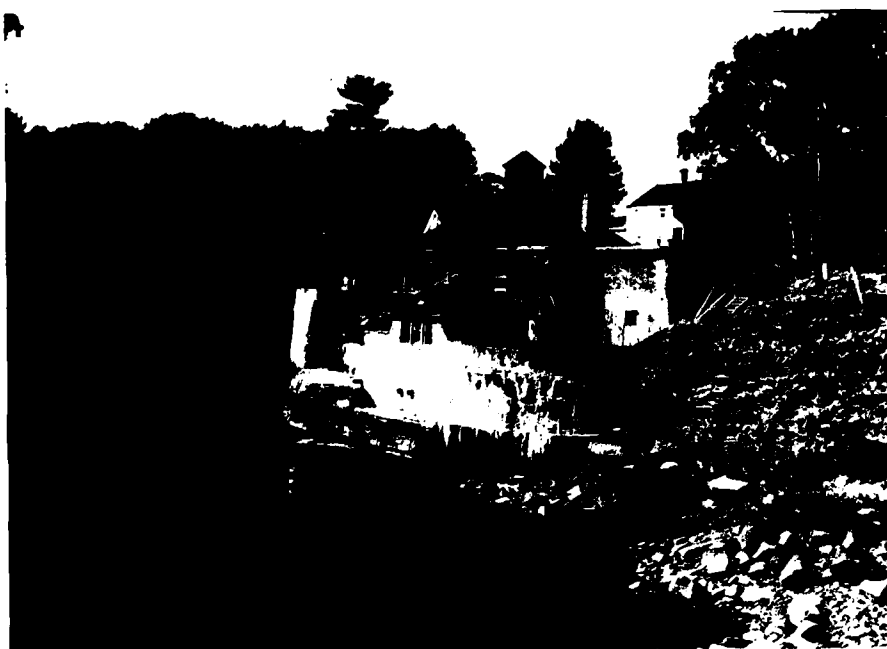
September 17, 1979  
Figure 10 - View of the north bank of the downstream  
channel from the U.S. Route 1 bridge.

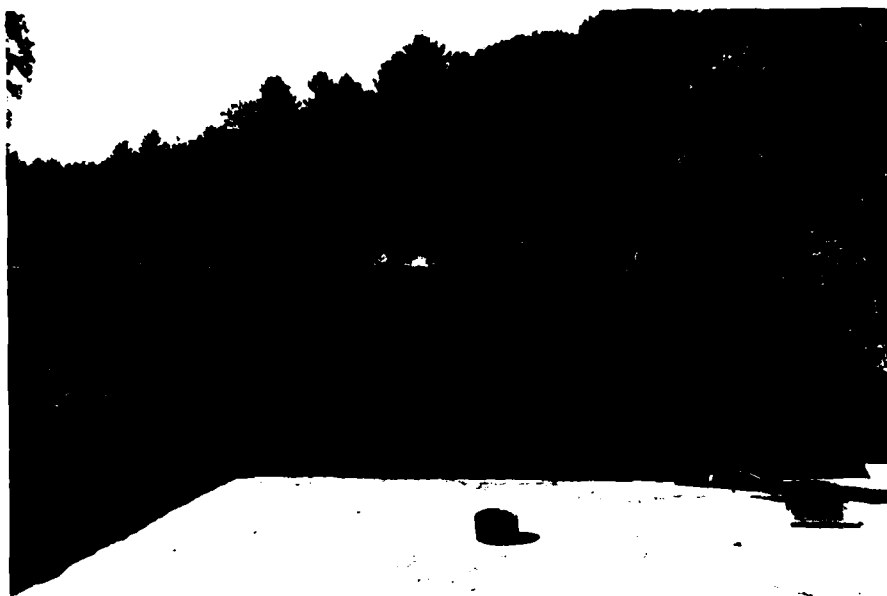
d. Reservoir Area. The watershed above the reservoir is rolling and partially wooded. (See Appendix C - Figure 11.) No structures were observed on the shore of the reservoir. No evidence of significant sedimentation in the reservoir was observed.

September 17, 1979  
Figure 11 - Looking upstream at the reservoir from  
the north abutment.
