**ANNISQUAM RIVER BASIN  
GLOUCESTER, MASSACHUSETTS**

**GOOSE COVE RESERVOIR DAMS & DIKES**

**PHASE I INSPECTION REPORT  
NATIONAL DAM INSPECTION PROGRAM**

**APRIL 1981**

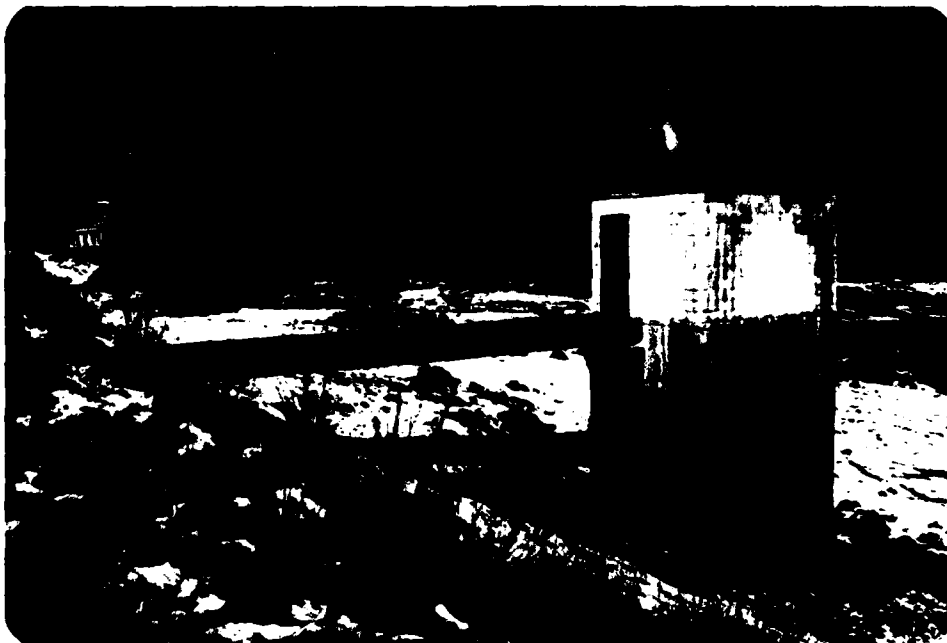
NO. 15 GATEHOUSE AND SERVICE BRIDGE SOUTH DAM

The service bridge is generally in good condition. There is minor rust on the steel I beams. The wood on the underside of the deck is in good condition, as is the concrete on the deck. The railings on the bridge have been removed (see Photo No. 15).

The outlet and gatehouse were visible during the inspection due to the low water level in the reservoir. The gatehouse is in good condition, with only slight spalling and efflorescence (see Photo Nos. 15 and 16). There is slight staining below the high water mark.
