KENNEBEC RIVER BASIN  
MANCHESTER, MAINE

COBBOSSECONTEE LAKE DAM  
ME 00096

PHASE I INSPECTION REPORT  
NATIONAL DAM INSPECTION PROGRAM

NOVEMBER 1979

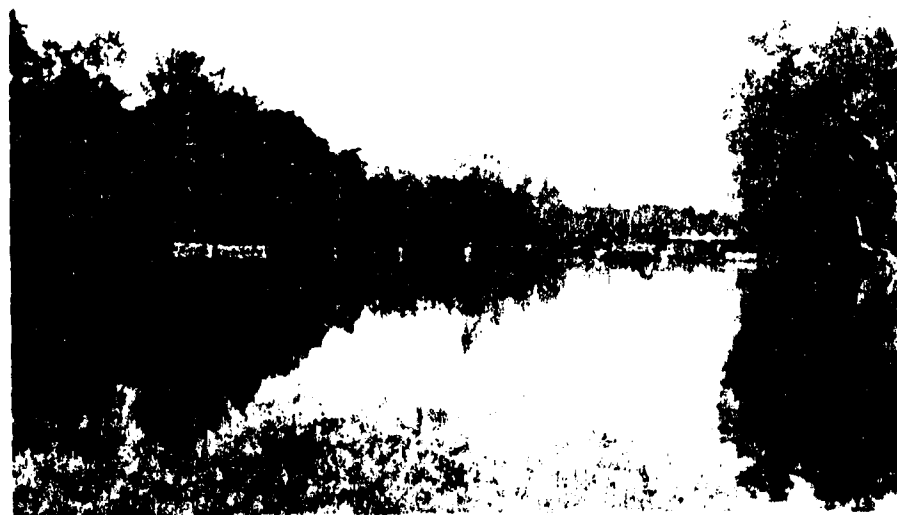
September 18, 1979  
Figure 11 - Looking down the approach channel  
from the dam.

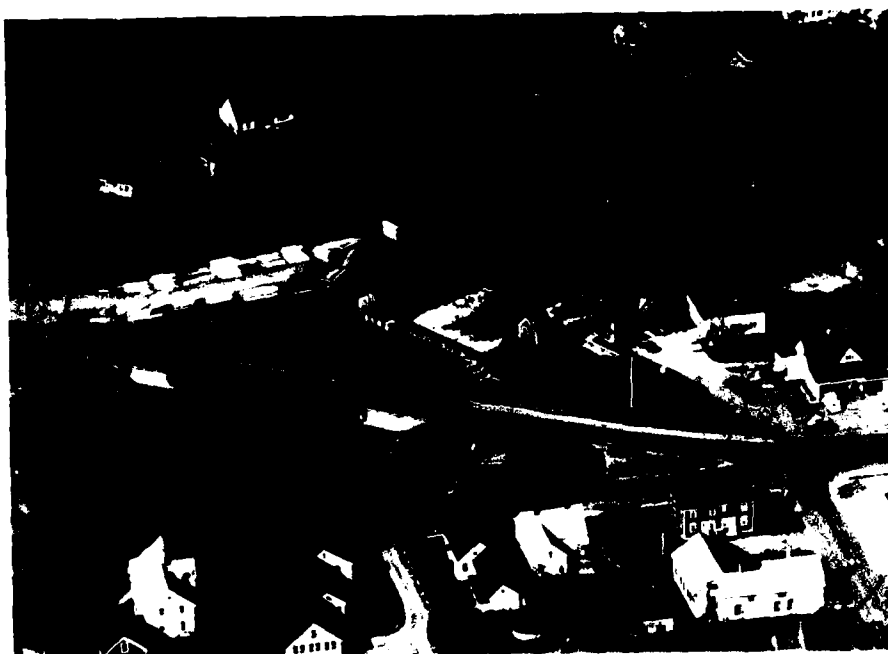
A stage discharge from Pleasant Pond, controlled by Gardiner Water District Dam, (See Appendix C - Figure 14.) was determined by use of the Corps of Engineers HEC-2 backwater computer program. It was determined that with a discharge of 3,250 cfs the elevation of Pleasant Pond would rise to 138.8' NGVD or 4.8 feet above normal level. This would cause backwater from the dam to the High Street bridge. The dam operators at Gardiner Water District Dam report no damage at elevation 138.1' NGVD (top of dam). The dam would be overtopped by 0.7 feet; damage would probably be minor. The 4.8-foot rise in Pleasant Pond would probably cause structural damage to cottages located on the shoreline; no loss of life is probable. Based on the above analysis, Cobbosseecontee Lake Dam was classified Significant Hazard.

October 1979  
Figure 14 - Overview of the Gardiner Water District  
Dam which impounds Pleasant Pond.
