CHARLES RIVER BASIN  
NEEDHAM, MASSACHUSETTS

ROSEMARY LAKE DAM  
MA 01112

PHASE I INSPECTION REPORT  
NATIONAL DAM INSPECTION PROGRAM

JANUARY 1980

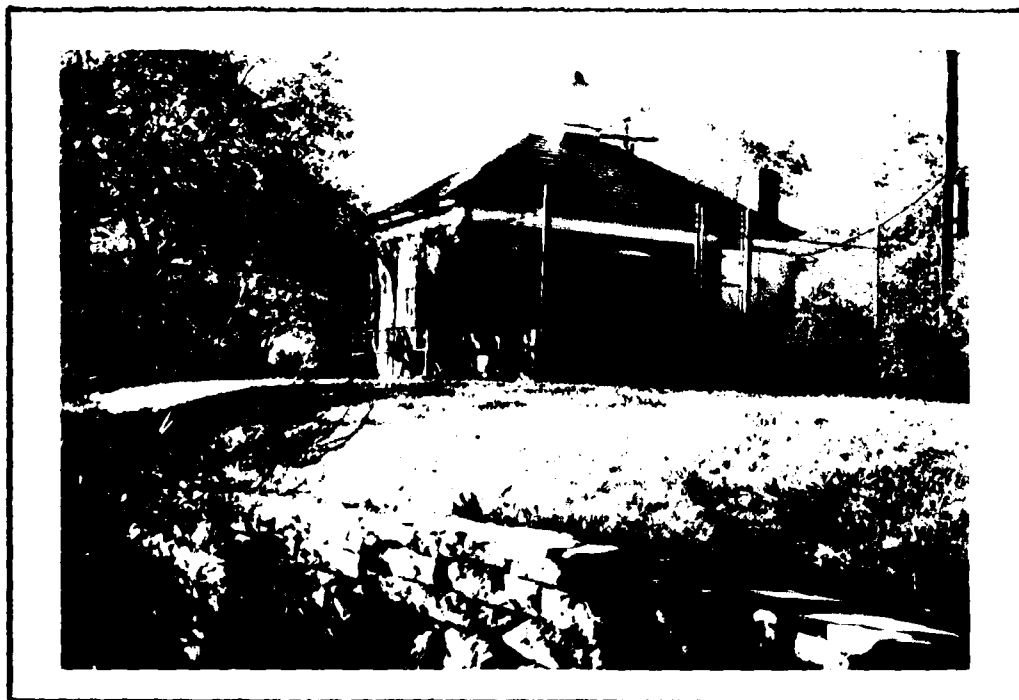
6. SEWERAGE PUMPING STATION ABOUT 2000 FEET DOWNSTREAM OF THE DAM ON THE LEFT BANK. (10/16/79)

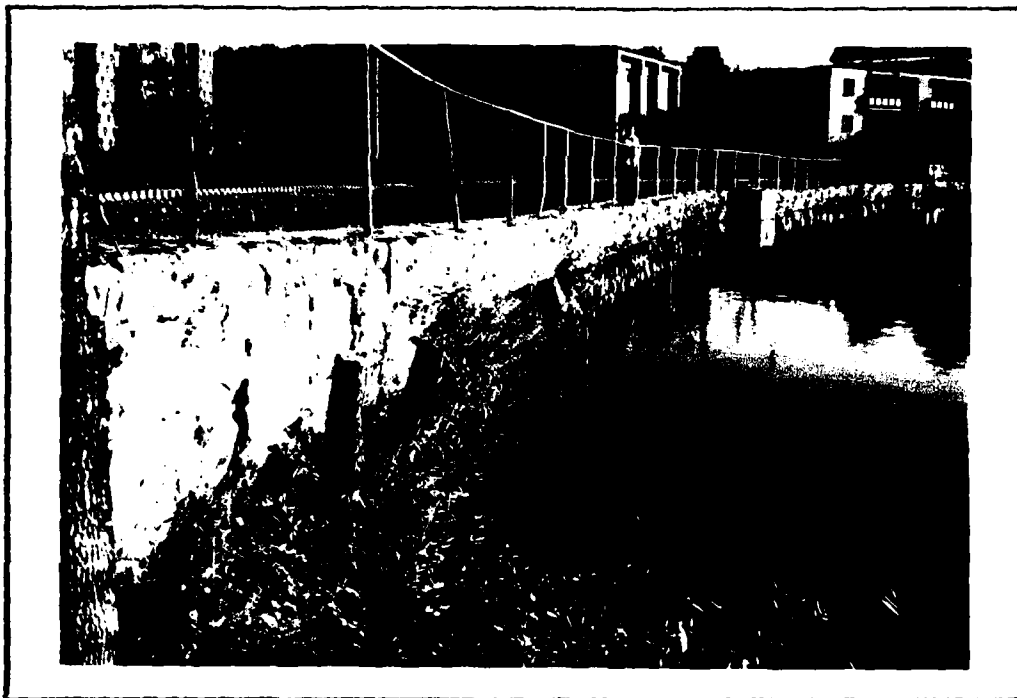
b. Dam. The dam appears to be in fair condition. The stone masonry parapet wall, rebuilt in 1933, appears to be sound; however, it is tilted slightly towards the lake. In addition, 3 tree stumps were observed along the parapet wall near the left abutment as shown on page 2, Appendix C of this report.

3. UPSTREAM FACE OF THE DAM SHOWING CUT OFF TREES IN THE FOREGROUND. (10/16/79)

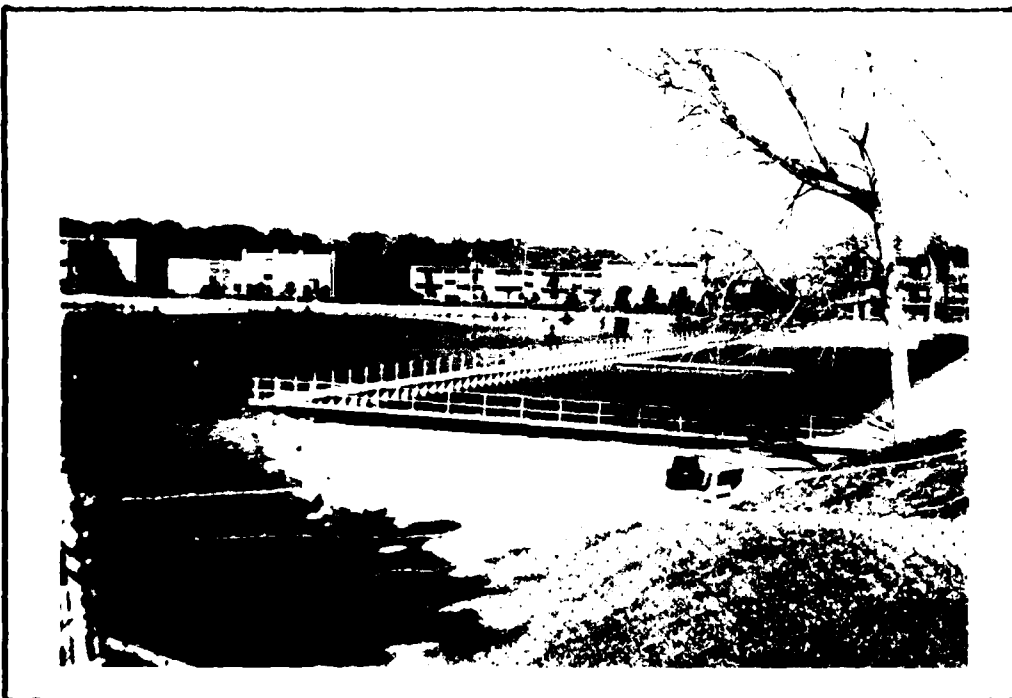
2. UPSTREAM OVERVIEW OF ROSEMARY LAKE. (10/16/79)
