PISCATAQUA RIVER BASIN  
SOMERSWORTH, NEW HAMPSHIRE

NEW DAM  
NH-00126

PHASE I INSPECTION REPORT  
NATIONAL DAM INSPECTION PROGRAM

MARCH 1979  
85

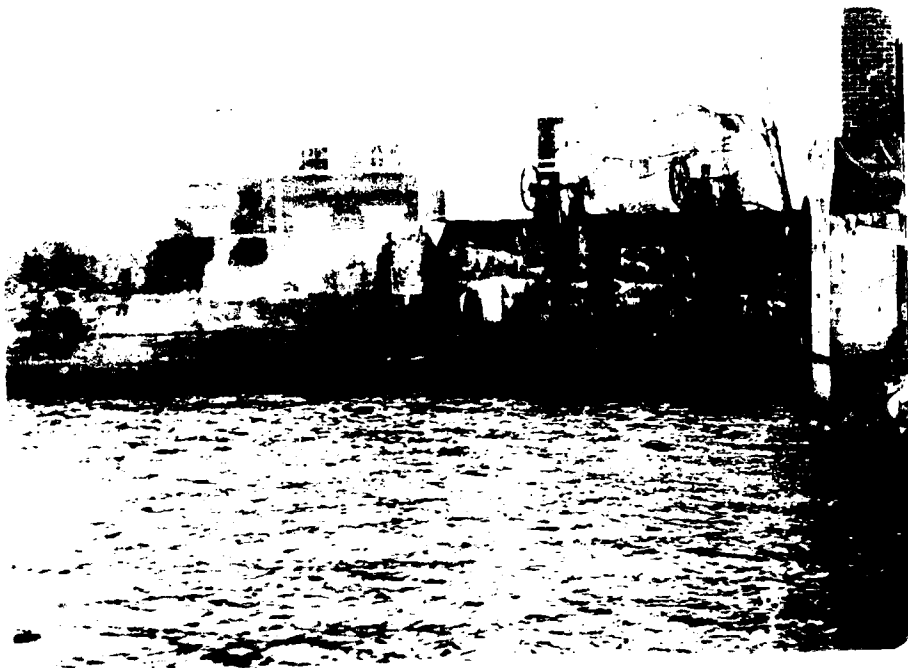
5 HEADWORKS GATES - SOUTH

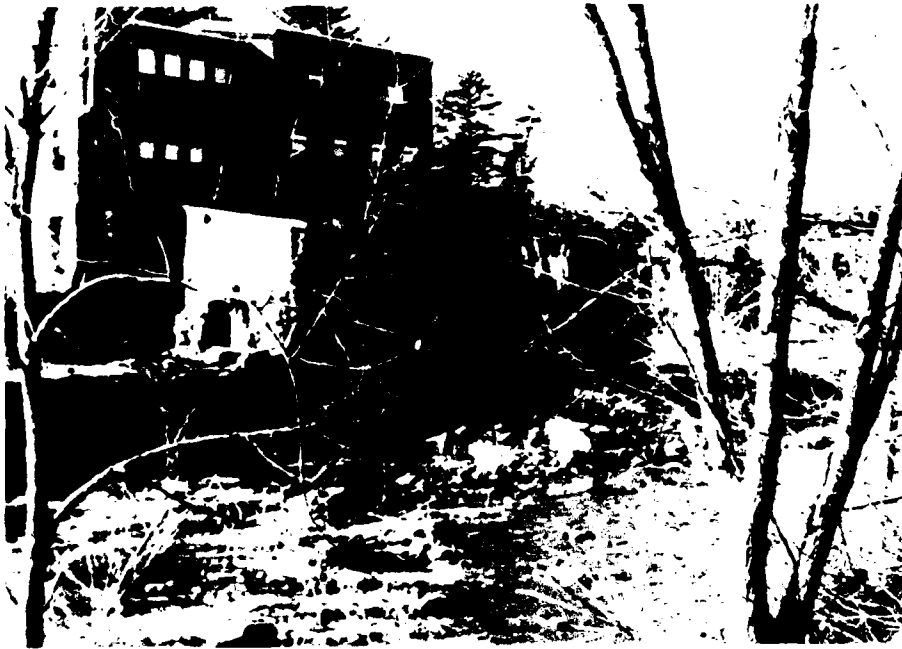
9 VIEW FROM DOWNSTREAM
