CHILDS BOG DAM  
NH 00096

PHASE I INSPECTION REPORT  
NATIONAL DAM INSPECTION PROGRAM

JULY 1979

Identification No.: NH00096  
Name of Dam: Childs Bog Dam  
Town: Harrisville  
County and State: Cheshire County, New Hampshire  
Stream: Branch of Minnewawa Brook  
Date of Inspection: April 30, 1979; June 18, 1979

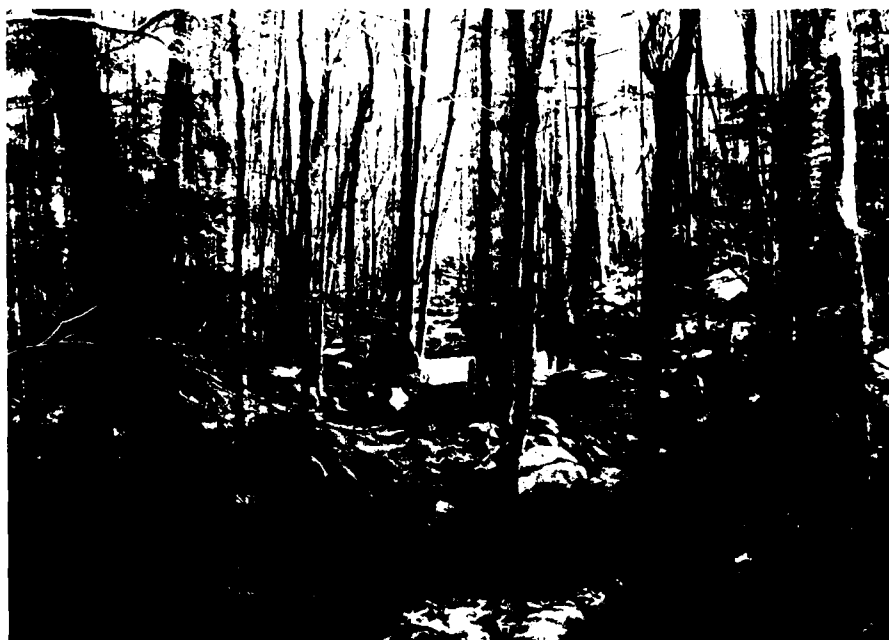
April 30, 1979  
 Figure 10 - Looking at the channel downstream of  
 Figure 9.
