MICROCOPY RESOLUTION TEST CHART
NATIONAL BUREAU OF STANDARDS-1963-A

AD-A156 109

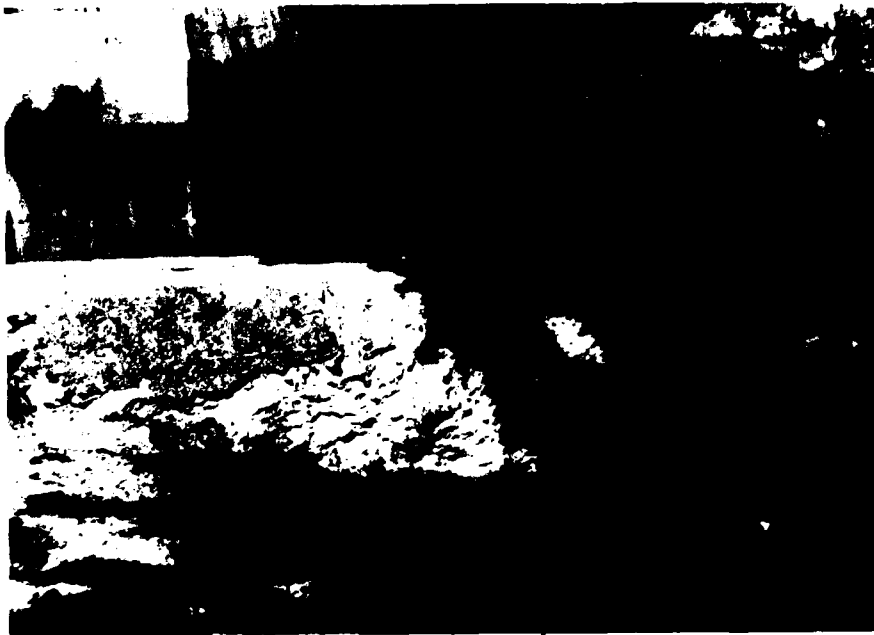
September 13, 1979
Figure 5 - Close-up of spalled area on training wall
at southeast abutment.

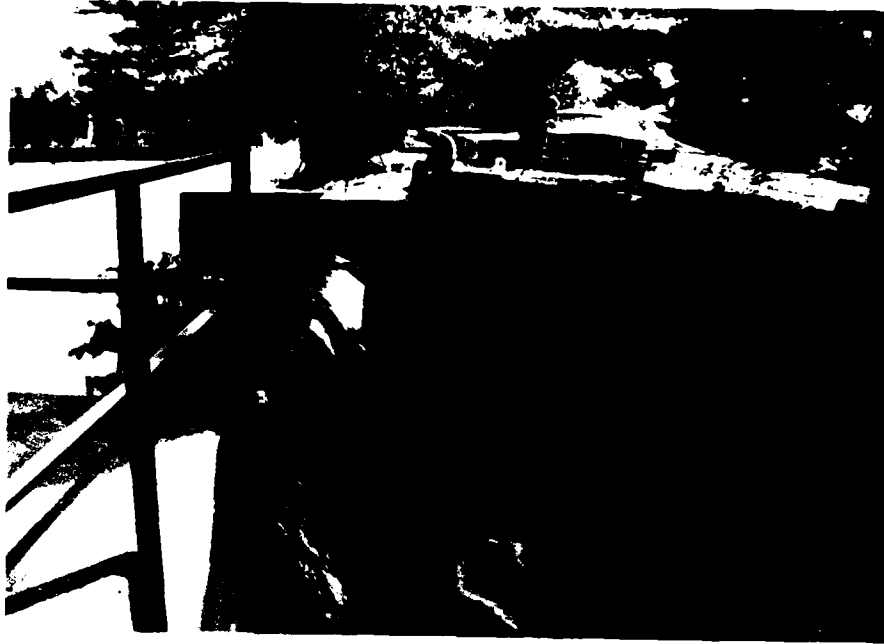
September 13, 1979
Figure 2 - Looking southeast across crest of the dam.

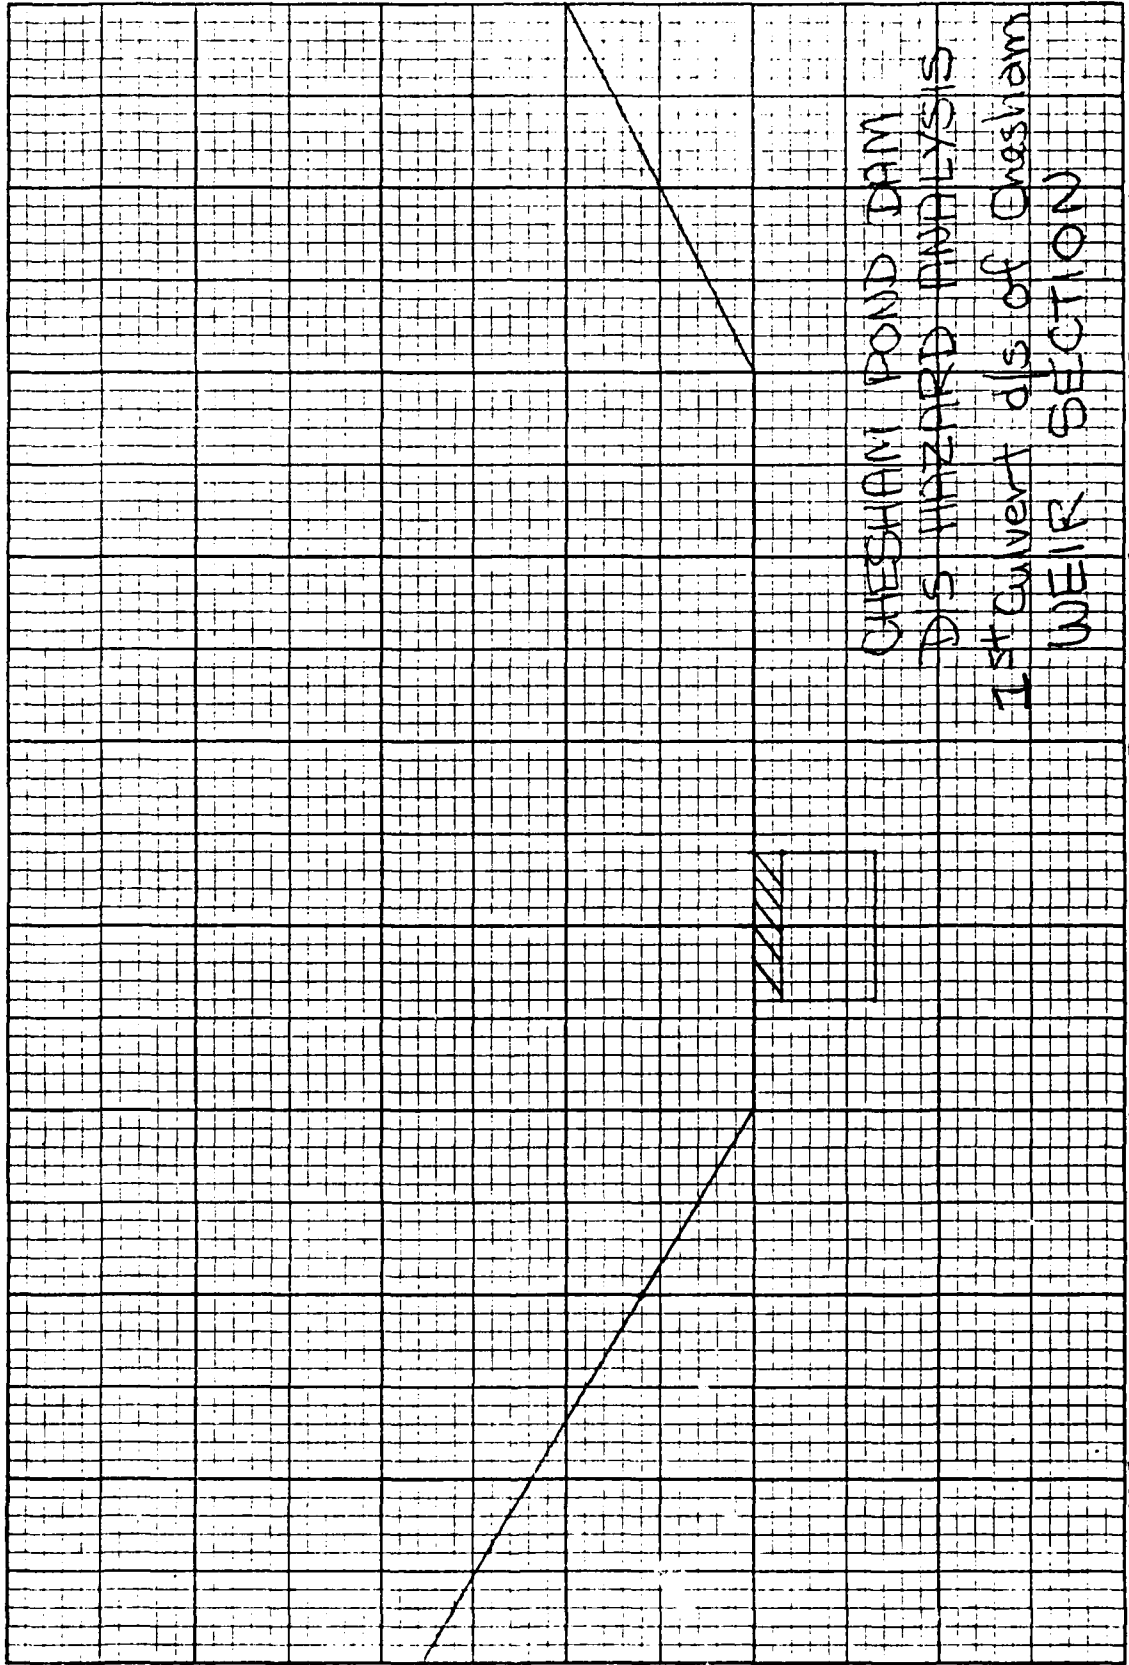
FEET ABOVE TOP OF ROAD

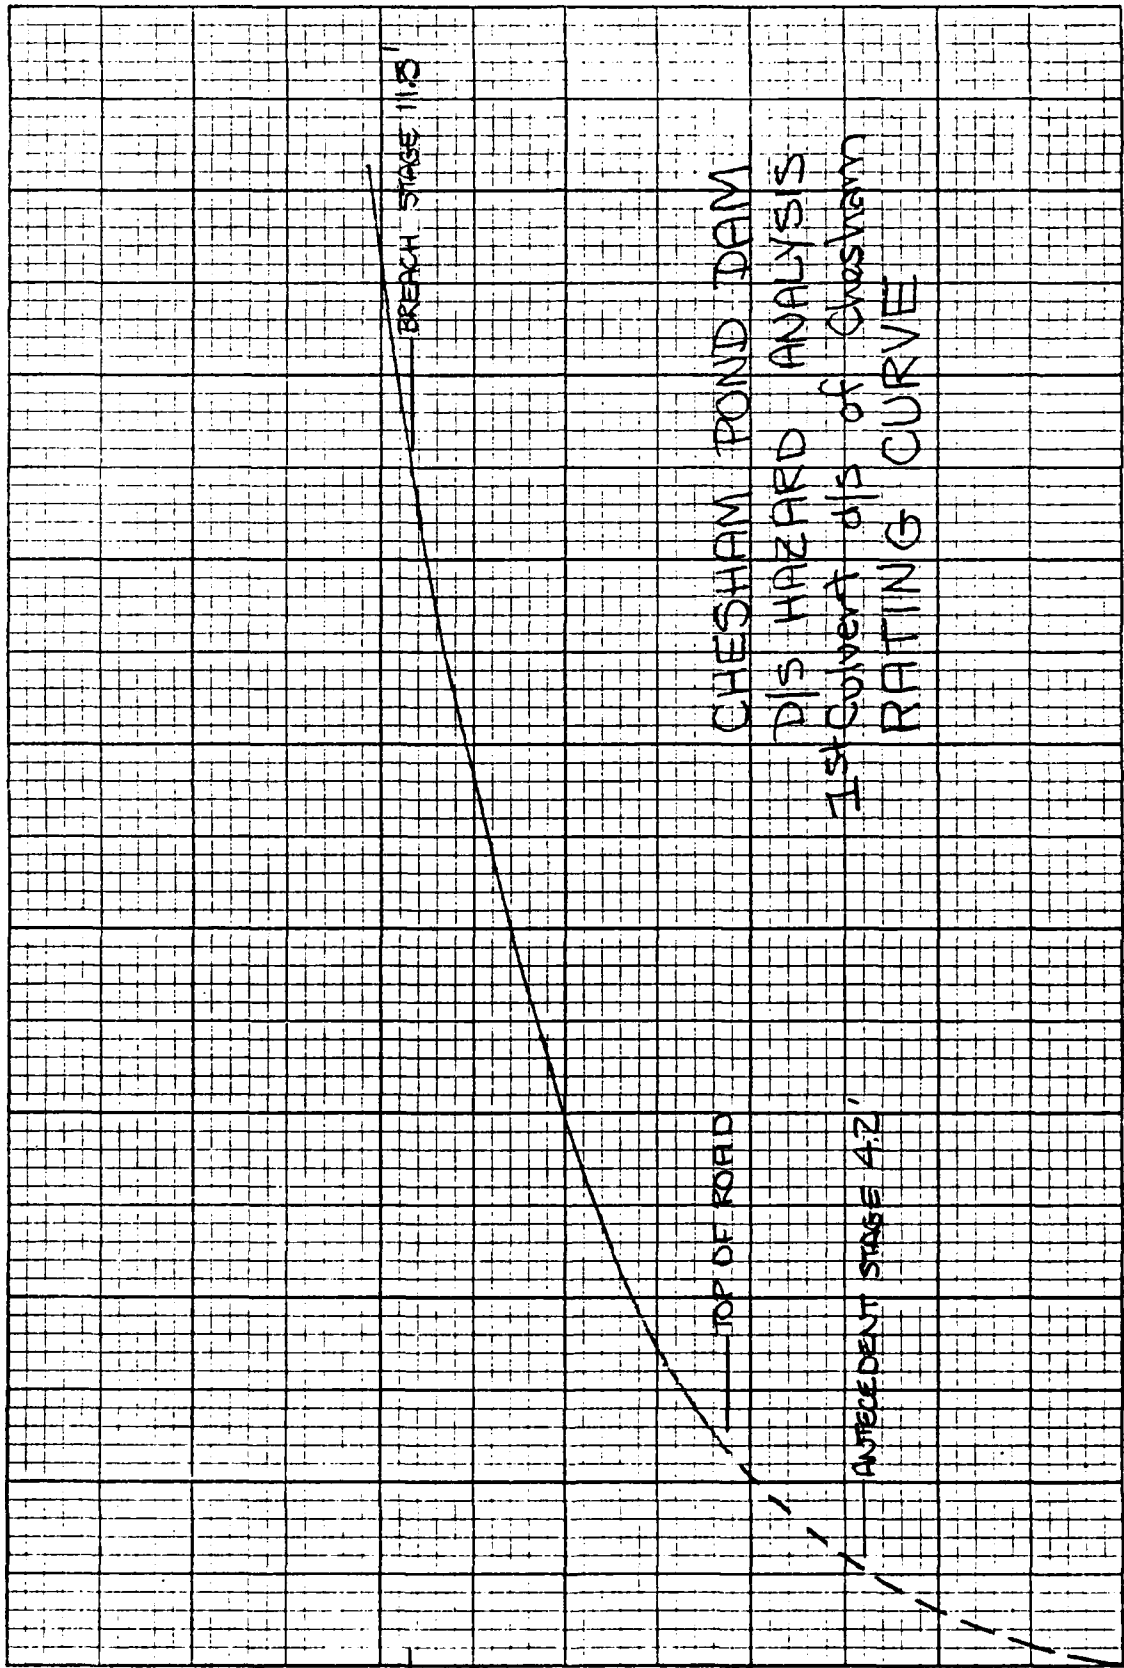
CHESHAM POND DAM
DIS HAZARD ANALYSIS
1st Culvert d/s of Chesham
RATING CURVE

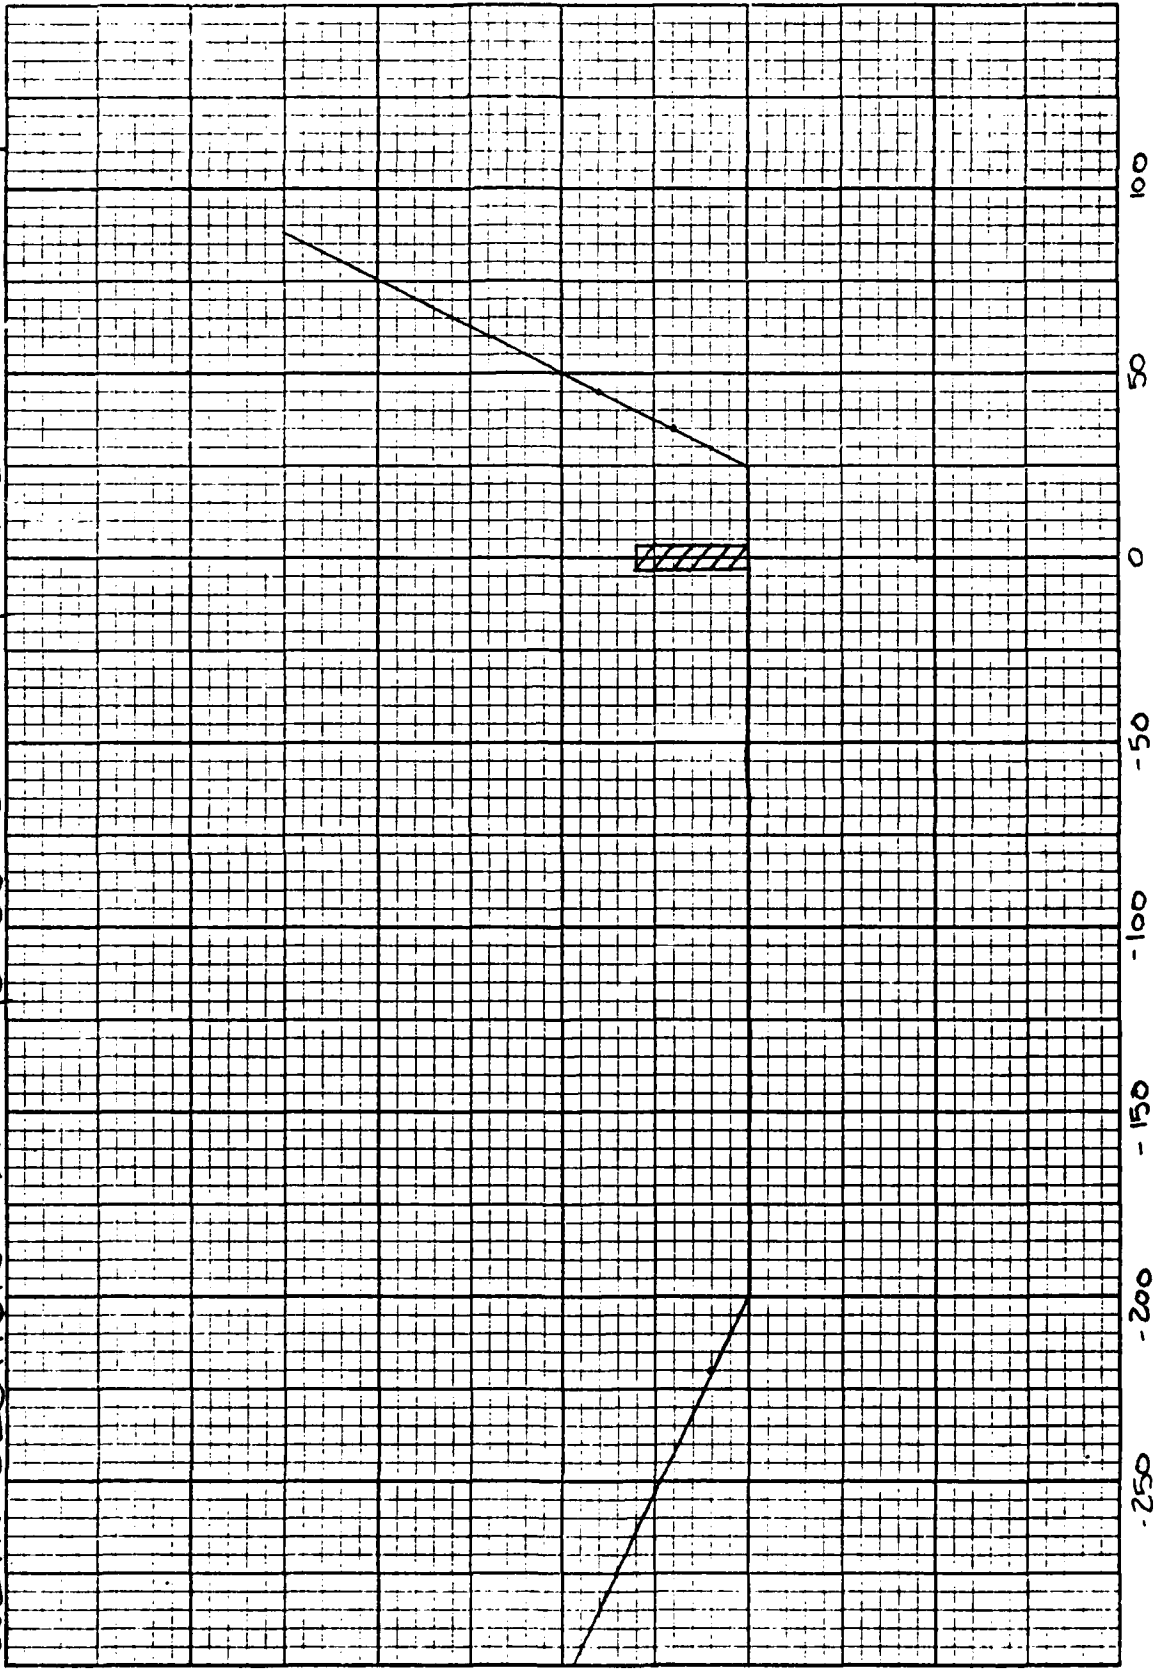
HEIGHT ABOVE ROAD (FEET)

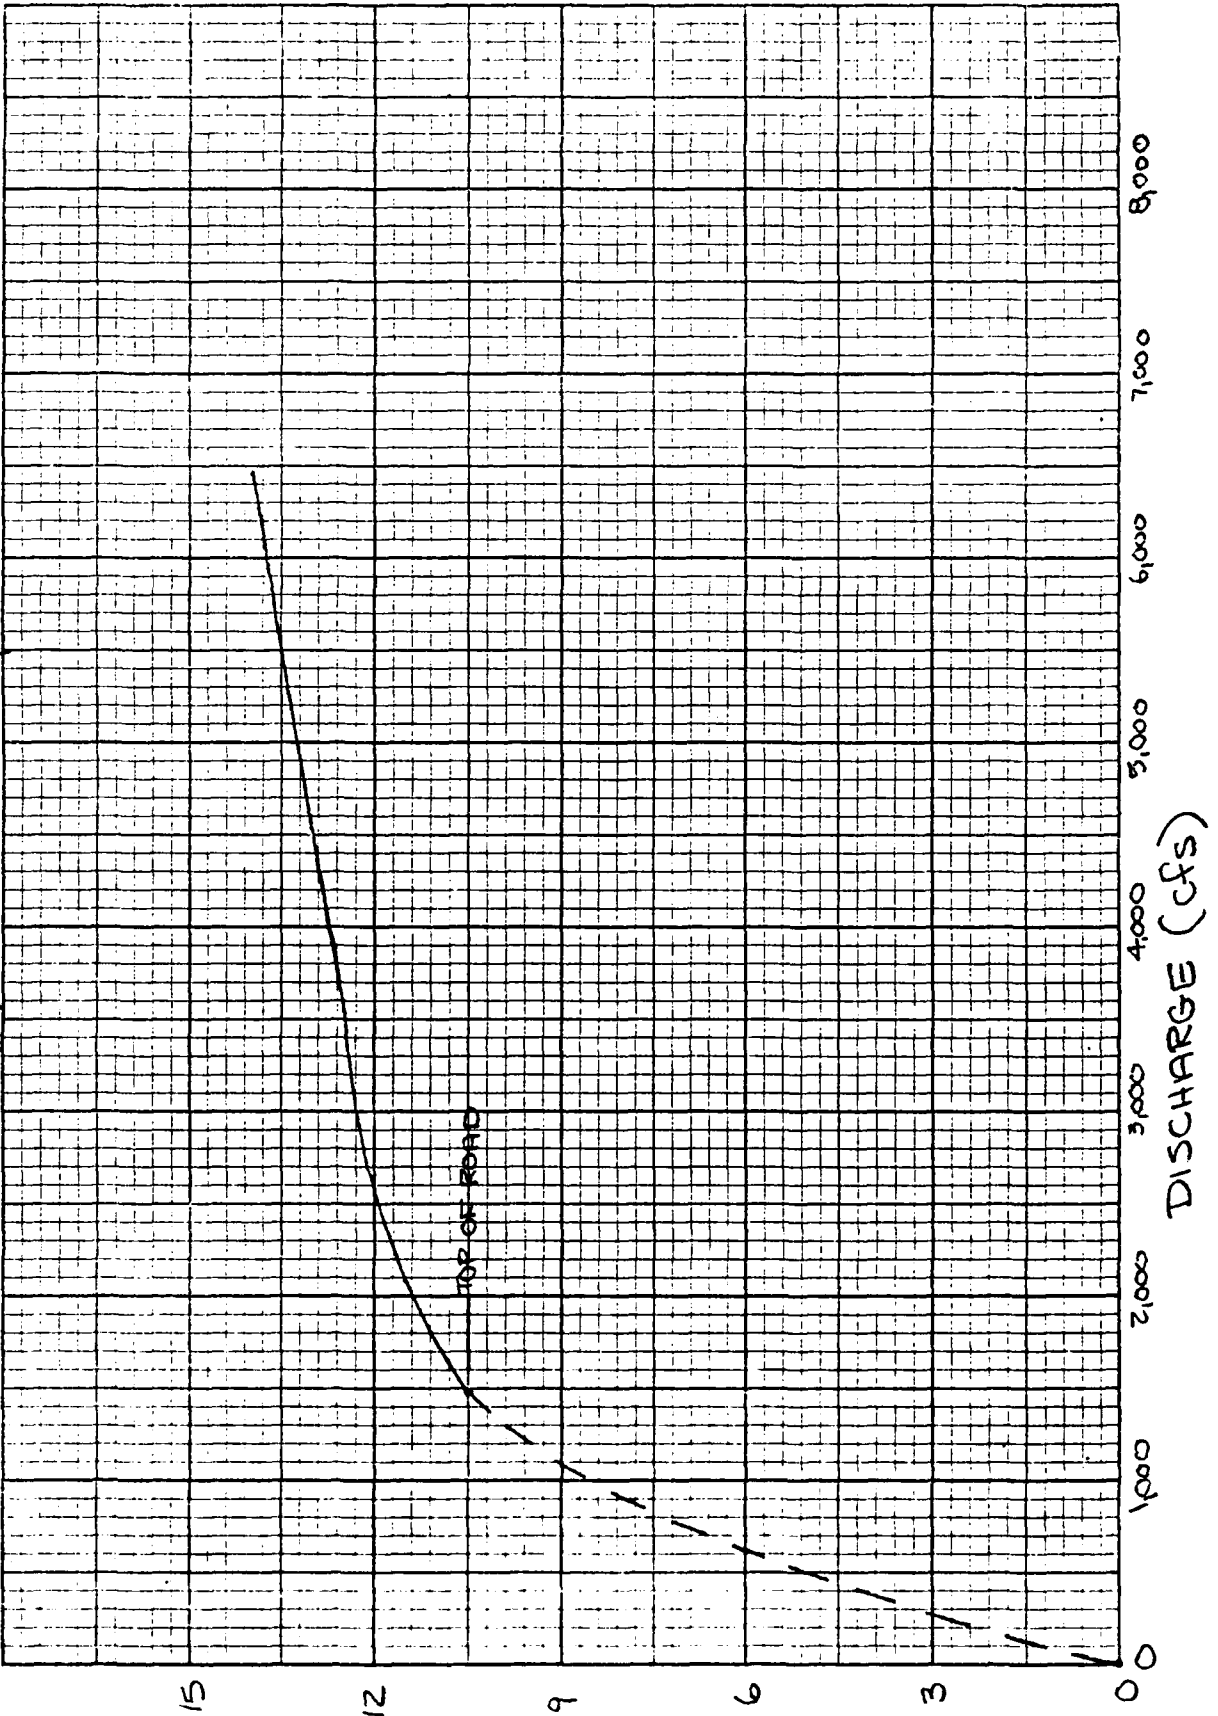
CHESHAM POND DAM
RATING CURVE - 2ND d/s culvert - D/S HAZARD ANALYSIS
