CONNECTICUT RIVER BASIN  
HANOVER, NEW HAMPSHIRE

## LOWER RESERVOIR DAM

NH 00048

### PHASE I INSPECTION REPORT NATIONAL DAM INSPECTION PROGRAM

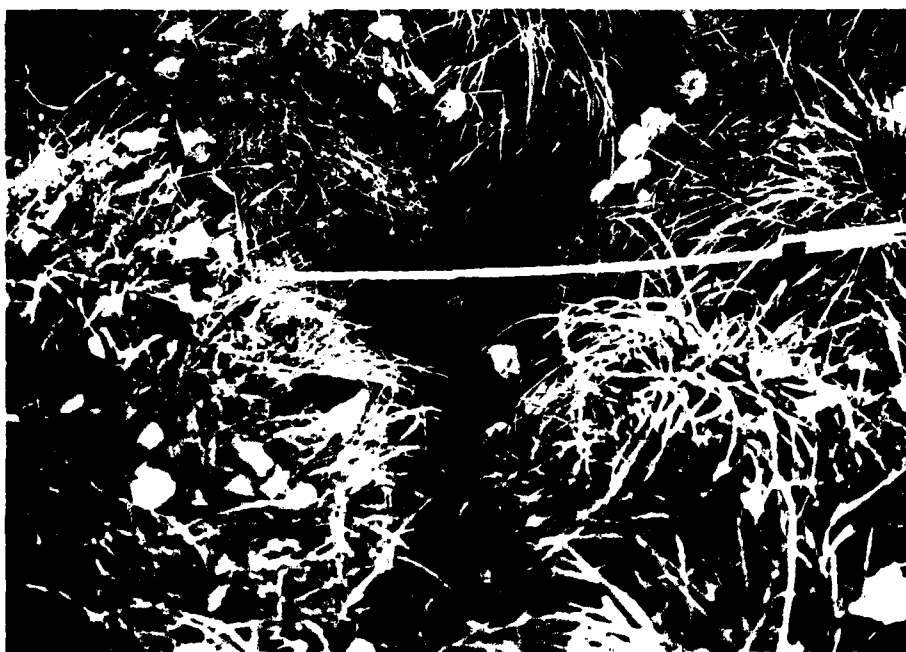
There is caving and erosion of the embankment immediately behind the masonry section of the right training wall of the spillway. This erosion is shown in Photo No. 5. This erosion channel is 4 feet deep, about 2 feet wide, and extends for a distance of about 5 feet along the training wall. The erosion has been caused by surface water runoff. No sign of seepage through the embankment was observed inside the eroded void.

PHOTO NO. 5 - Caving and erosion immediately behind the  
masonry section of the right training wall.

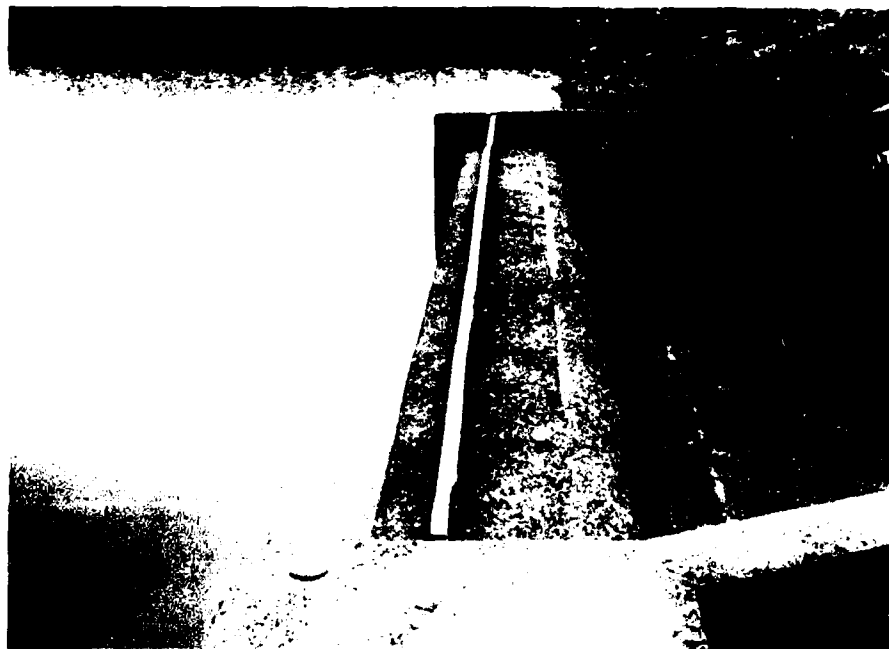
The flashboards on the spillway crest were in good condition. However, there is no means of removing the flashboards during high water without exposing personnel to hazardous conditions.

PHOTO NO. 7 - Weir crest and flashboards of the spillway.

(c) Devise a means to allow removal of the flashboards during high water so that personnel will not be exposed to hazardous conditions during the removal operation.

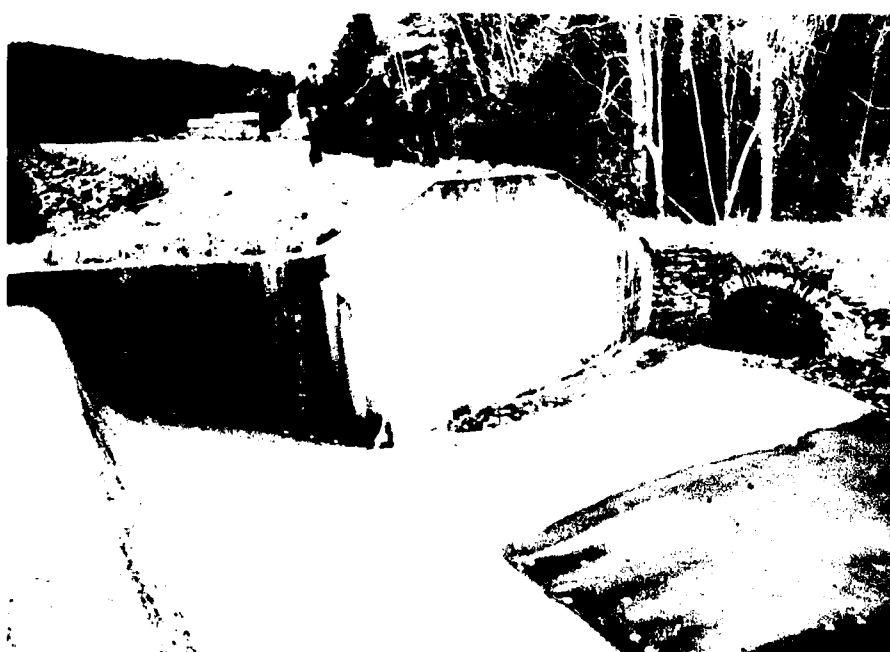
PHOTO NO. 13 - Masonry bridge at downstream end of spillway section.

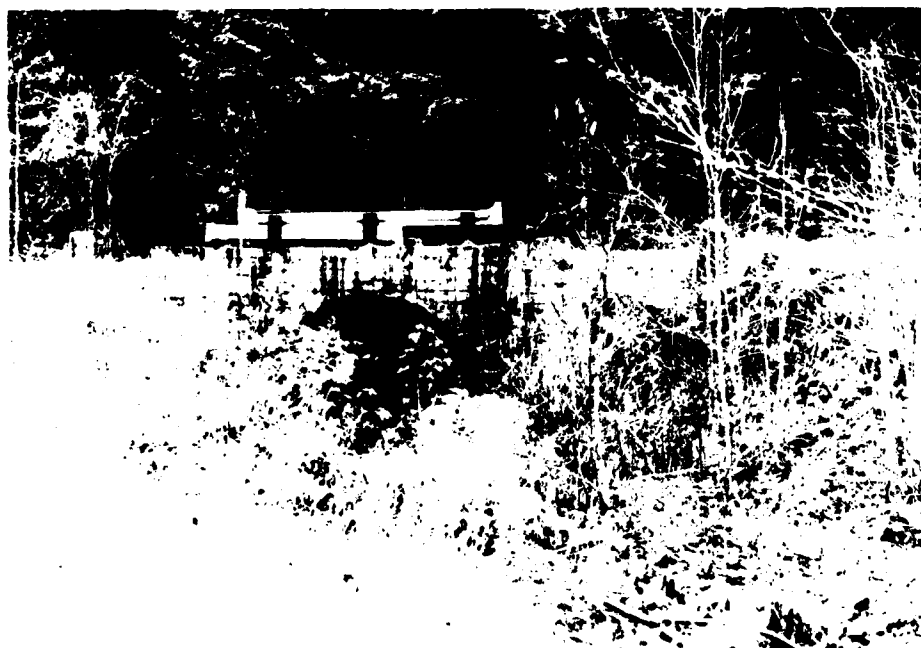
PHOTO NO. 21 - Reservoir road bridge over Camp Brook located about 3000 feet downstream of the dam.
